ASBESTOS & LEAD PAINT SURVEY REPORT

**HARLEM LINE
HARTSDALE STATION
HARTSDALE, NY 10530**

**PROJECT: CAPITAL – HARLEM LINE – HARTSDALE STATION:
PEDESTRIAN OVERPASS, PLATFORMS & STAIRCASES REPAIRS**

EPM's Project No. 18041-2

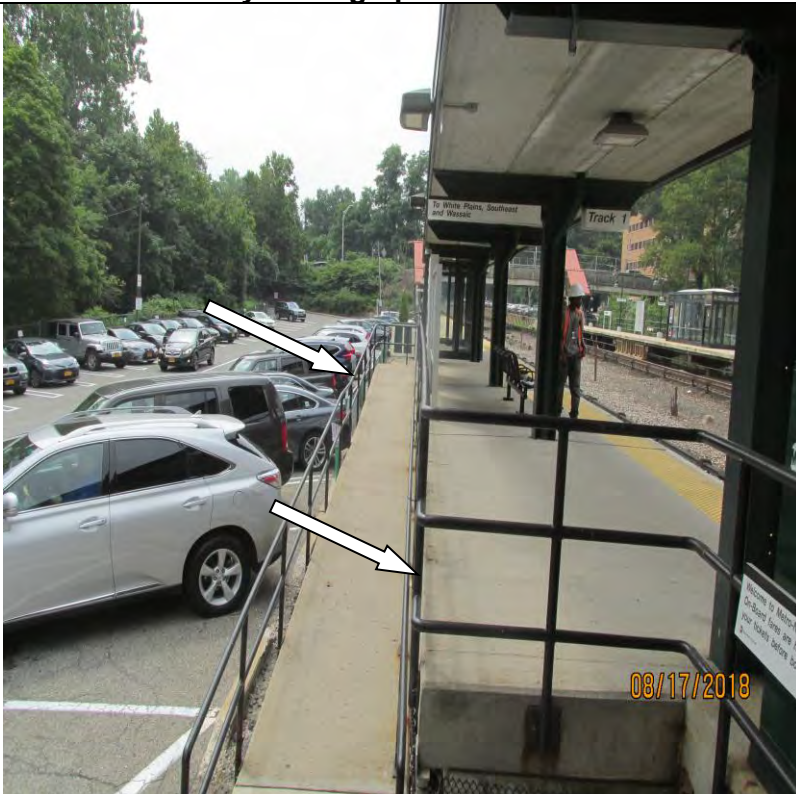
**Photo
No. 7**

Location: Outbound Platform - center

Description: Lead containing black paint on metal railing of ramp (Reading No. 310).

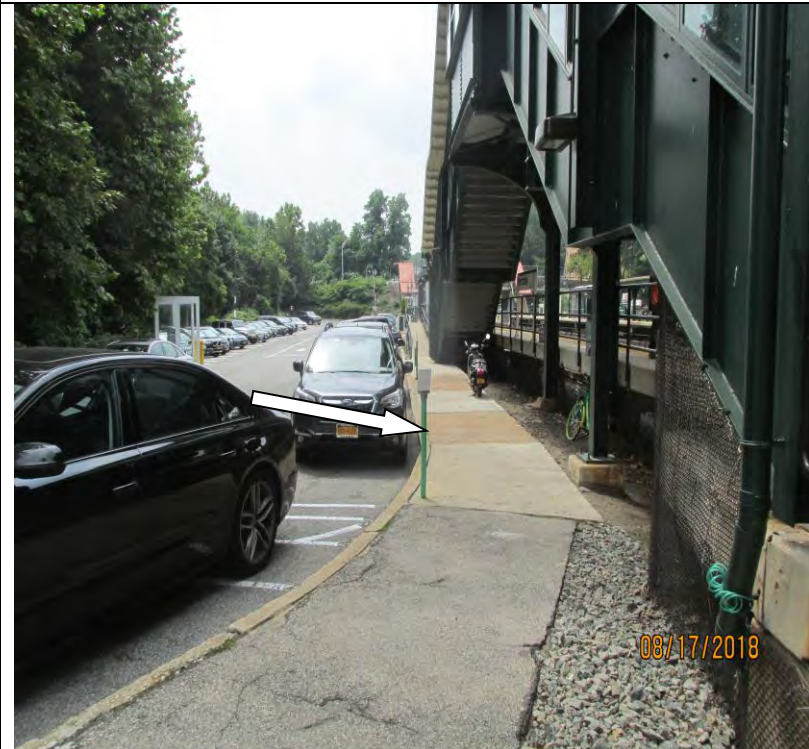
**Photo
No. 8**

Location: Parking Lot adjacent to out bound platform
