ASBESTOS & LEAD PAINT SURVEY REPORT

**MNR HARLEM LINE
PURDY'S STATION
PURDYS, NY 10589**

PROJECT: STATION IMPROVEMENTS

EPM's Project No. 18041-81

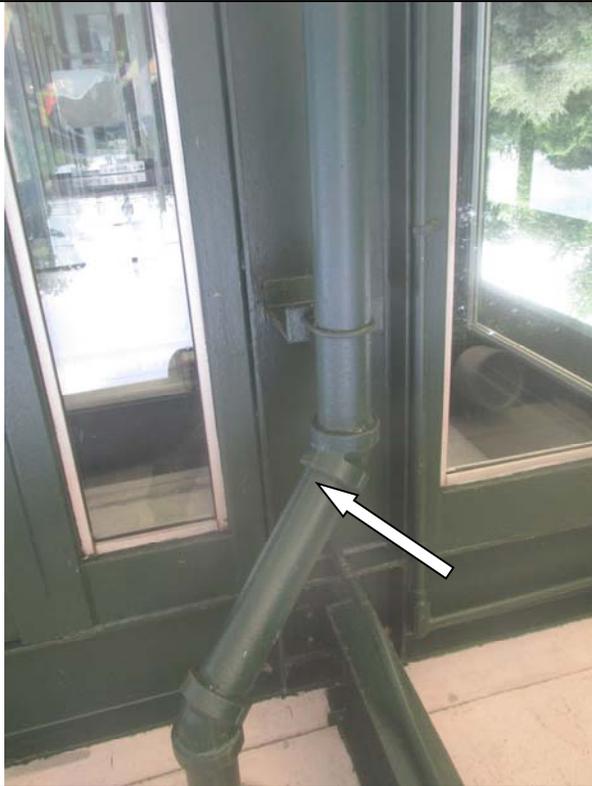
Photo No. 5

Location: Platform - middle section (near shelter)
Description: Lead containing green paint on metal drain pipe. (Reading No. 49).

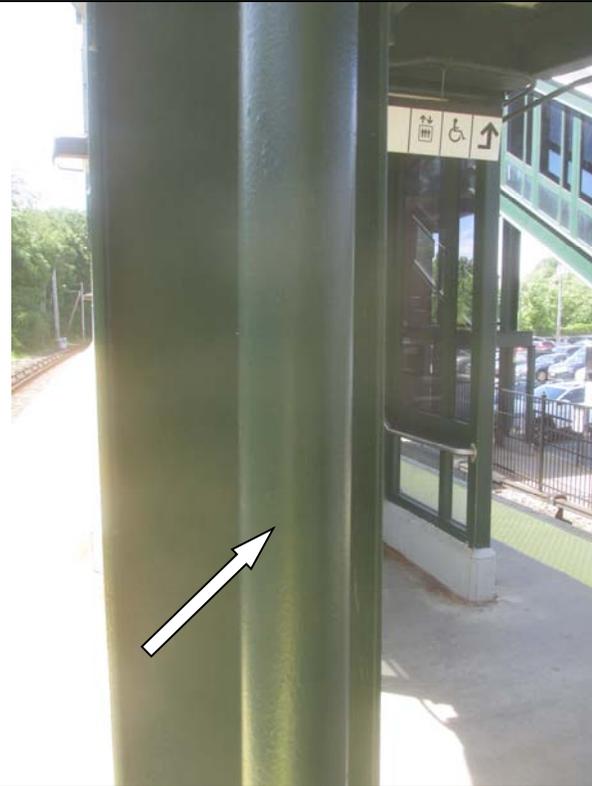
Photo No. 6

Location: Platform - middle section (near stairs)
Description: Lead containing green paint on metal drain pipe. (Reading No. 53).

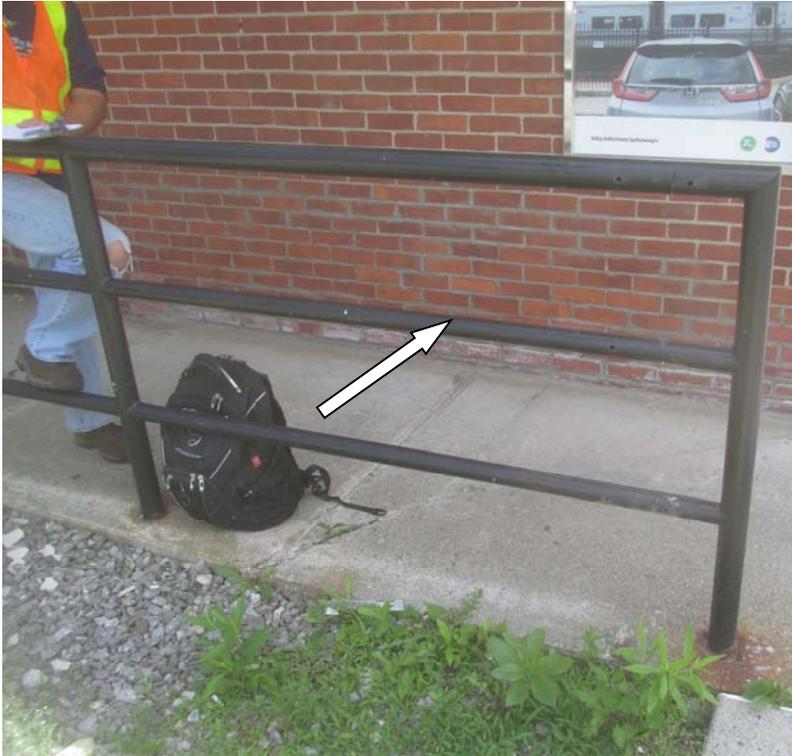
**Photo
No. 15**

Location: Concession Building, exterior
Description: Lead containing black paint on metal railing.
(Reading No. 113)

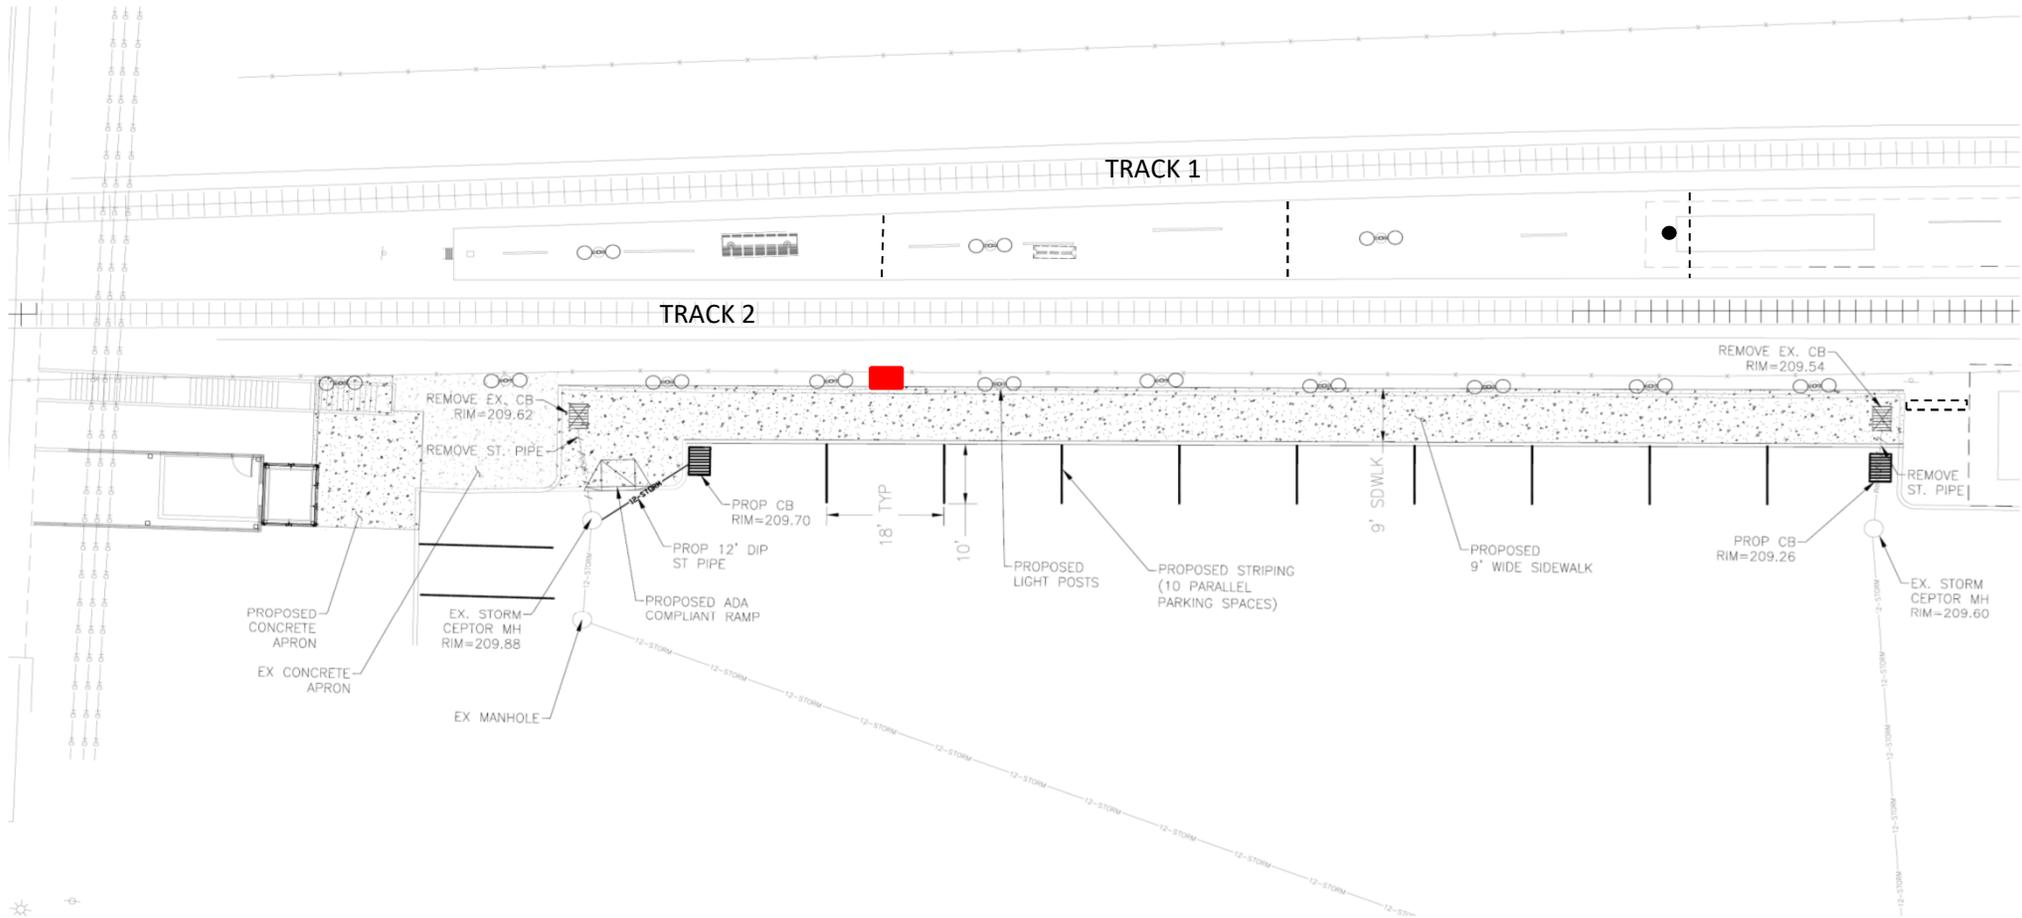
■ PACM ELECTRICAL WIRE INSULATION ON THREE FEEDER CABLES IN ELECTRICAL METER BOX. NO IMPACT ANTICIPATED
