Tremco Roof Condition Assessment

North Rockland High School

June 27th, 2021

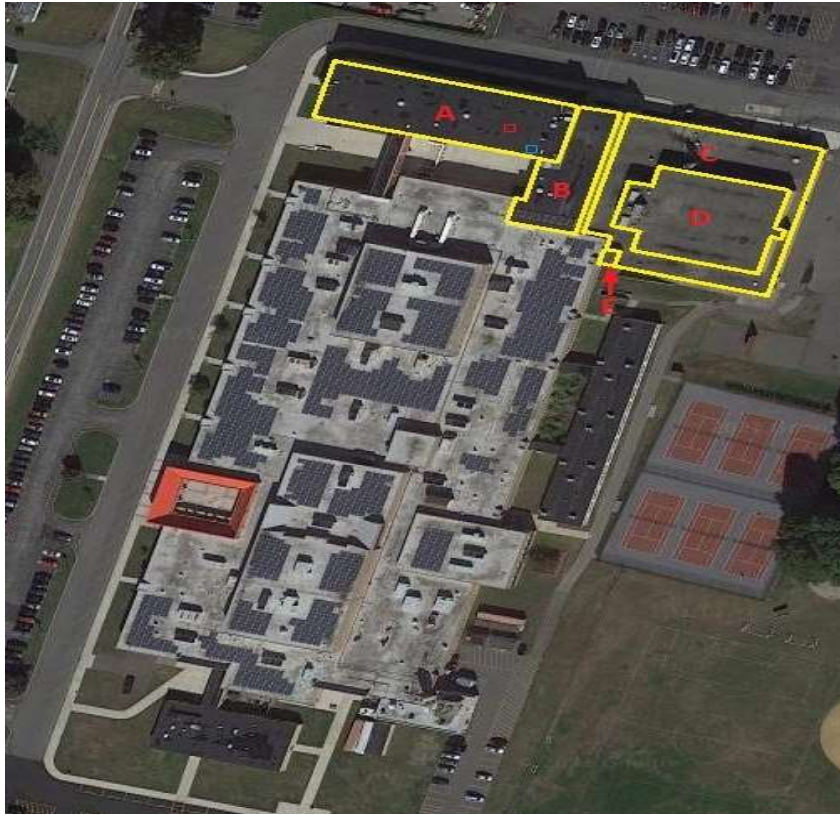
- EPDM
- 3" Iso
- ½" coverboard
- Sloped Lightweight Concrete deck

- EPDM
- 2 ½" Iso
- ½" coverboard
- Sloped Lightweight Concrete deck

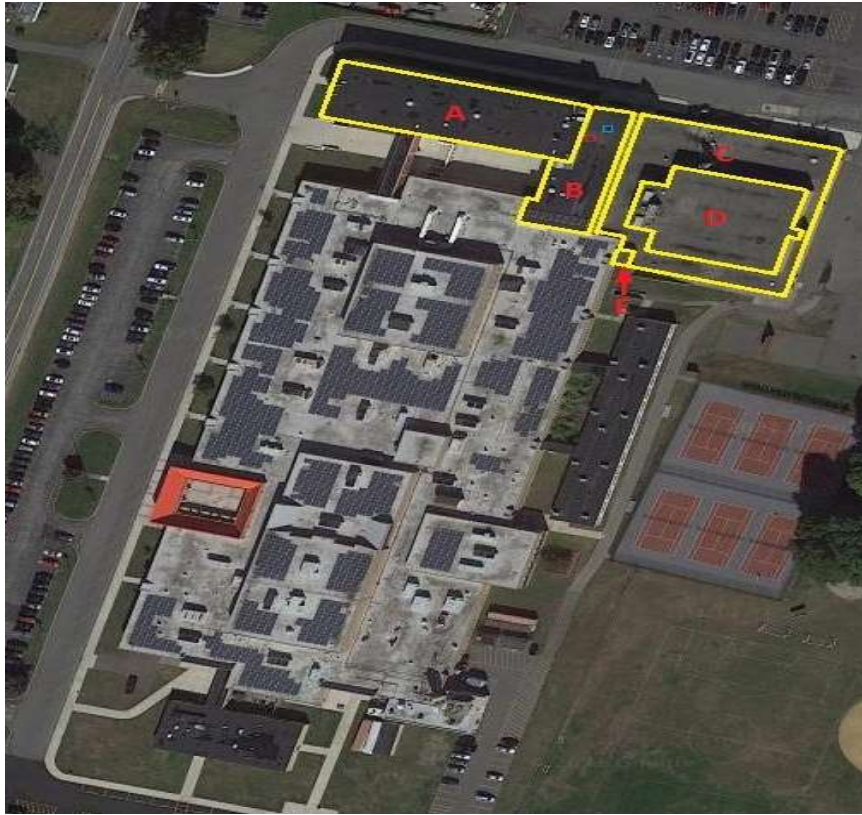
- EPDM
- 2" Iso
- ½" coverboard
- Sloped Lightweight Concrete deck

- EPDM
- 3" Iso
- ½" coverboard
- Sloped Lightweight Concrete deck

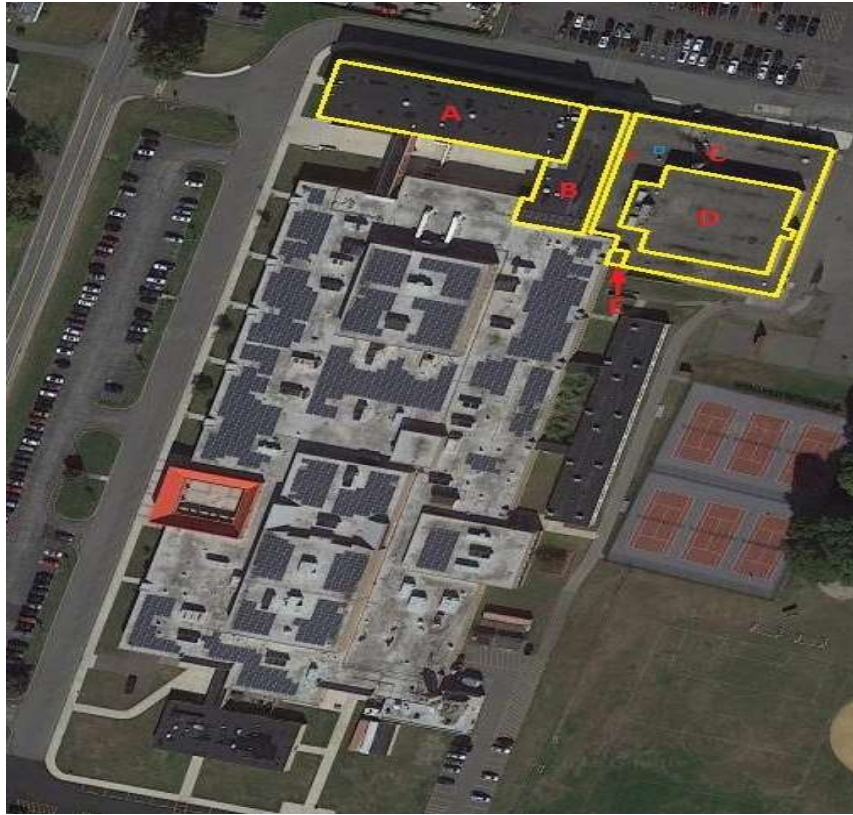
- Ballasted EPDM
- 3" Iso
- 1/2" coverboard
- Sloped Lightweight Concrete deck

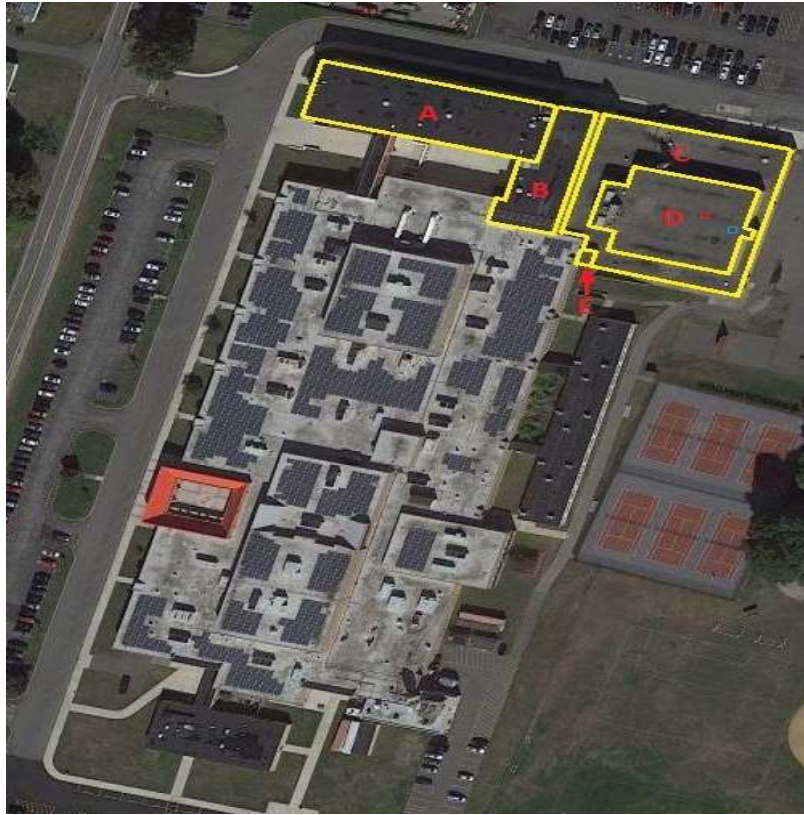
- Ballasted EPDM
- 5" Iso
- ½" coverboard
- Sloped Lightweight Concrete deck

- Ballasted EPDM
- 3" Iso
- ½" coverboard
- Sloped Lightweight Concrete deck

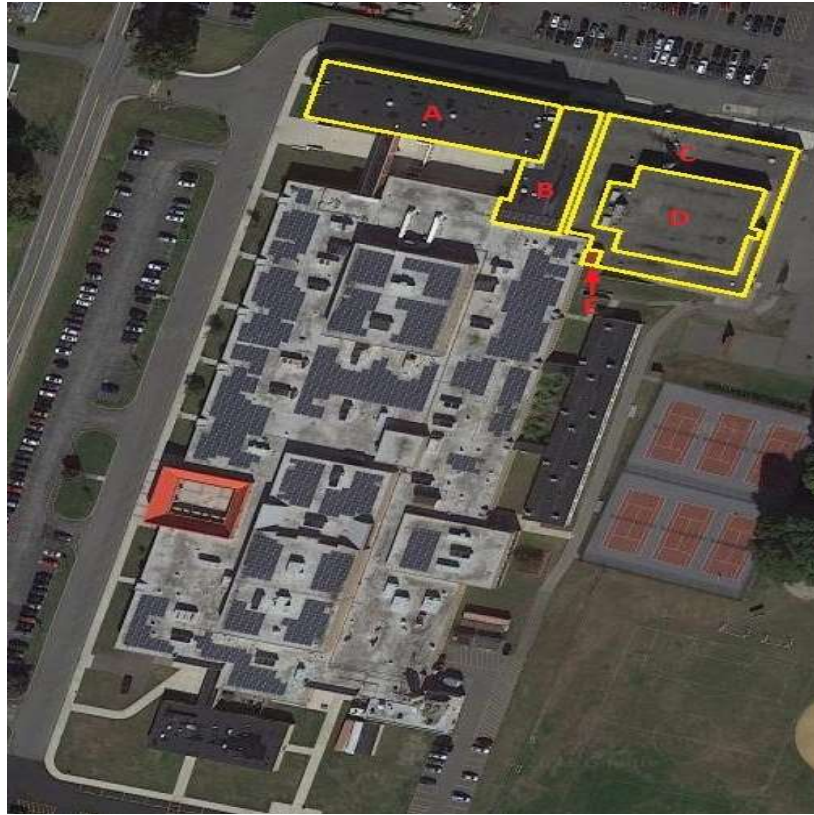
- Ballasted EPDM
- 3" Iso
- ½" coverboard
- Sloped Lightweight Concrete deck

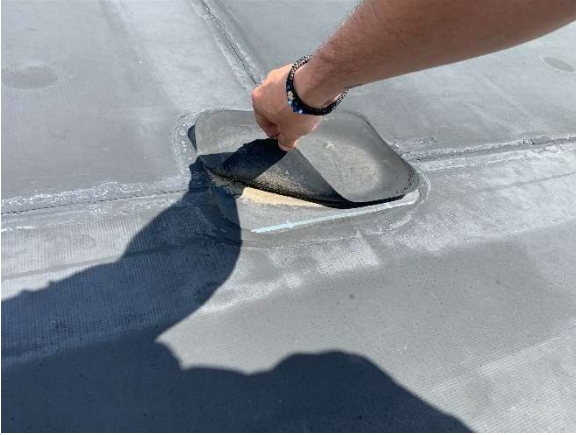
Open patch.

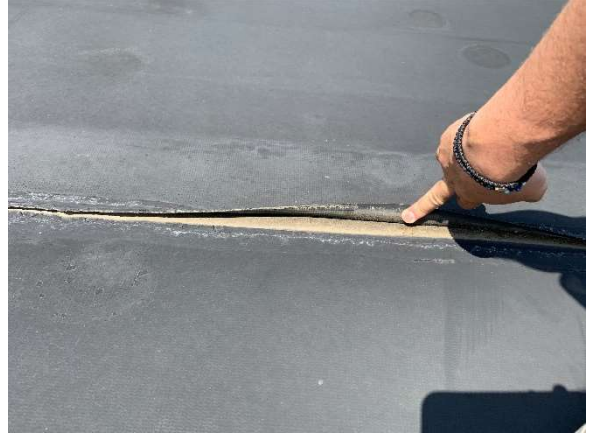
Open Seam.

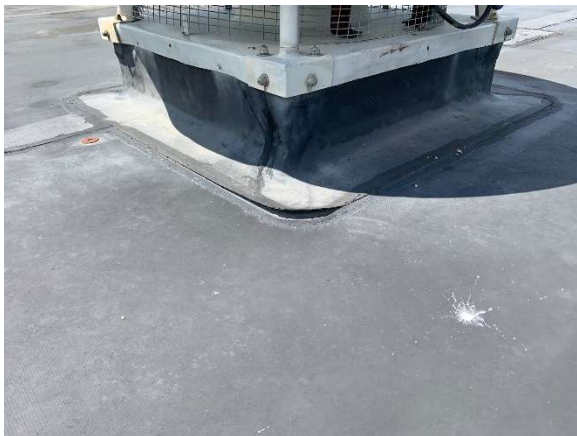
Failing Seam.

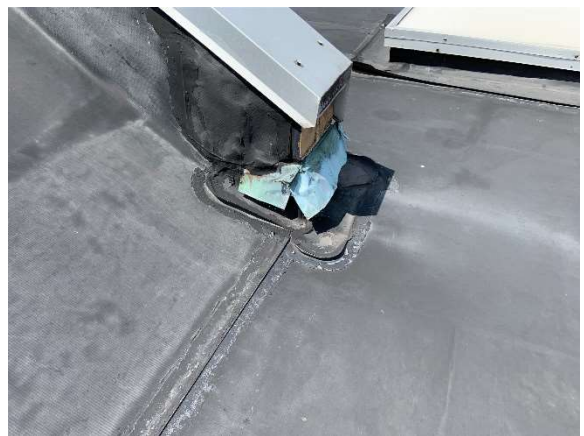
Damaged counter flashing.

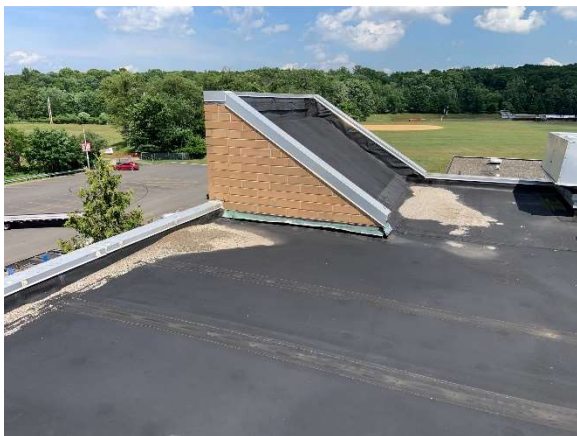
Debris.

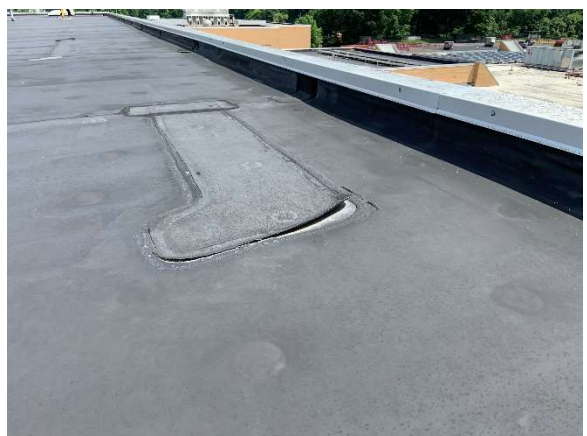
Open patch.

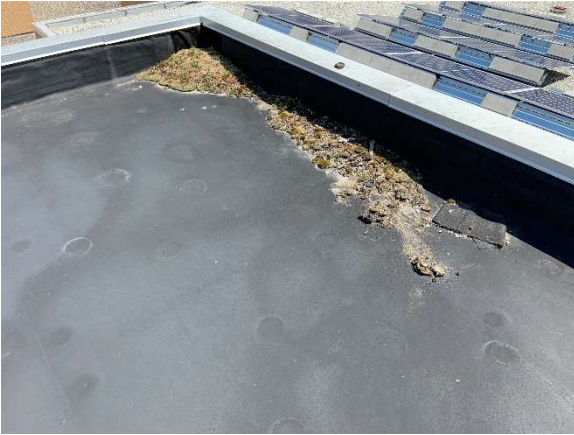
Debris.

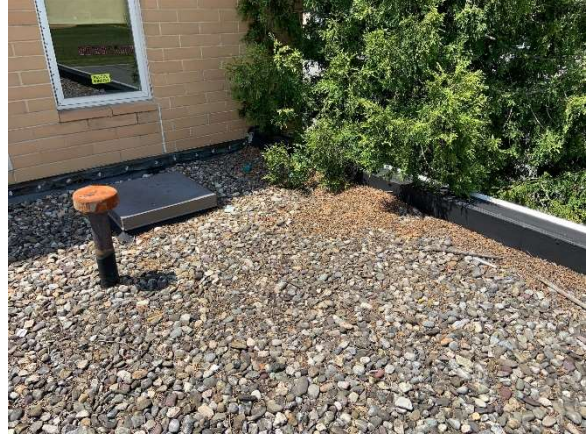
Debris.

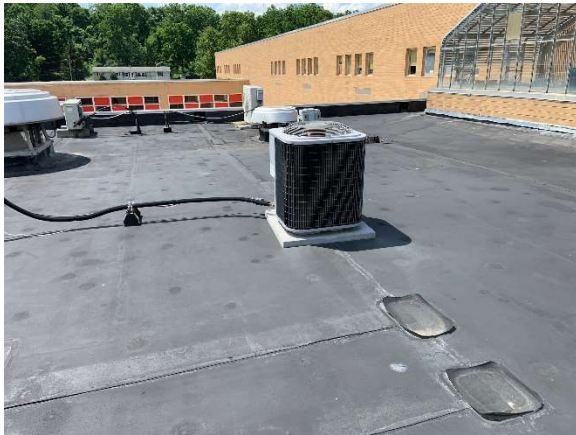
Open patches.

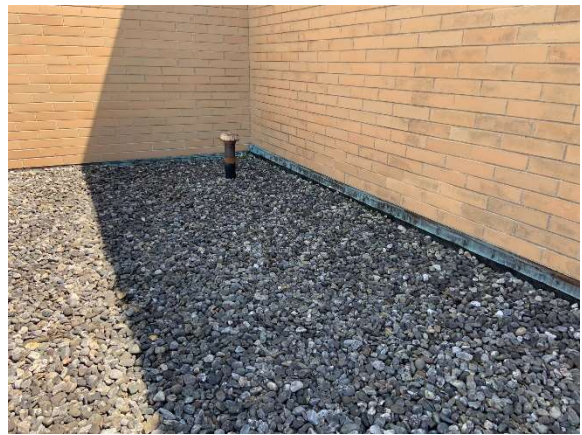
Damaged counter flashing.

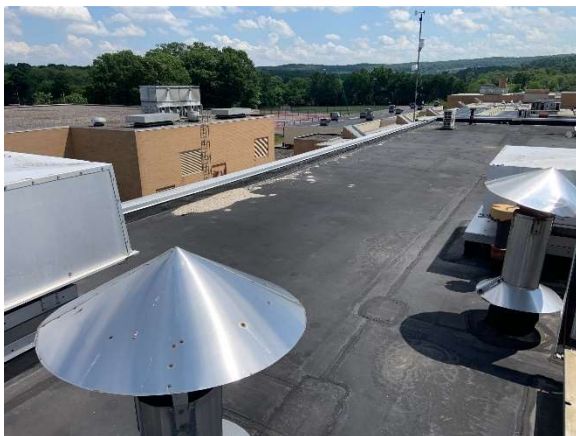
Debris.

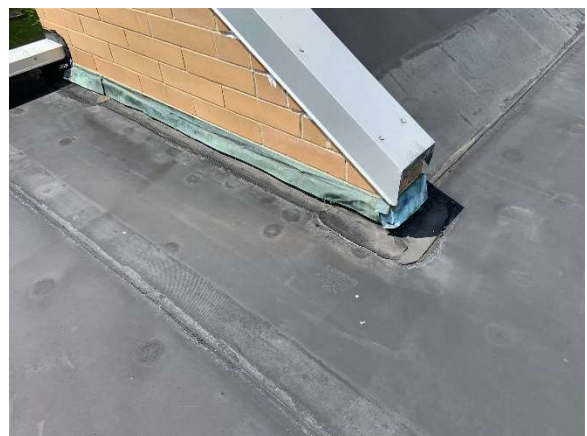
Damaged counter flashing.
