**LIMITED HAZARDOUS MATERIALS SURVEY
CAMP BUCKNER REVITALIZATION
USMA MILITARY RESERVATION
HIGHLAND MILLS, NY
Contract #: W912-DS-18-AE-0007
Task Order #: W912-DS-19-F00XX**

December 26, 2019

Architect-Engineering Services in Support of the Camp Buckner Revitalization
United States Military Academy West Point Military Reservation, Highland Mills, NY
Hazardous Materials Survey
Task Order W912DS19F00XX
Contract Solicitation W912DS-18-AE-0007

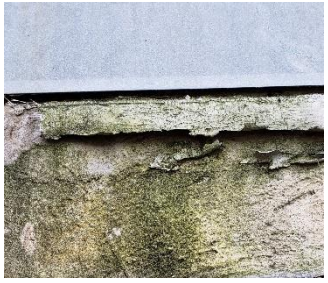
Table 2: Description of Positively-Identified ACM				
Description	Sample #	Location	Asbestos Content	Photograph
PHASE 3 Exterior Vapor Barrier (Homogeneous area #32)	B1516-1114-B94	Building 1516/ Exterior	6.2% - 6.7% Chrysotile

Materials presented in Table 2 and in the list of PACM are RACM. Wherever these materials are found, they shall be removed in accordance with state and federal regulations.

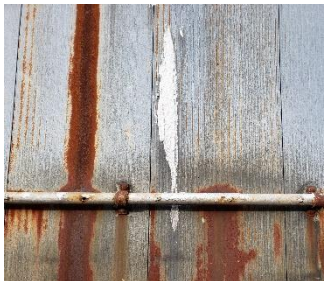
B1516-1114-B98	Building 1516/ Exterior	Not Analyzed/ Positive Stop	
	B1516-1114-B99	Building 1516/ Exterior	Not Analyzed/ Positive Stop	
PHASE 3 Exterior Silver Paint (Homogeneous area #34)	B1516-1114-B100	Building 1516/ Exterior	2.6% - 4.1% Chrysotile

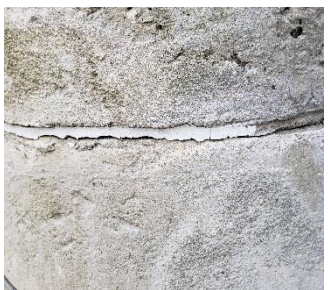
B1516-1114-B101	Building 1516/ Exterior	Not Analyzed/ Positive Stop	
	B1516-1114-B102	Building 1516/ Exterior	Not Analyzed/ Positive Stop	
PHASE 3 Exterior Grey Caulk (Homogeneous area #39)	B1520-1114-B115	Building 1520/ Exterior	8.8% Chrysotile

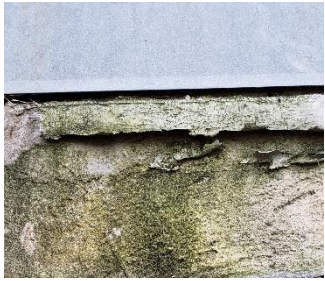
Table 2: Description of Positively-Identified ACM				
Description	Sample #	Location	Asbestos Content	Photograph
PHASE 3 Cloth Vapor Barrier (Homogeneous area #42)	B1520-1114-B124	Building 1520/ Exterior	7.8% Chrysotile

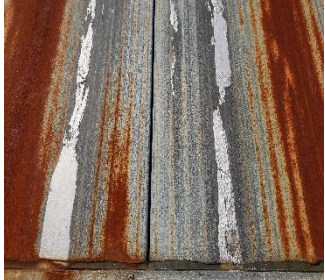
B1520-1114-B125	Building 1520/ Exterior	Not Analyzed/ Positive Stop	
	B1520-1114-B126	Building 1520/ Exterior	Not Analyzed/ Positive Stop	
PHASE 3 Exterior Silver Paint (Homogeneous area #44)	B1520-1114-B130	Building 1520/ Exterior	4.6% Chrysotile

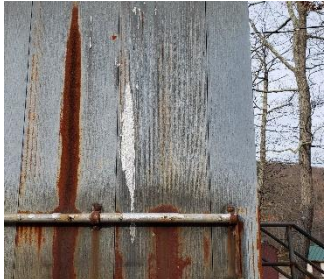
B1520-1114-B131	Building 1520/ Exterior	Not Analyzed/ Positive Stop	
	B1520-1114-B132	Building 1520/ Exterior	Not Analyzed/ Positive Stop	
PHASE 2 Exterior Silver Paint (Homogeneous area #58)	B1503-1114-B173	Building 1503/ Exterior	4.4% Chrysotile

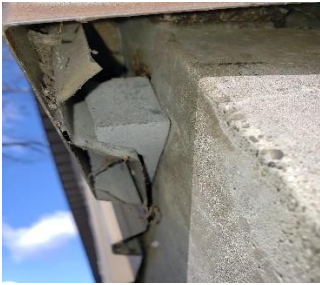
Table 3: Description of Materials with Trace Asbestos (<1%)				
Description	Sample #	Location	Asbestos Content	Photograph
PHASE 1 Exterior Caulk (Homogeneous area #06)	B1611-1113-B16	Building 1611/ Exterior	Anthophyllite Trace

Materials presented in Table 3 are materials with trace concentrations of asbestos (less than one percent (<1%) asbestos). Work practice requirements and prohibitions as stated in the Construction Asbestos Standard, 29 CFR 1926.1101, must be observed regardless of the exposure levels and of the percentage of asbestos in the materials.

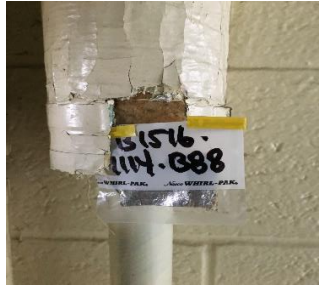
B1611-1113-B17	Building 1611/ Exterior	Anthophyllite Trace	
	B1611-1113-B18	Building 1611/ Exterior	Anthophyllite Trace	
PHASE 3 Outer Wrap on Fiberglass (Homogeneous area #30)	B1516-1114-B88	Building 1516/ Various Locations	Chrysotile Trace

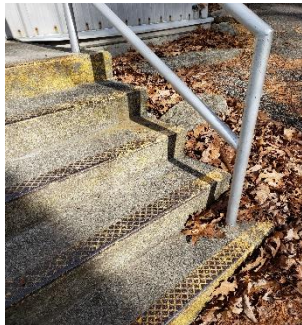
Condition	Intact	
	Location	Both 1500 & 1600 buildings	
Yellow Paint on Exterior Step/Stairs	Max. detected concentration	4.5 mg/cm ²

Condition	Deteriorated	
	Location	Both 1500 & 1600 buildings	
Gray Paint on Gate Door in Arms Room	Max. detected concentration	1.8 mg/cm ²

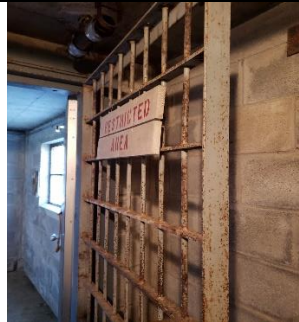
Location	Building 1612

Table 4: Description of Lead-Based Paint Surfaces			
Description/Location	Assessment		Photo
	Condition	Deteriorated

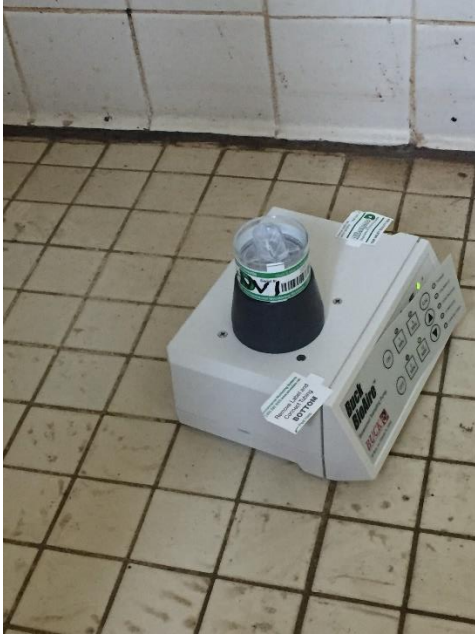
Bldg 1611

Swab samples collected from several buildings at Camp Buckner were analyzed as containing low levels of *Aspergillus/Penicillium*, *Chaetomium*, *Myxomycetes*, and *Cladosporium*. The concentration of these mold types was likely low due to the extremely cold weather conditions at the time of sampling, combined with limited activity (water source) in the showers since the summer months.

Non-viable air samples collected in the showers of several barracks detected elevated levels of mold in relation to the ambient samples. Ambient mold concentrations were likely low due to cold ambient conditions at the time of sampling. Analysis detected concentrations of *Cladosporium* at a much higher concentration than background ambient air samples. However, *Cladosporium* was detected as the dominant mold species in ambient background air samples as well. Non-viable air samples also detected *Aspergillus/Penicillium*, *Chaetomium*, and *Myxomycetes*. All mold species detected on the swab samples of the shower walls were also detected on the non-viable air samples.

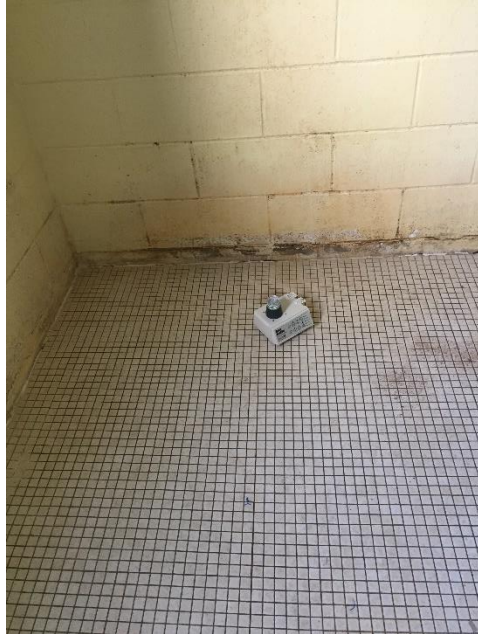
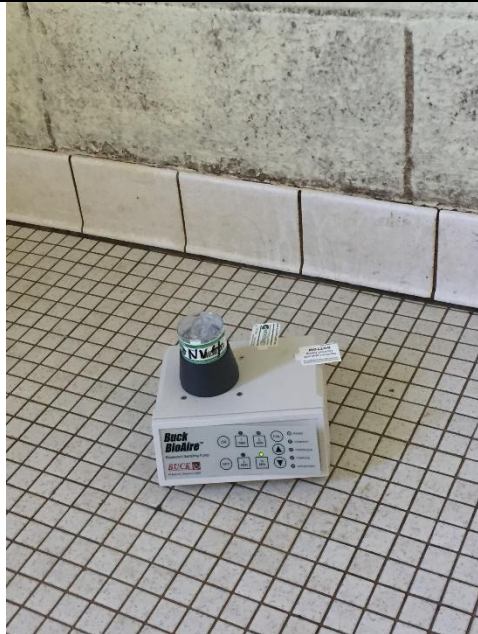
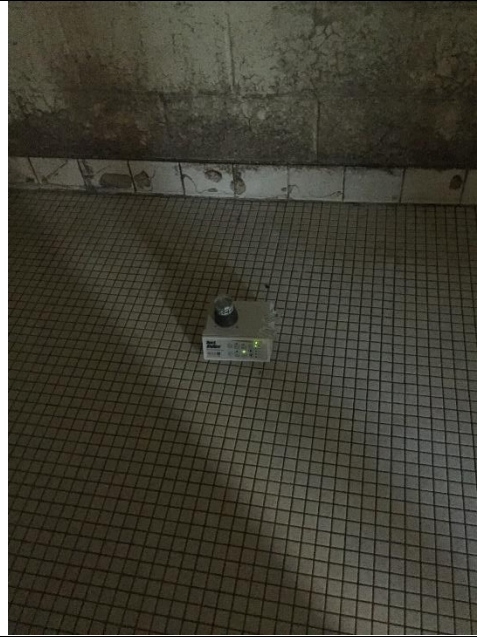
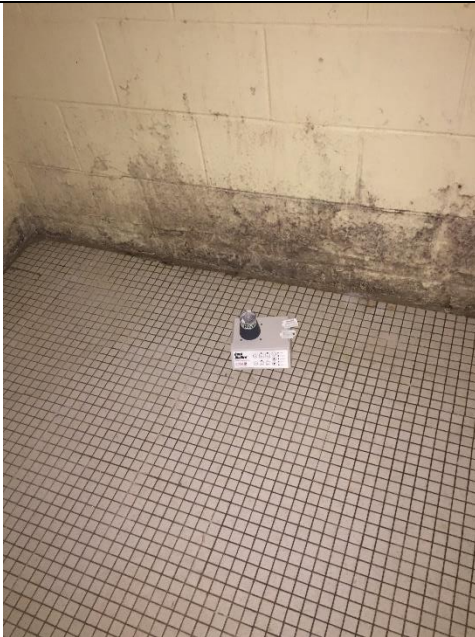
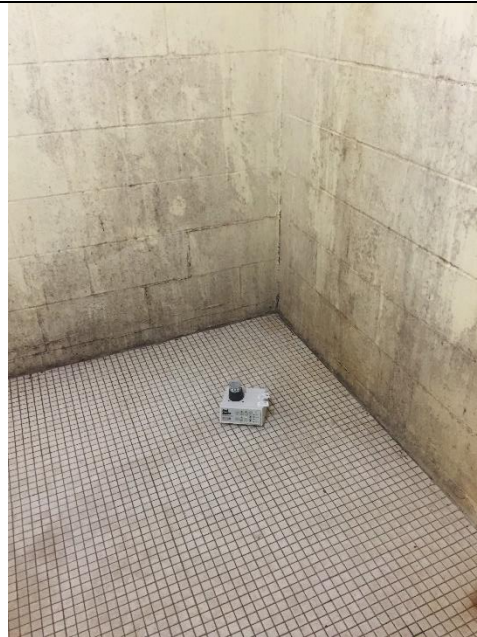
GCI's New York State-licensed mold inspector, Mr. Michael Vollo, License # MA00871 conducted a mold inspection of the Facility. GCI found evidence of apparent microbial growth in the cadet showers.

Typical Shower
