UNITED STATES POSTAL SERVICE
WESTCHESTER DISTRICT

ASBESTOS AND LEAD-BASED PAINT HAZARD CONTROL PROGRAM
FIELD SURVEY REPORT

MID-HUDSON GMF
97 ENTERPRISE DRIVE
NEWBURGH, NY 12555

GEA ENGINEERING, P.C.
365 ROUTE 304
BARDONIA, NY 10954

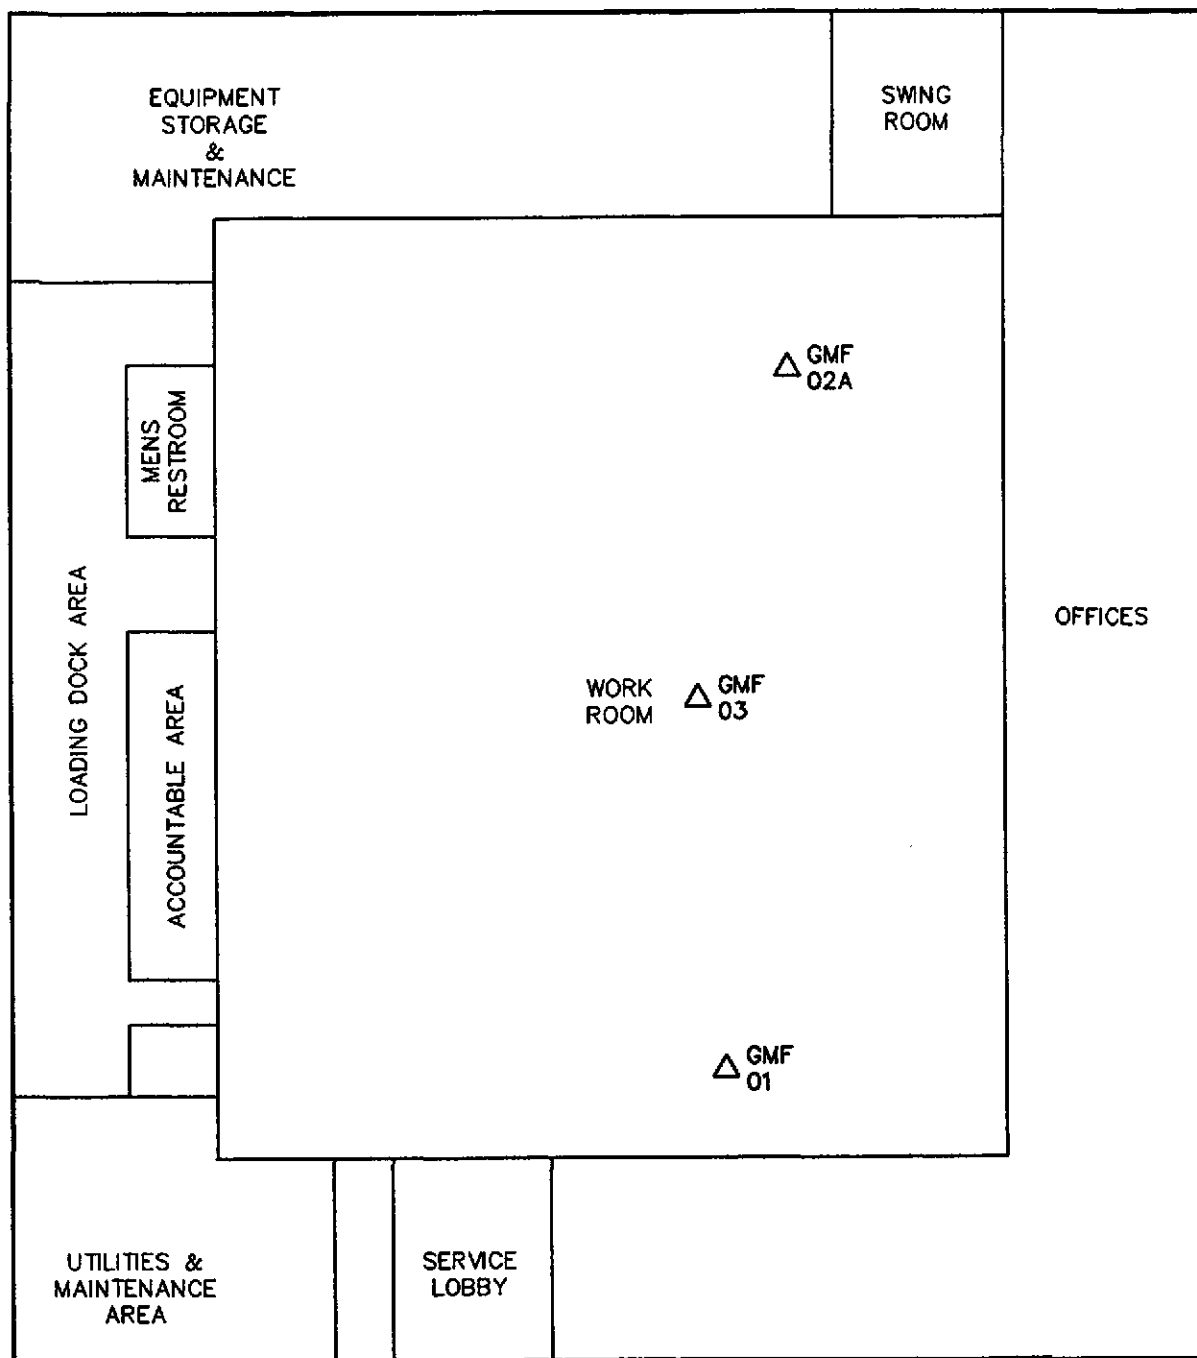
SAMPLE LOCATION PLAN
ASBESTOS AND LEAD-BASED PAINT
HAZARD CONTROL PROGRAM
FIELD SURVEY REPORT
US POST OFFICE
NEWBURGH, NY 12555

SAMPLE NUMBER	LOCATION	MATERIAL	PERCENT ASBESTOS
GMF-01	Work Room Floor @ Lobby	12"X18" Asphaltic Tile	<0.3
GMF-02	Work Room Floor @ B3	12"X18" Asphaltic Tile	0.8
GMF-03	Work Room Floor @ C8	12"X18" Asphaltic Tile	<0.3
