RENOVATION SURVEY FOR ASBESTOS-CONTAINING MATERIALS, LEAD-BASED PAINT & PCBs

DOT Region 8, Orange County
112 Dickson Street
Newburgh, New York 12550-5324
Adelaide Project# OGS:24105.00-IN
OGS Project# Q1858

Jason Fullum
May 14, 2024

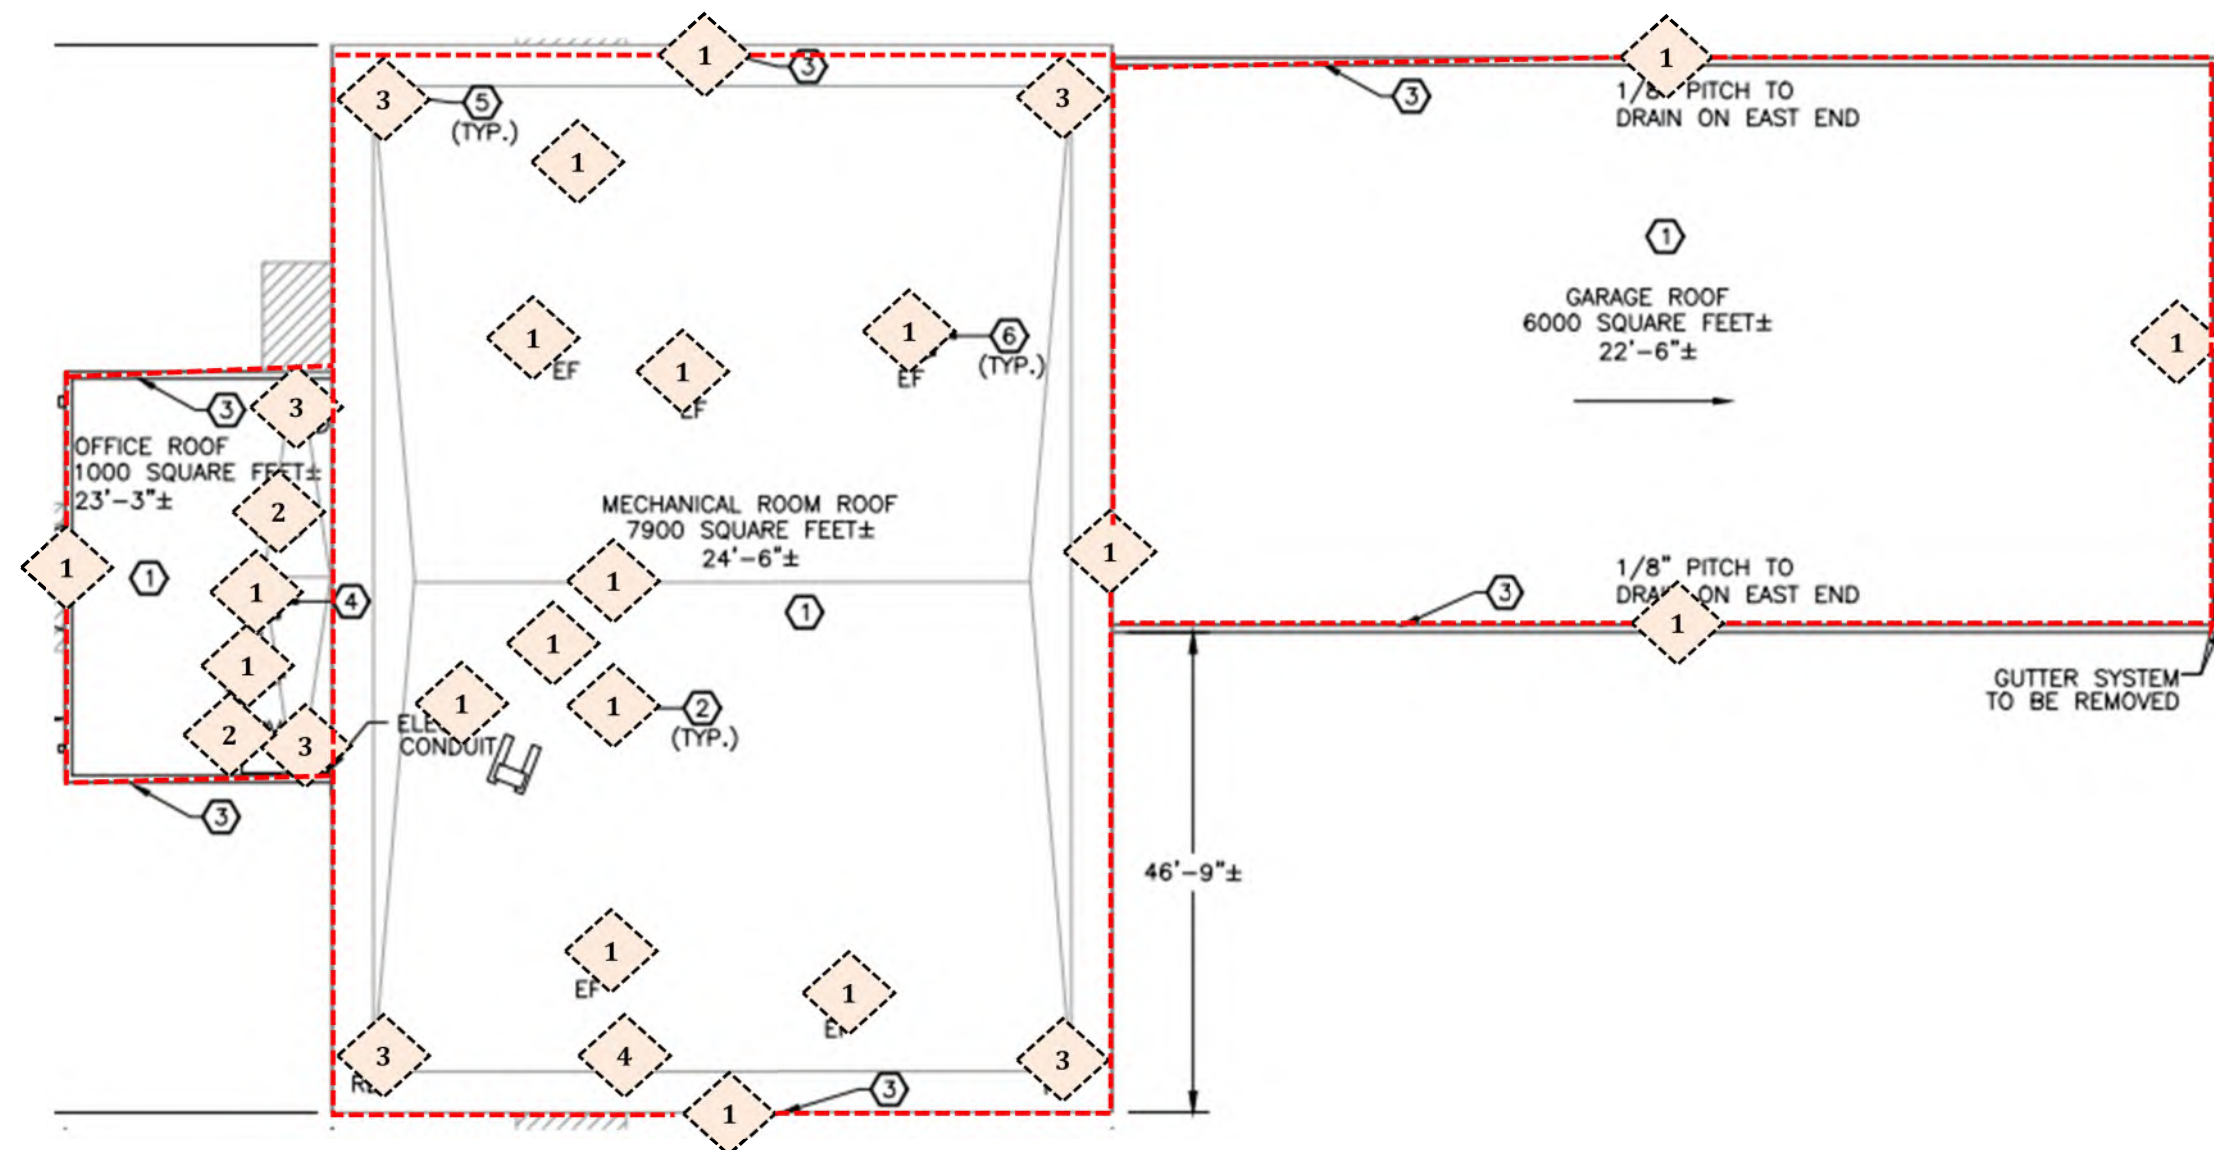
ASB-01

ACM LEGEND: (see report for details)	
1	Flashing Tar - Perimeter, Vents, Fans
2	Black Repair Tar
3	Roof Drain Tar and Pipe Insulation and Fittings on Interior
4	Pitch Pocket Tar

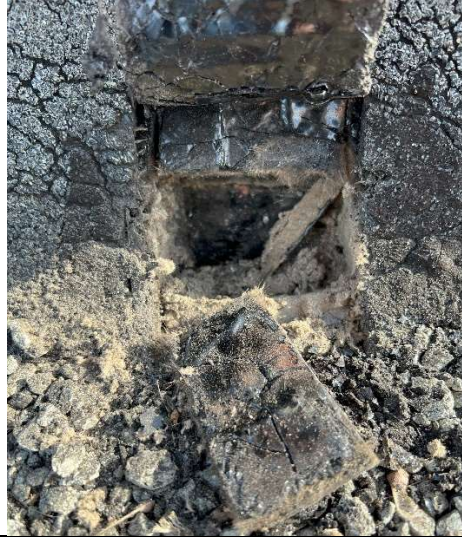
HA #6
Perimeter Flashing Tar
1.8% of Chrysotile

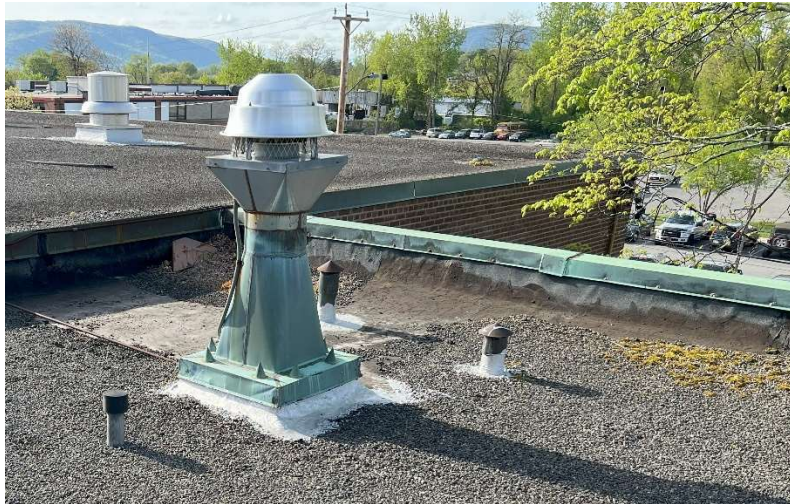
HA #8
Black Repair Tar
3.4% of Chrysotile

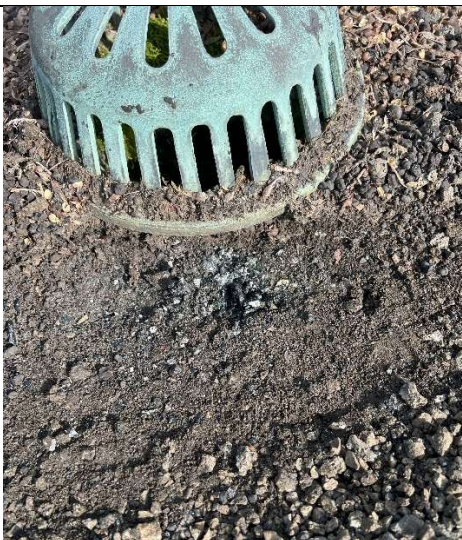
HA #9
Roof Drain Tar
2.1% of Chrysotile

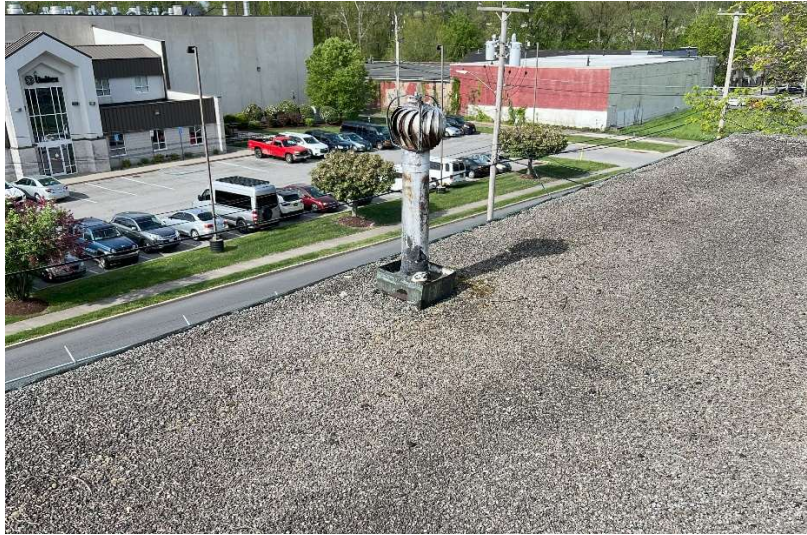
HA #10
Pitch Pocket Tar
2.8% of Chrysotile

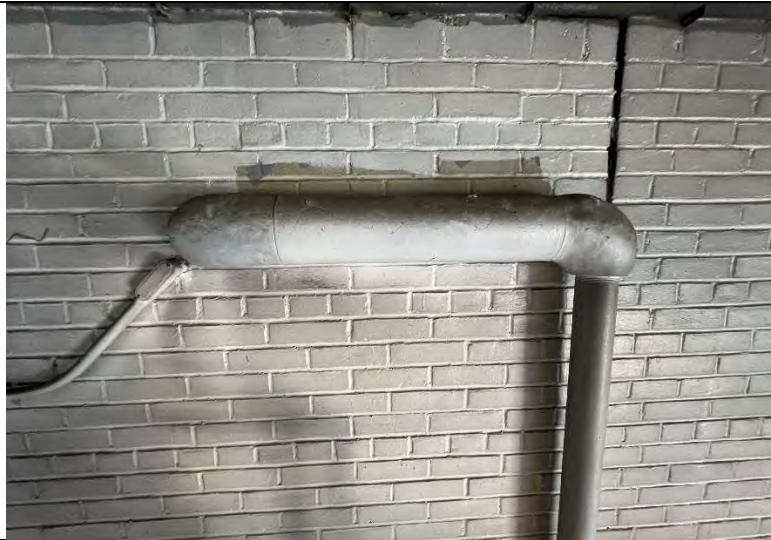
HA #14 & 15
Roof Drain Insulation and
Fittings
3.5% and 30.8% of
Chrysotile
