Valley Central School District 2023 Capital Project - Phase 1

Limited Hazardous Material Pre-Renovation Survey Report

2023 Capital Projects – Phase 1

**RE: Limited Hazardous Material Pre-Renovation Survey Report
Berea Elementary School - 2023 Capital Projects, Phase 1
944 New York State Route 17K, Montgomery, New York 12549
AECC Project Number: 23-075**

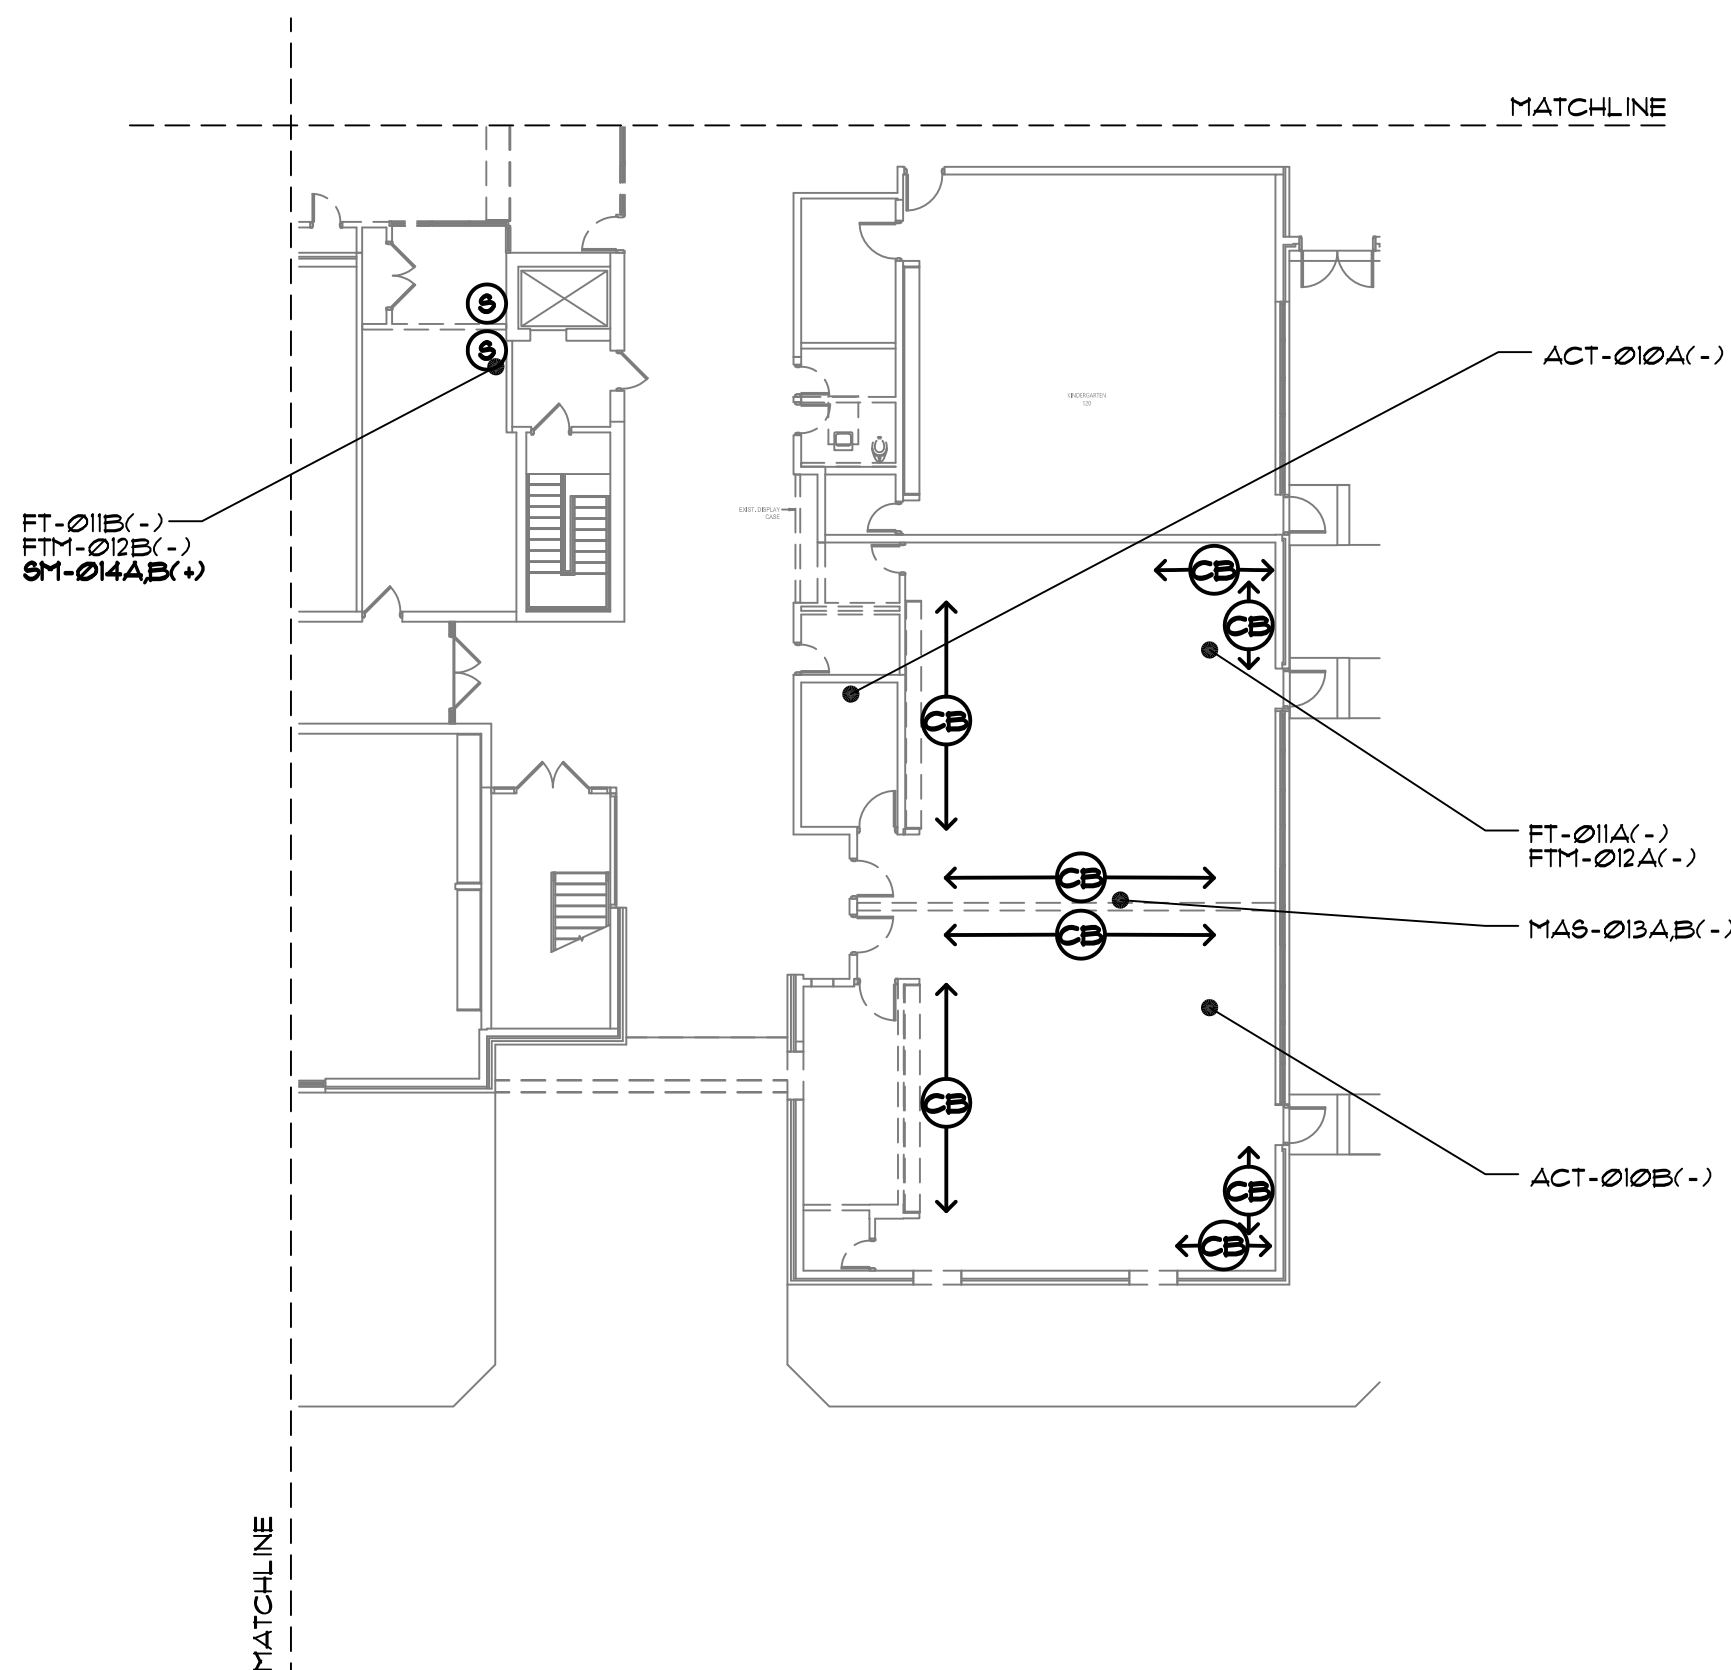
Figures 1 & 2

CB PRESUMED ASBESTOS-CONTAINING CHALKBOARD / CORKBOARD MASTIC

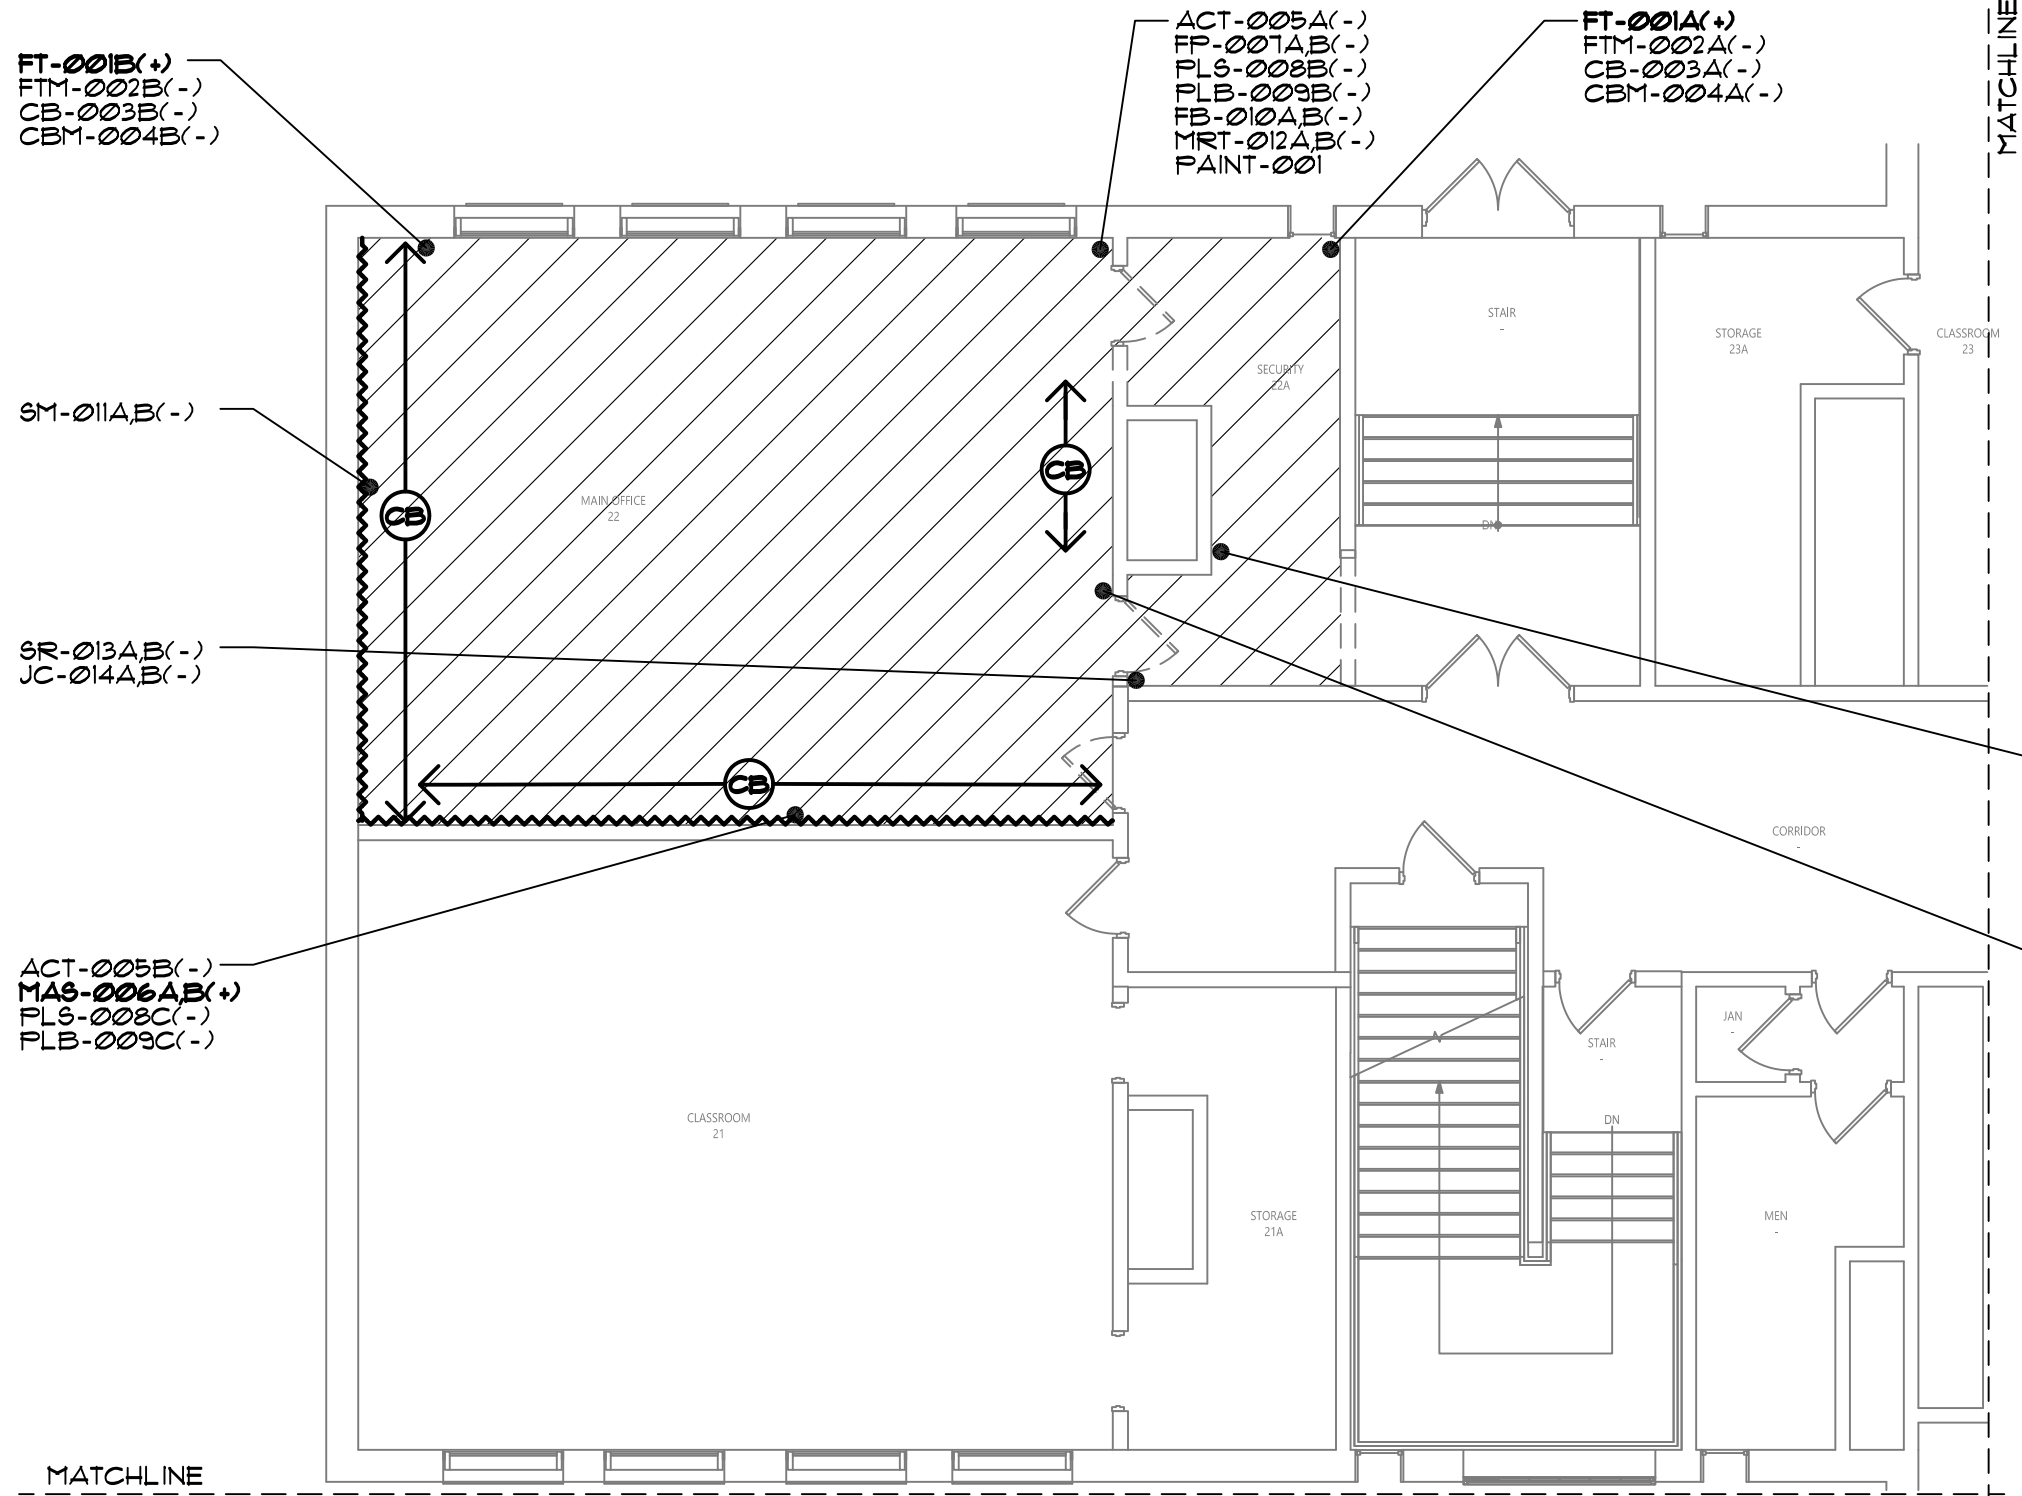
Figure 1

PRESUMED ASBESTOS-CONTAINING CHALKBOARD AND/OR CORKBOARD MASTIC

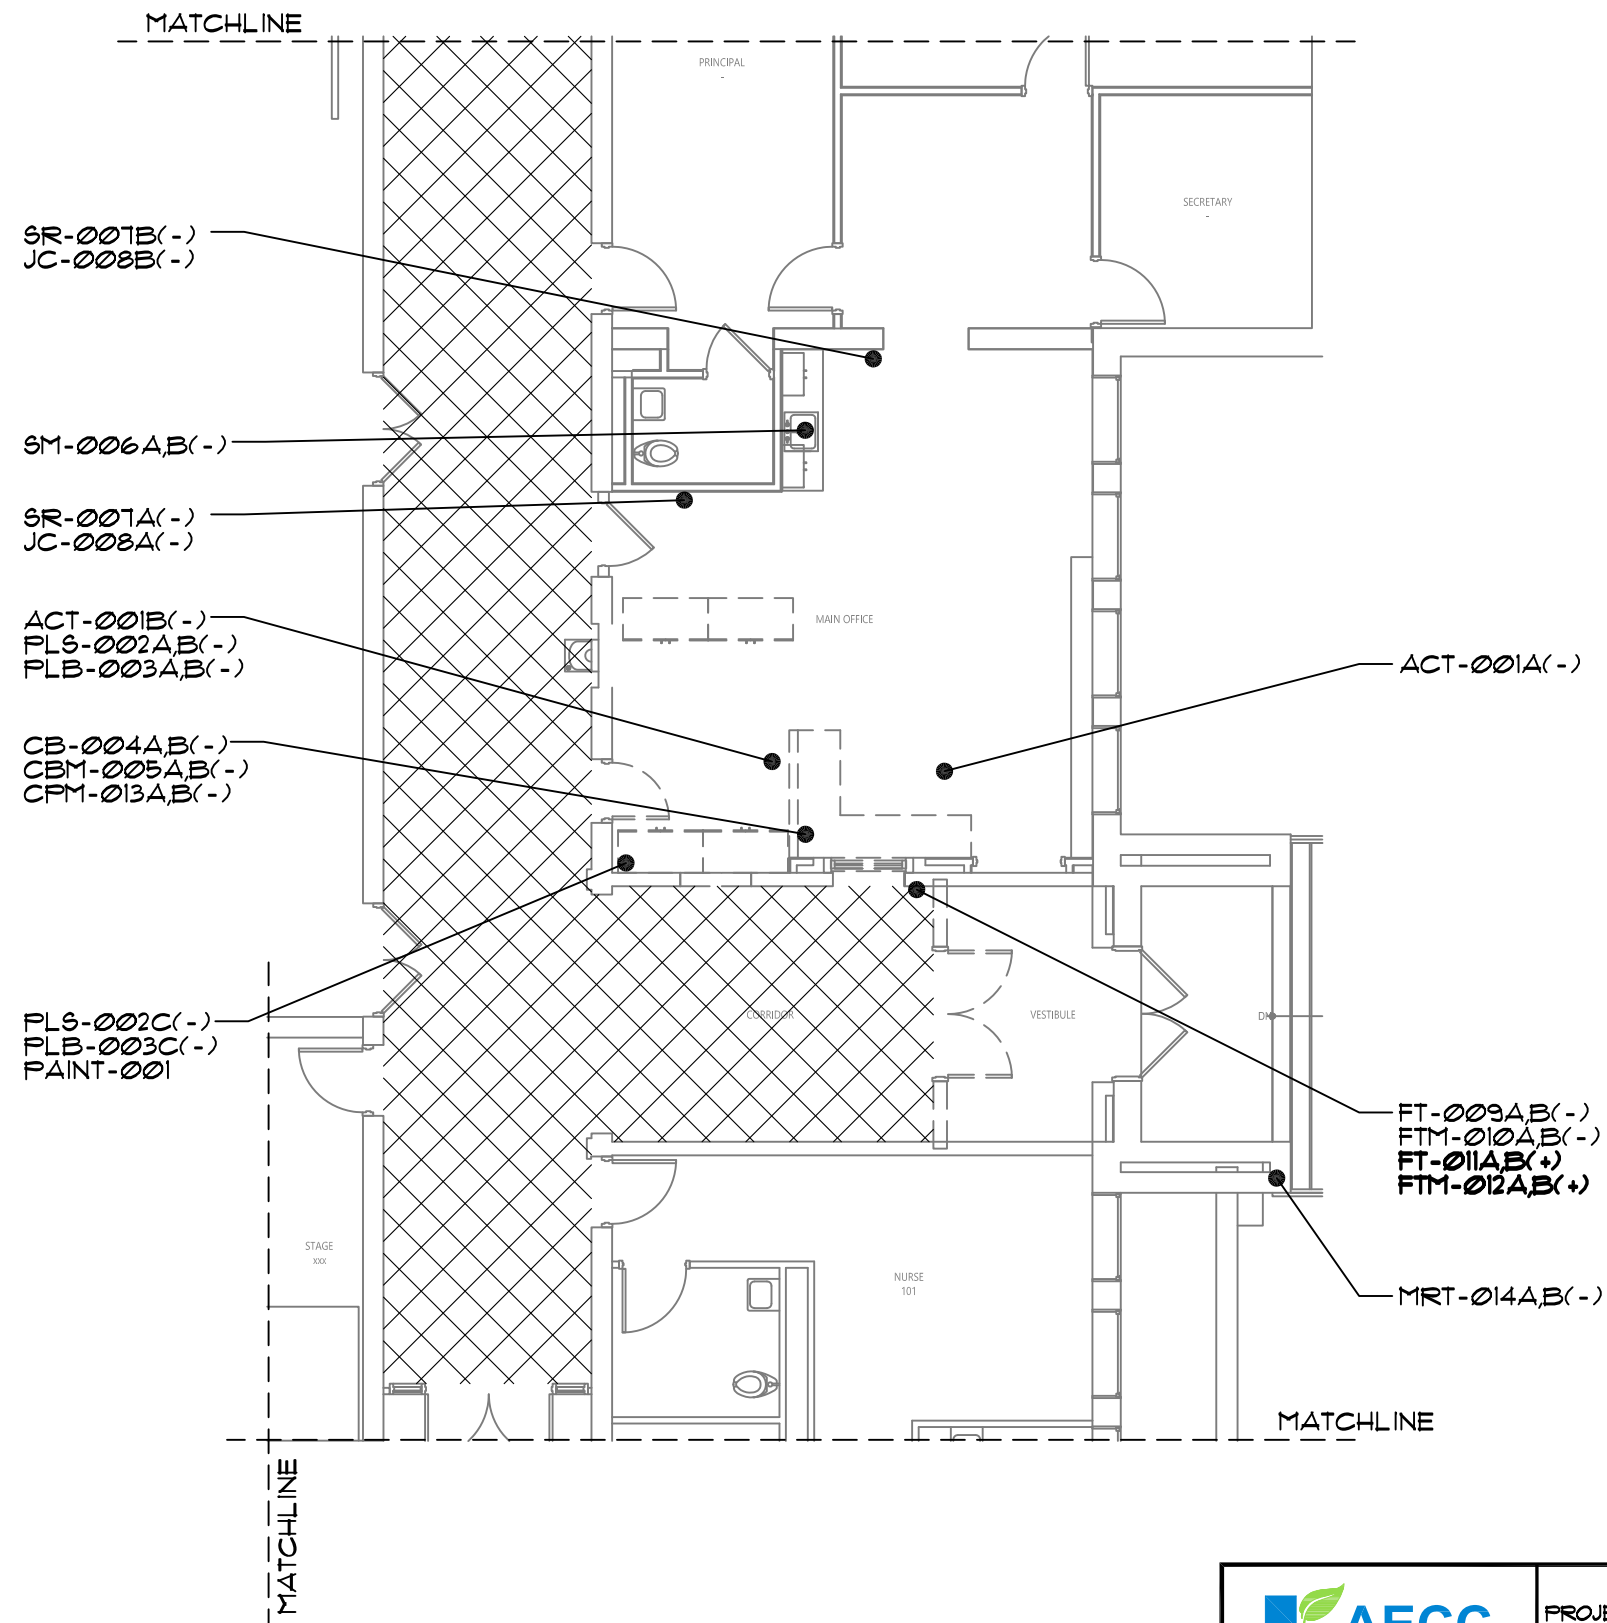
Figure 1

LEGEND:	
	ASBESTOS-CONTAINING FLOOR TILE AND ASSOCIATED MASTIC
NOTE: THIS SURVEY WAS LIMITED TO SPECIFIC BUILDING MATERIALS AND PAINT APPLICATIONS ANTICIPATED TO BE IMPACTED DURING A CAPITAL IMPROVEMENT PROJECT (2023 CAPITAL PROJECTS, PHASE 1) PER THE DIRECTION OF THE PROJECT ARCHITECT. BUILDING MATERIALS AND PAINT APPLICATIONS NOT INCLUDED IN THIS SURVEY MUST BE TREATED AS HAZARDOUS MATERIALS UNTIL EXAMINED BY AN ENVIRONMENTAL PROFESSIONAL AND LABORATORY RESULTS PROVE OTHERWISE.
