March 2, 2023

**Re: ND-2023-1QACM-Limited Asbestos Inspection Report
Chase Bank Branch – Vernon Hills Scarsdale
676 White Plains Road
Scarsdale, New York 10583
OVP # 48100R006846**

Apex Project No.: JPM001-0418070-23002979-047

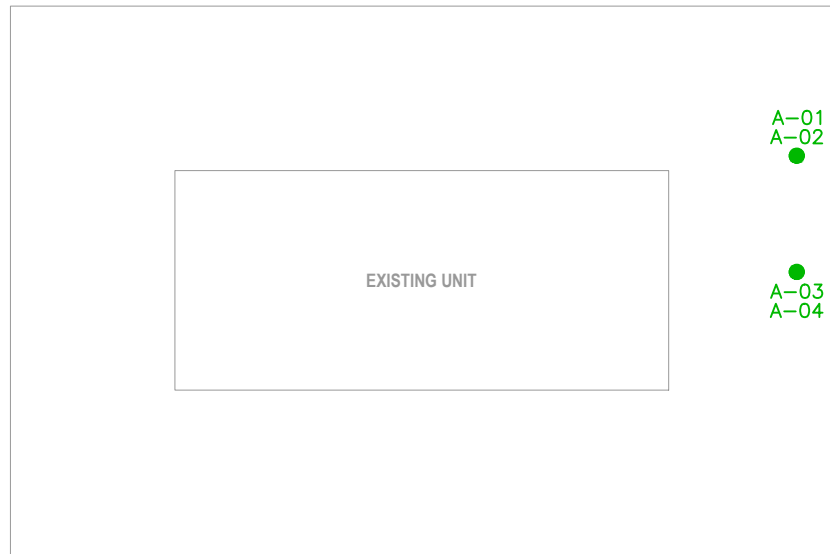
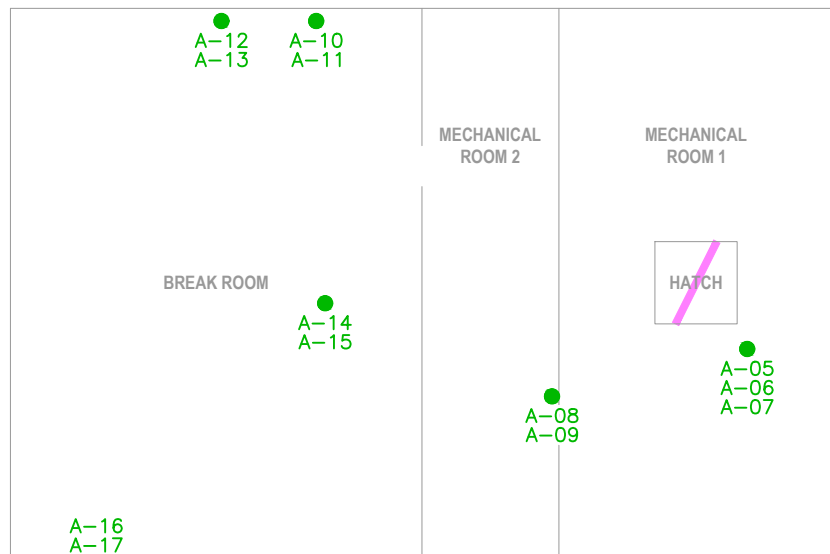
<p>FIGURE</p> <p style="font-size: 2em; text-align: center;">1</p>
DRAWN BY EM			
DATE 02-16-23			
SCALE NTS			
CAD NO. 0418070-23002979.47			
PRJ NO. JPM001-0418070-23002979

- NEGATIVE ASBESTOS SAMPLE LOCATION
- ASSUMED ACM POSITIVE TSI INSULATION

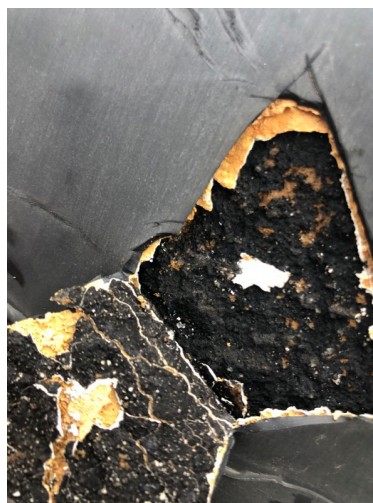
Photograph: 2
Description:

HA-1 black rubberized membrane and HA-2 associated black mastic collected from the roof.

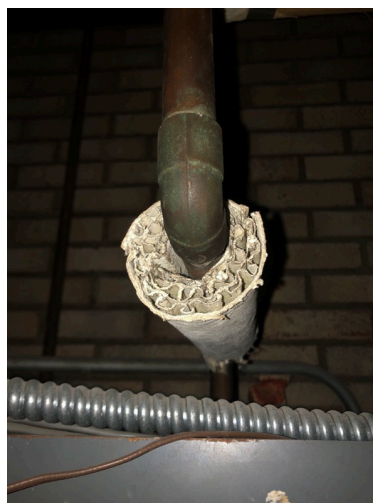
Photograph: 3
Description:

View of the gray TSI pipe insulation present in mechanical room 1 and assumed to contain asbestos.

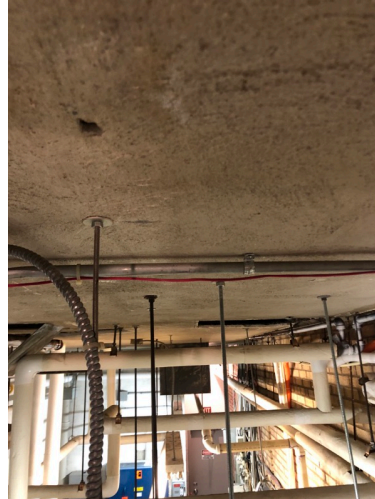
Photograph: 4
Description: HA-3 gray
stucco collected
from mechanical
room 1.

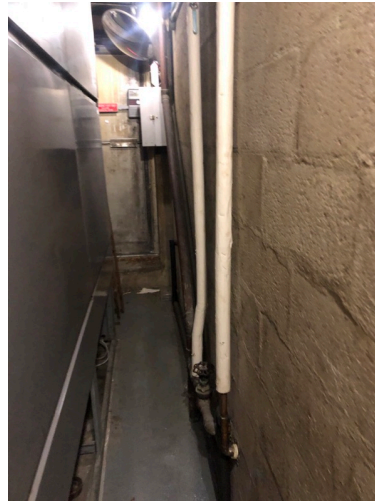
Photograph: 5
Description: HA-4 gray
concrete
masonry unit
mortar collected
from mechanical
room 2.

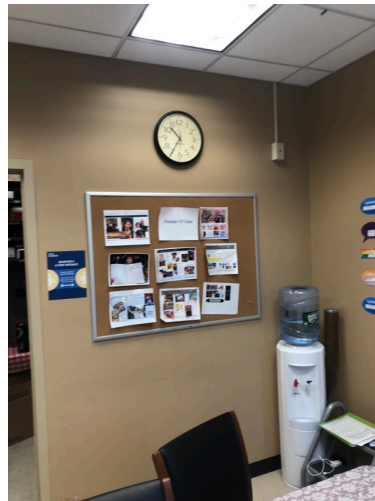
Photograph: 6
Description: HA-5 gray
wallboard, HA-6
associated white
joint compound,
and HA-7 gray
acoustic ceiling
tile collected
from the break
room.

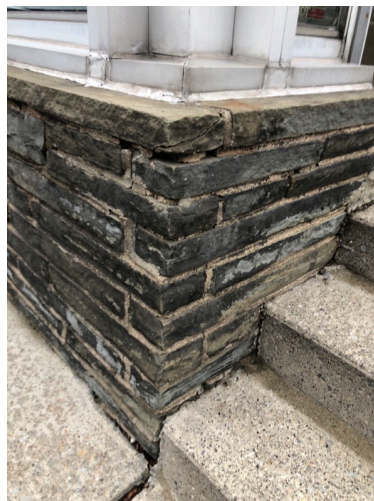
Photograph: 7
Description:

HA-8 gray brick
mortar collected
from the exterior
wall.
