# B I D A D D E N D U M 0 1

November 4, 2024  
44-90-00-00-0-009-036  
Bid Addendum #1

Orange-Ulster BOCES  
Emanuel Axelrod Special Education Center  
Additions and Alterations

**PRE-CONSTRUCTION SURVEY REPORT  
FOR  
ASBESTOS-CONTAINING MATERIALS (ACM)**

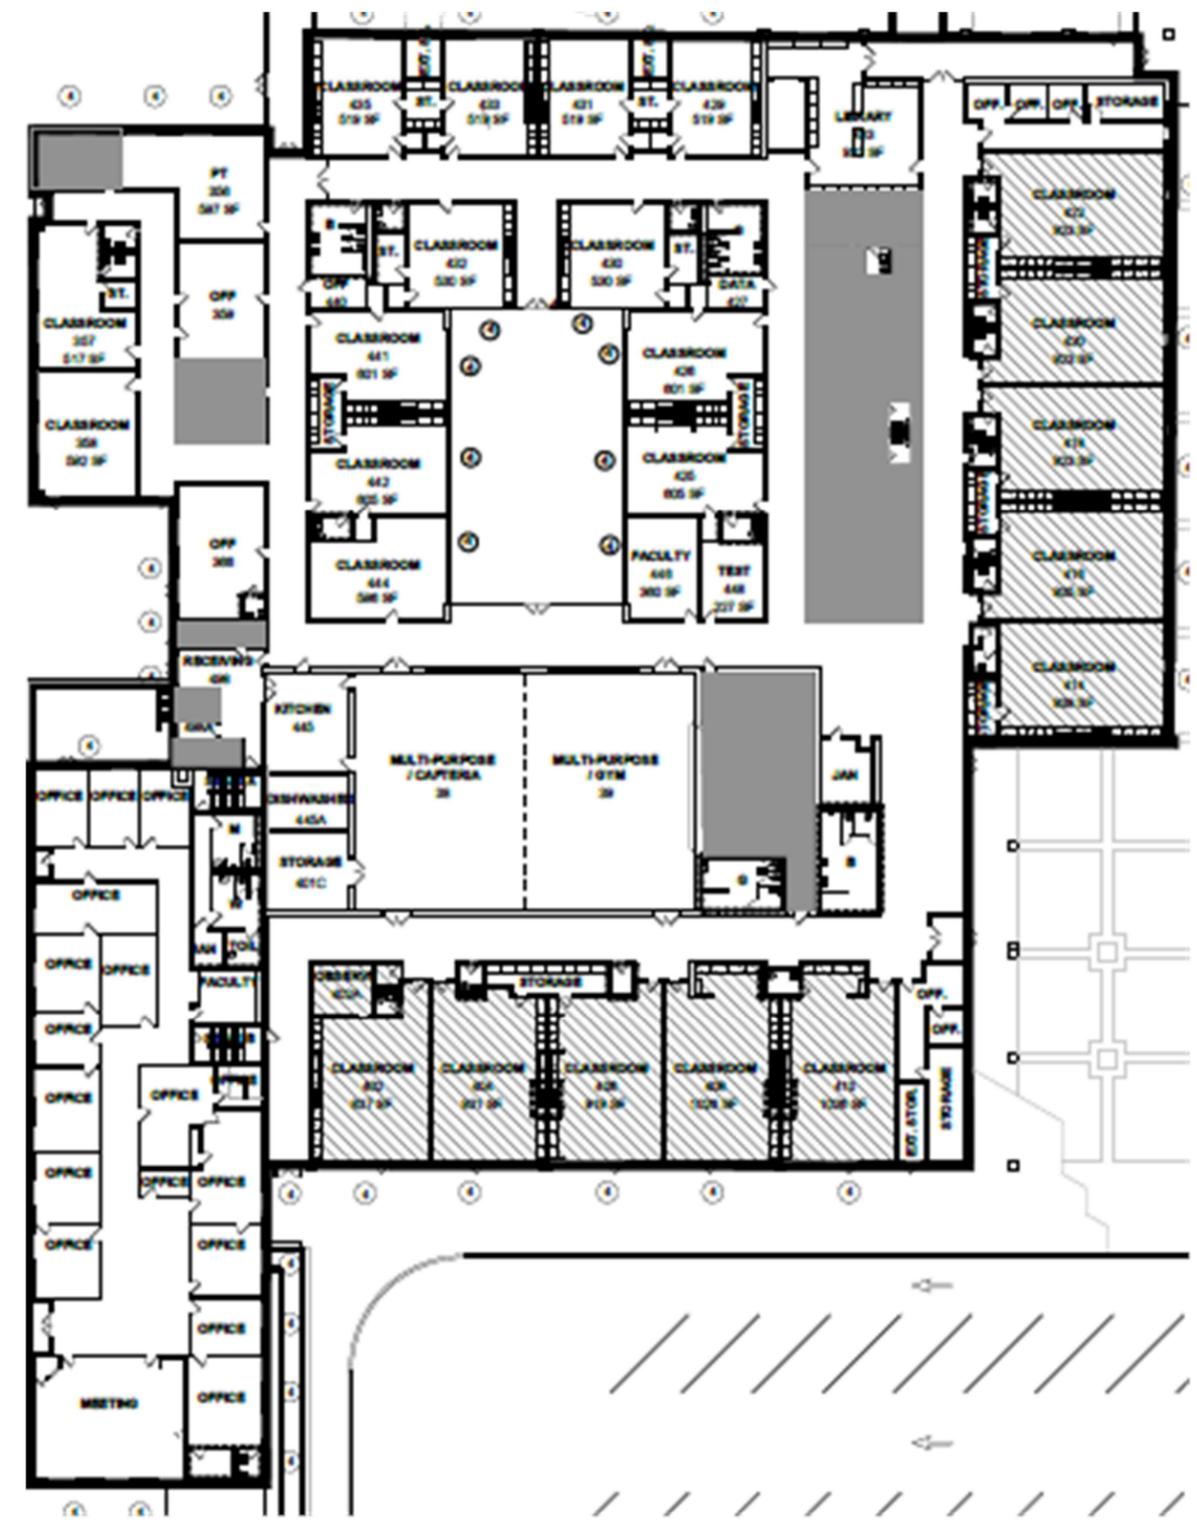
-ACM Anti-Sweat Tar- Classrooms, Throughout 1969 Build, On Sink Basin Approximately 60 SF

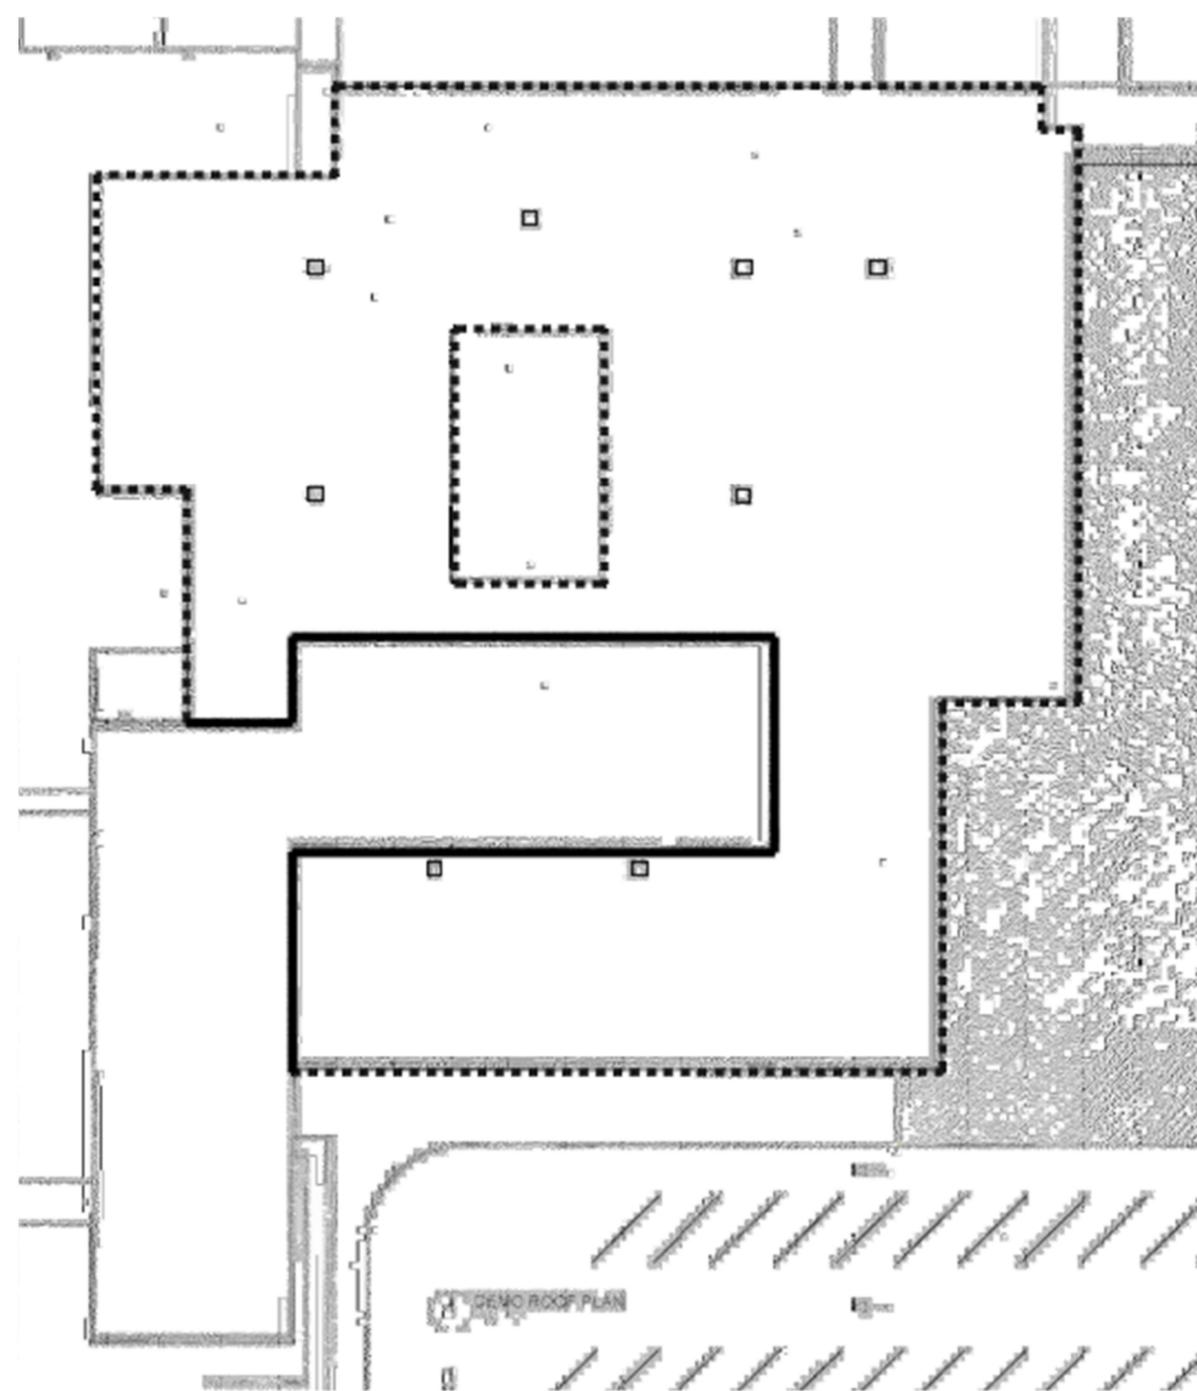
<p><b>-ACM Caulk-</b> Lower Roof to Upper Roof, On Termination Bar  Approximately 410 LF</p>
