# Roof Condition Assessment

**106 Hammond Rd.**

**Thiells, New York 10984**

Michael Shilale Architects,LLP

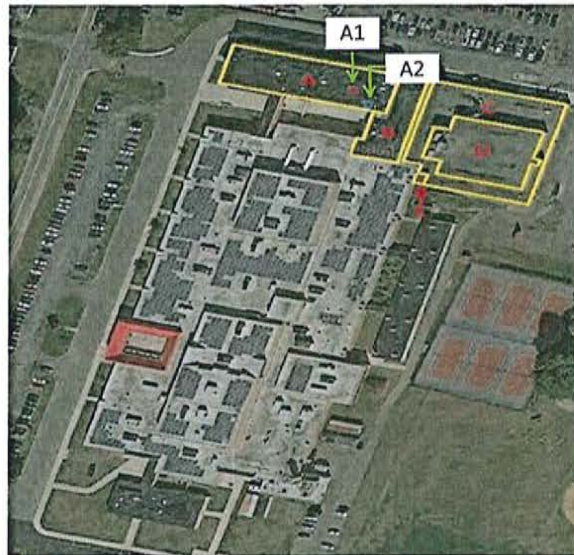
### Core Sample Layout A1:

- EPDM
- 3" Iso
- ½" coverboard
- Sloped Lightweight Concrete deck

- EPDM
- 2 ½" Iso
- ½" coverboard
- Sloped Lightweight Concrete deck

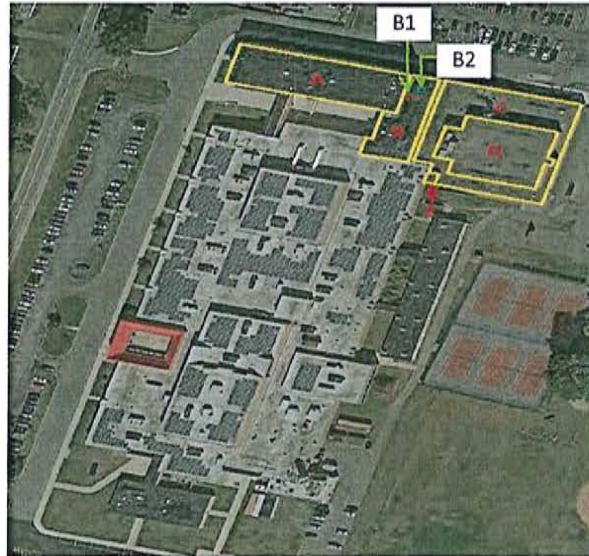
### Core Sample Layout B1:

- EPDM
- 2" Iso
- ½" coverboard
- Sloped Lightweight Concrete deck

- EPDM
- 3" Iso
- ½" coverboard
- Sloped Lightweight Concrete deck

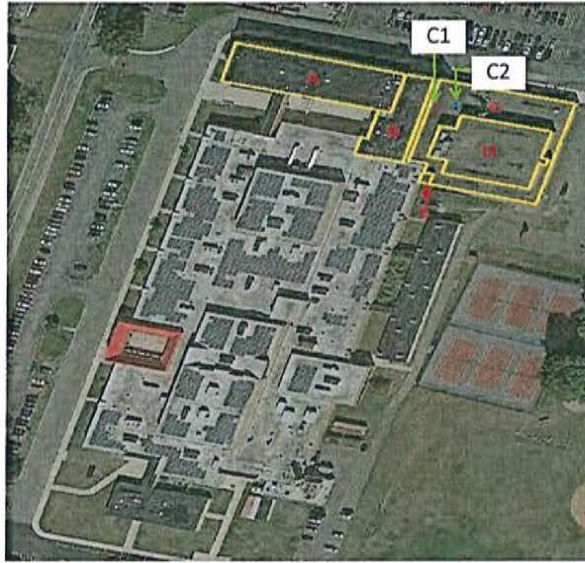
### Core Sample Layout C1:

- EPDM
- 3" Iso
- ½" coverboard
- Sloped Lightweight Concrete deck

- Ballasted EPDM
- 3" Iso
- ½" coverboard
- Sloped Lightweight Concrete deck

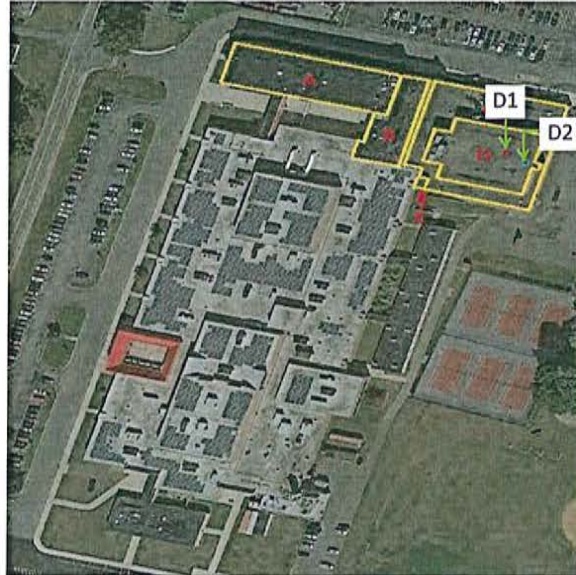
### Core Sample Layout D1:

- Ballasted EPDM
- 5" Iso
- ½" coverboard
- Sloped Lightweight Concrete deck

- Ballasted EPDM
- 3" Iso
- ½" coverboard
- Sloped Lightweight Concrete deck

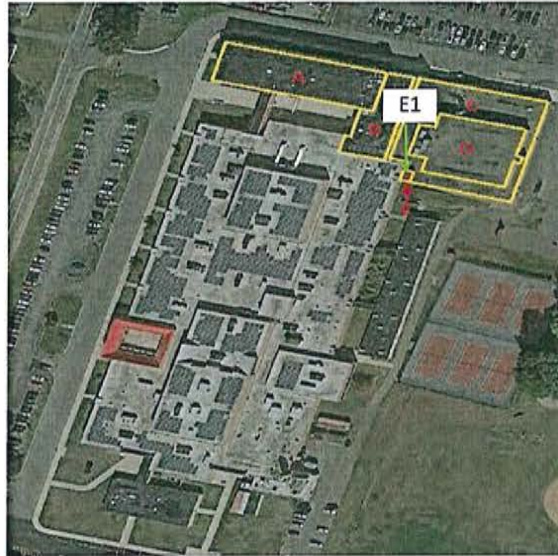
### Core Sample Layout E1:

- Ballasted EPDM
- 3" Iso
- ½" coverboard
- Sloped Lightweight Concrete deck

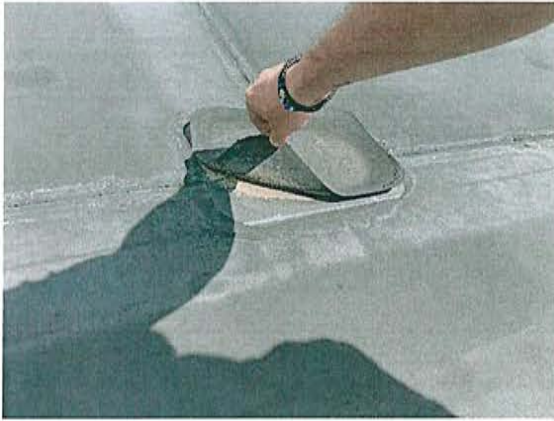
Open patch.

- It is recommended that all active leaks be repaired to provide a dry environment.
- Penetrations, base flashings, units, drain details etc. with failures should be cleaned, patched, and sealed with proper materials and methods.
- Cuts, tears, and pinholes should be sealed.
- All debris and vegetation should be cleared from the roof.
- All drains should be cleared of debris.
- Failing repairs recommend be ripped off and repaired.

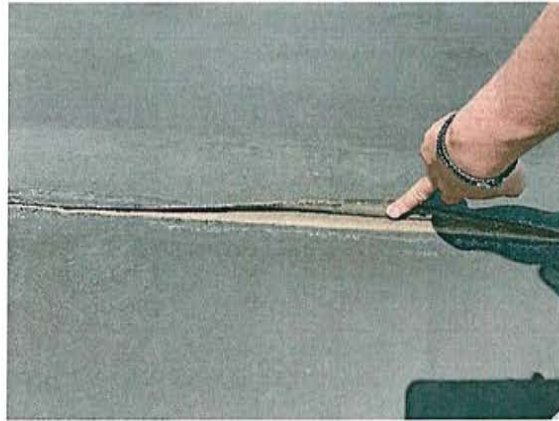
Open Seam.

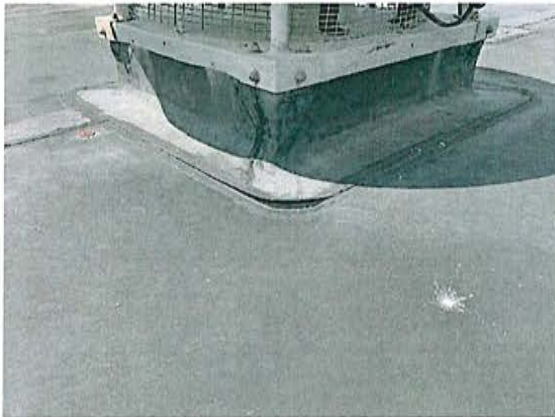
Failing Seam.

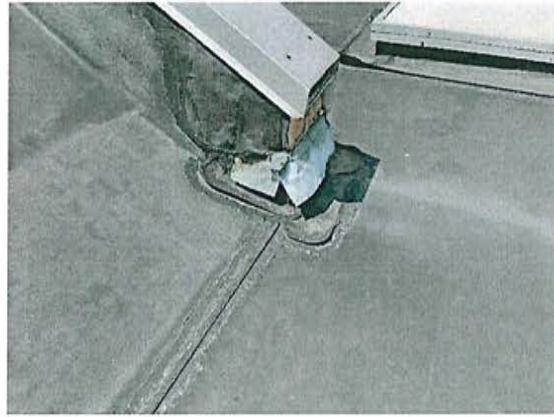
Damaged counter flashing.

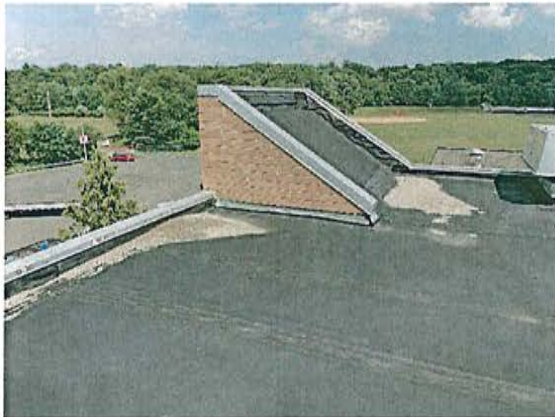
Debris.

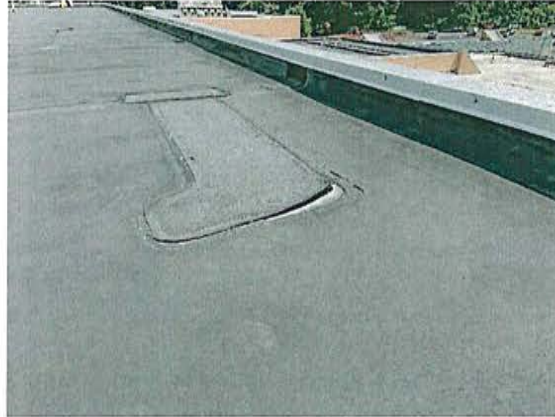
Open patch.

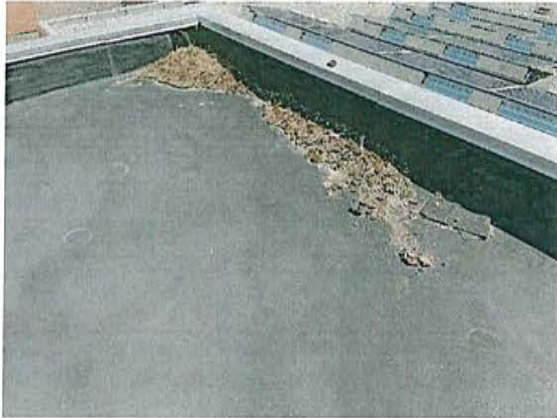
Debris.

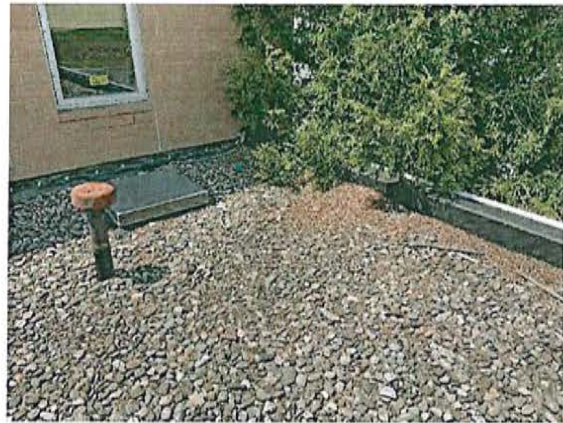
Debris.

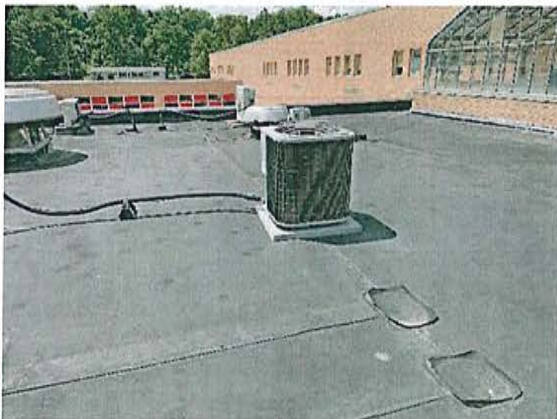
Open patches.

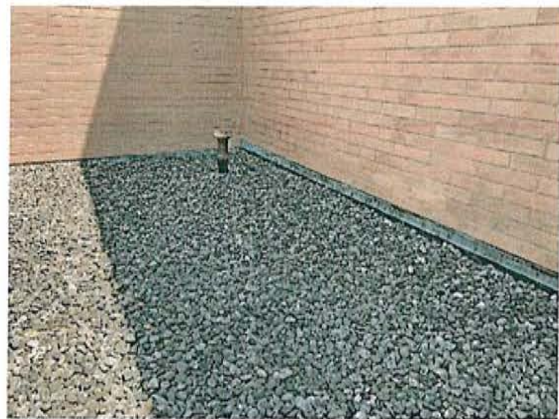
Damaged counter flashing.

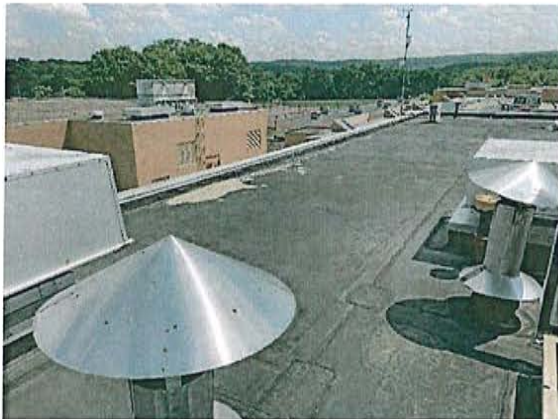
Debris.

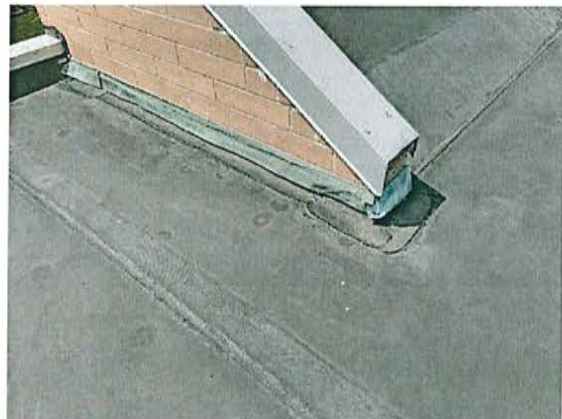
Damaged counter flashing.

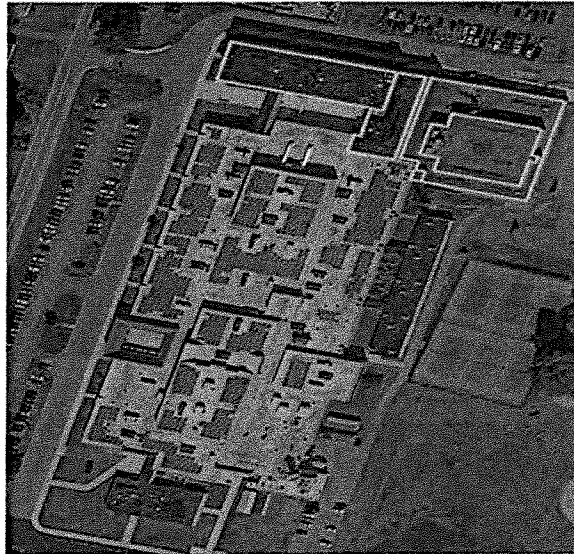
**Yellow = Potentially Restorable**

**Red= Replaceable**
