Project Title:
Philipse Manor Hall State Historic Site
Construction of Elevator/Restroom
Addition, Interior and
Exterior Rehabilitation and Site
Enhancements

Project Location:
29 Warburton Ave, Yonkers, NY 10701

Sheet Title:
MANOR TYPICAL EXISTING CONDITIONS

Drawing Number:
A110

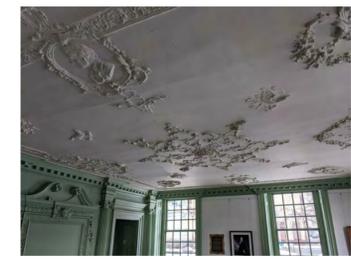
ROOM 103 - PAPER MACHE CEILING NOT TO BE DISTURBED. CONTRACTOR SHALL TAKE MEASURES TO PROTECT DURING CONSTRUCTION

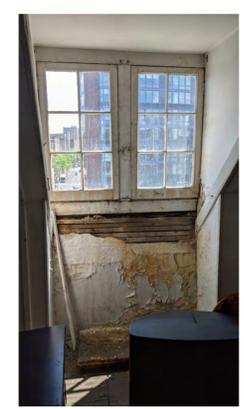
TYPICAL DORMER WINDOW

DAMAGED & MISSING SHUTTER
