**Request for Proposals Roof Replacement (Phase 3) for Village Hall in the Village of  
Hastings-on-Hudson**

**Addendum No. 2  
November 30, 2022**

**RE Asbestos Investigative Survey Report – Roof and Exterior Restoration  
Village Hall, 7 Maple Avenue, Hastings-on-Hudson, NY**

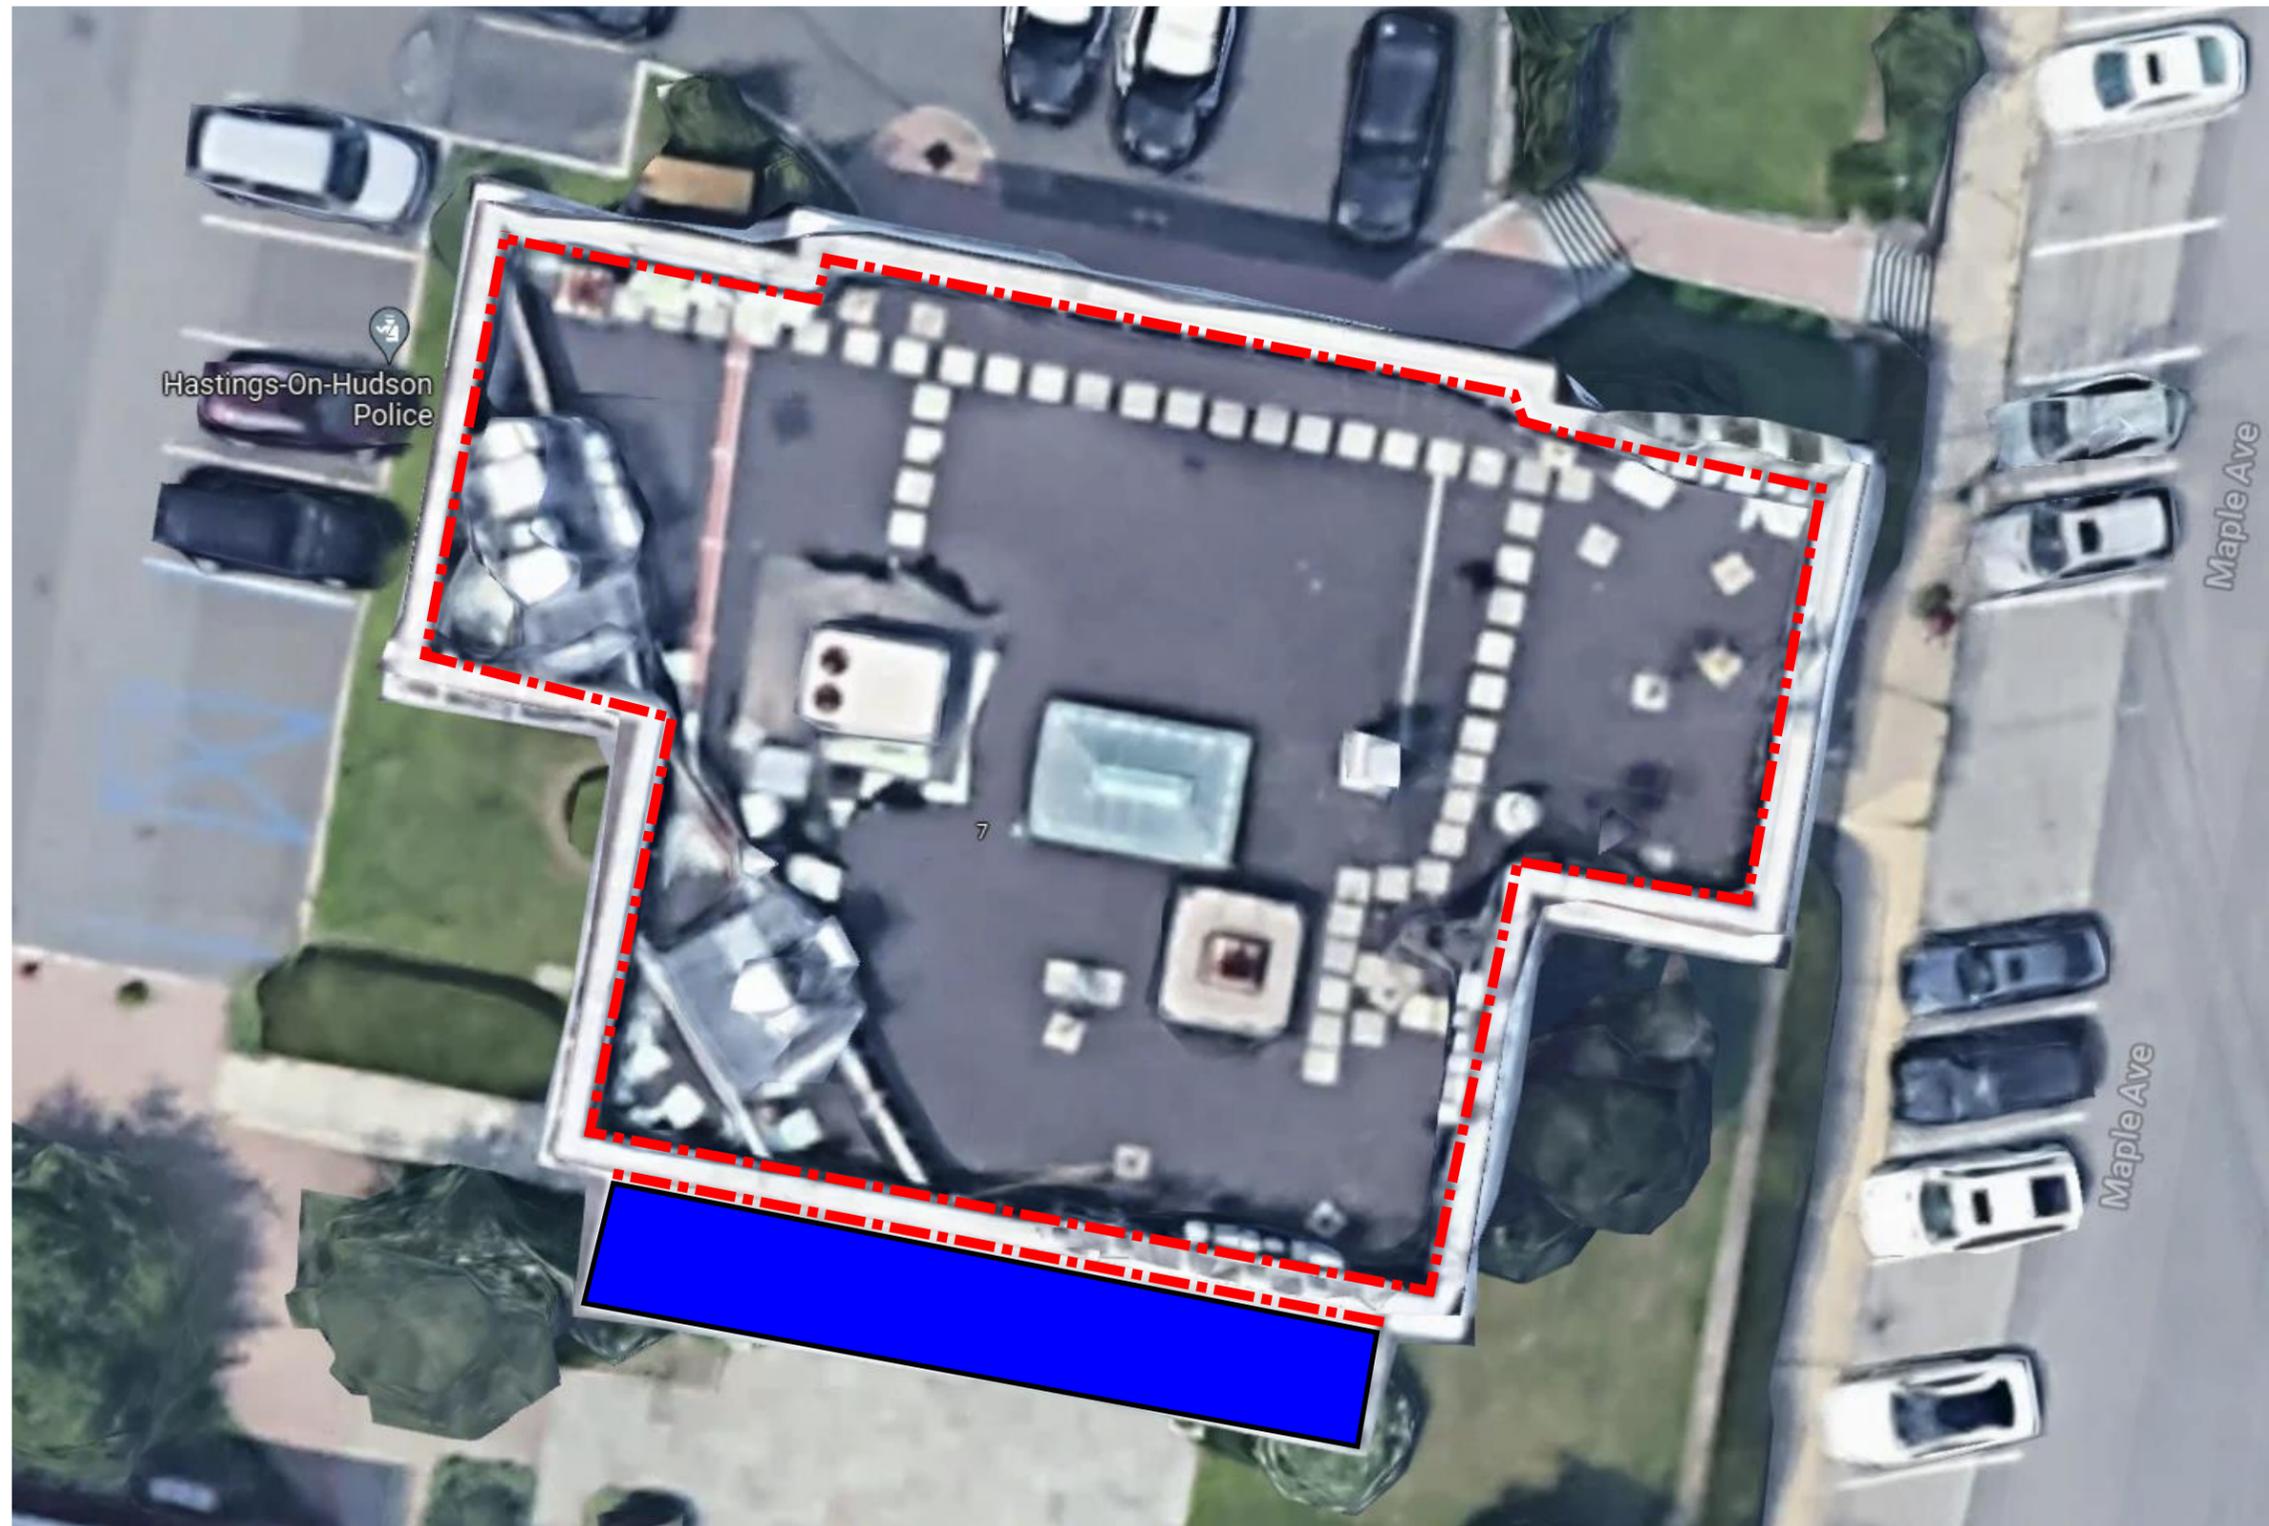
Easton Architects, LLP  
Village Hall  
7 Maple Street  
Hastings-on Hudson, NY  
ACM Location Plan  
03/17/22  
nts

CONFIRMED ASBESTOS CONTAINING MATERIALS		
<u>Location</u>	<u>Material</u>	<u>Estimated Quantity</u>
Main Roof	Flashing Tar (bottom layer)	495 SF ±
Portico Roof	Roof Membrane Flashing Tar	550 SF ± 55 SF ±

See attached sketch for approximate locations.

Federal, State and local law requires removal of the material identified only if it will be impacted and/or disturbed by the planned renovation and/or demolition. All such work should be executed in accordance with all applicable Federal (EPA, OSHA), New York State Department of Labor (NYS-DOL) and New York City Department of Environmental Protection (NYC-DEP) regulations.
