TA-JJ-2023-001  
JOHN JAY HOMESTEAD: SITE AND BUILDING ENHANCEMENTS  
JOHN JAY HOMESTEAD STATE HISTORIC SITE

### Hazardous Materials Investigation Report –1/31/2024

# HAZARDOUS MATERIALS INVESTIGATION REPORT

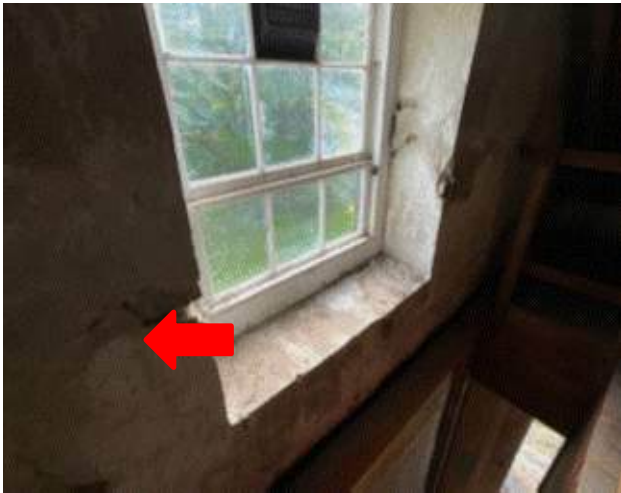
### PHOTO 1

Material: Multi-Layer Wall Plaster (HA-SH-01-  
L1/L2/L2-T)  
Location: School House - Throughout

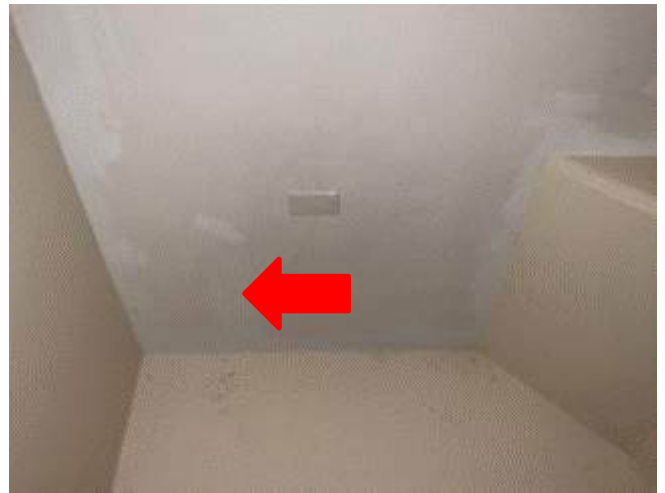
### PHOTO 2

Material: Multi-Layer Ceiling Plaster (HA-SH-02-  
L1/L2/L2-T)  
Location: School House – First Floor

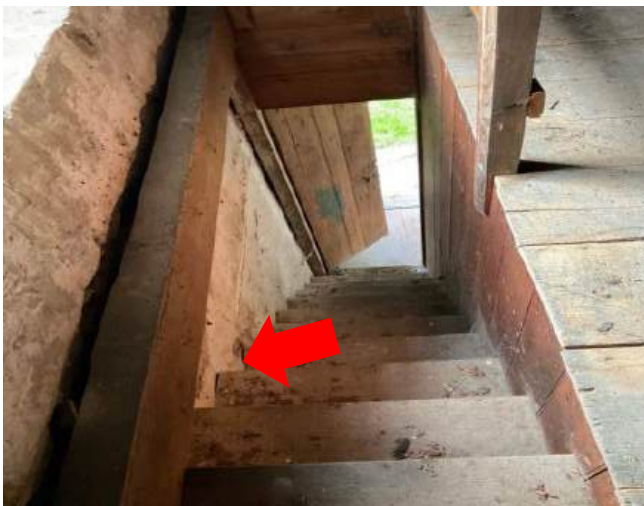
### PHOTO 3

Material: Cementitious Repair (HA-SH-03)  
Location: School House - Attic

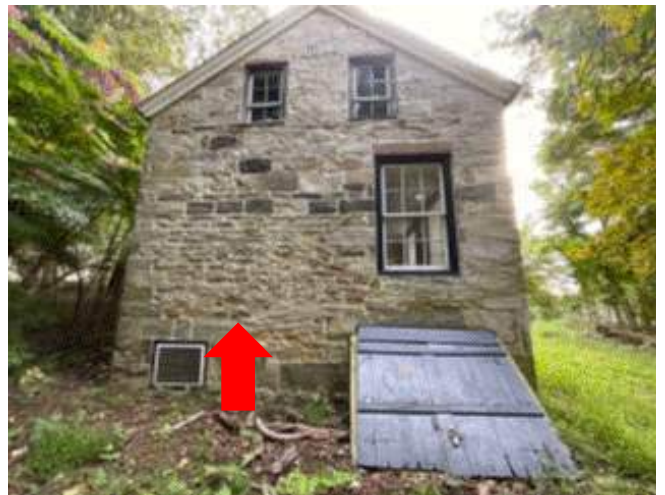
### PHOTO 4

Material: Stone Rubble Mortar (HA-SH-04)  
Location: School House- Exterior

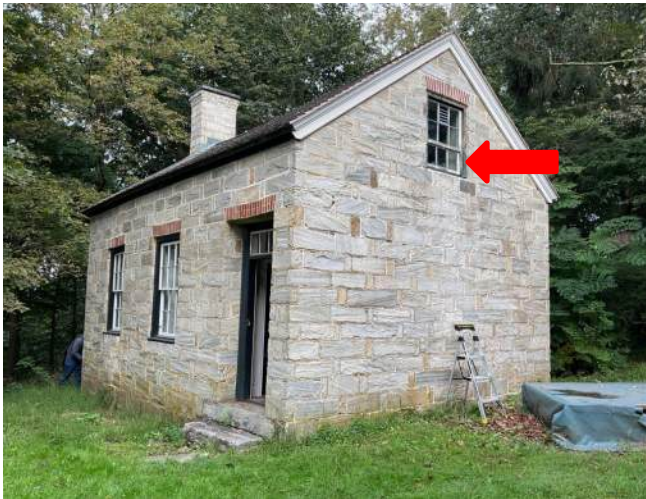
### PHOTO 5

ACM: Exterior Window Glazing (HA-SH-05)  
Location: School House - Exterior

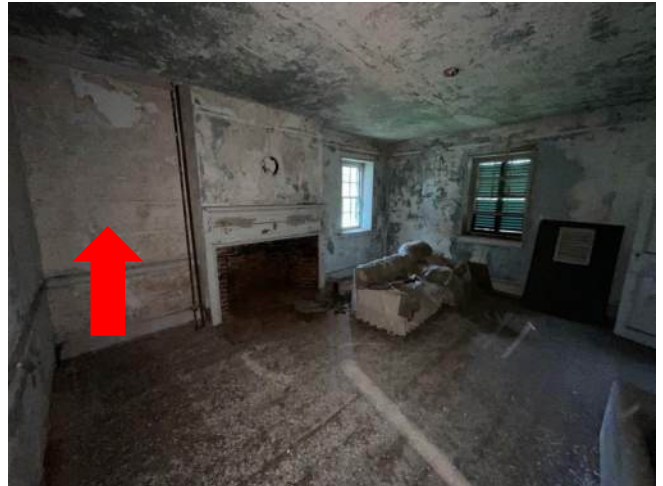
### PHOTO 6

Material: Multi-Layer Wall Plaster (HA-01-L1/L2)  
Location: Brick Cottage - Throughout

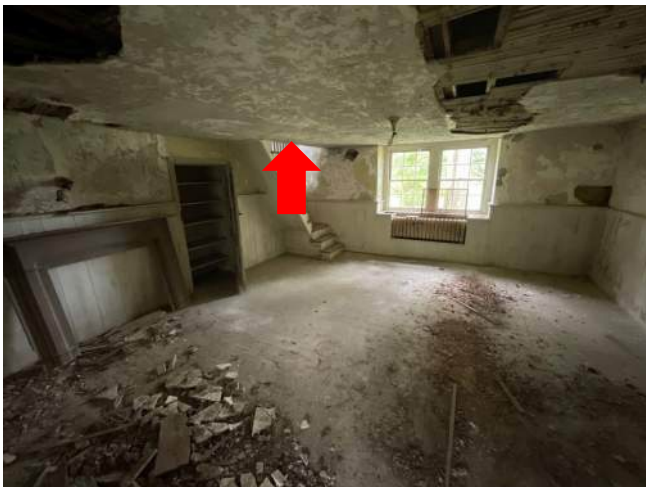
### PHOTO 7

Material: Multi-Layer Ceiling Plaster (HA-02-L1/L2)  
Location: Brick Cottage - Throughout

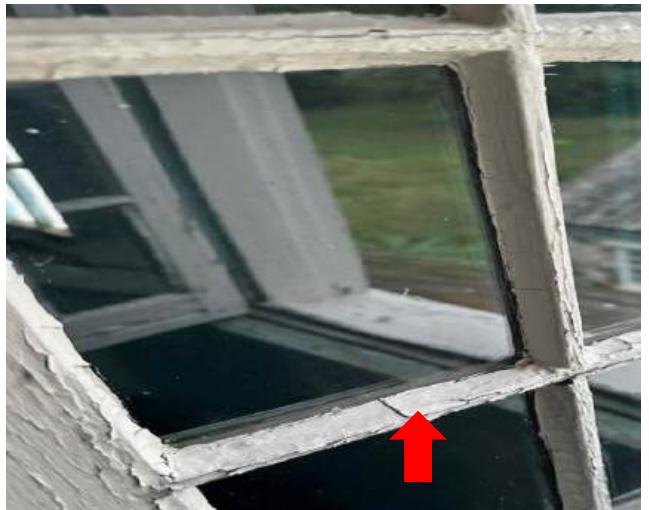
### PHOTO 8

Material: Window Glazing (HA-03)  
Location: Brick Cottage - Throughout

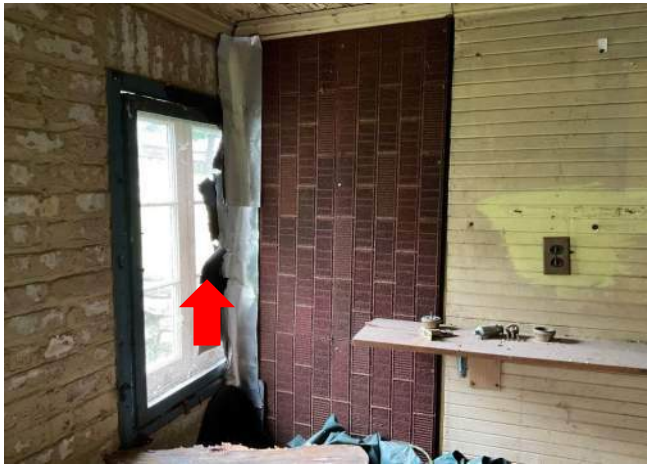
### PHOTO 9

Material: Wall Vapor Barrier (HA-04)  
Location: Brick Cottage 1st Floor North Area Entrance

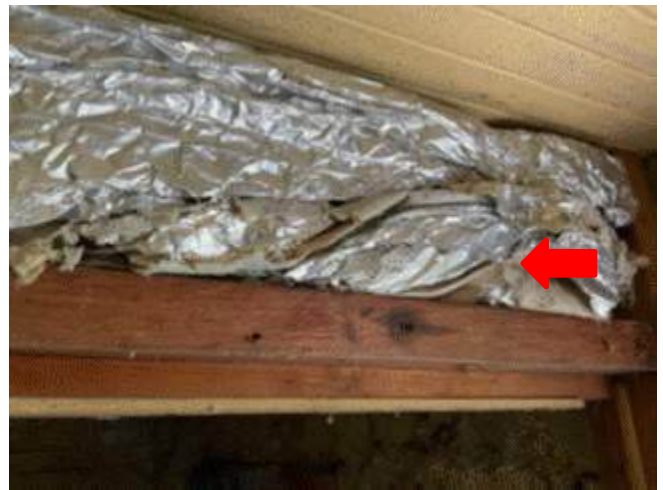
### PHOTO 10

Material: Multi-Layer Wall Insulation (HA-05-L1/L2/L2-M)  
Location: Brick Cottage 1st Floor North Area Entrance

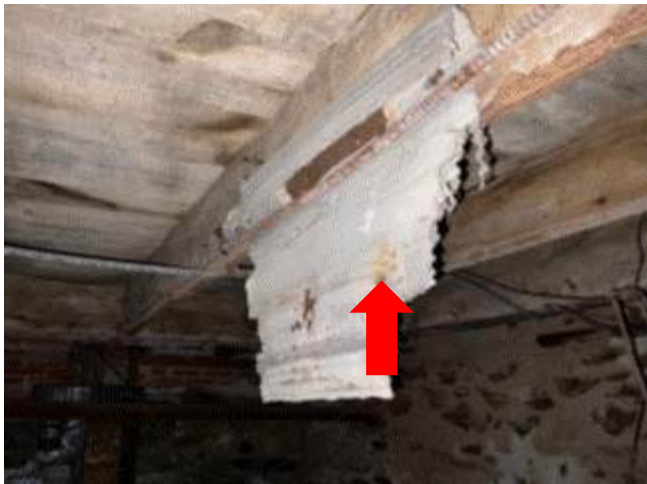
### PHOTO 11

ACM: Corrugated Insulation (HA-06)  
Location: Brick Cottage Basement Ceiling

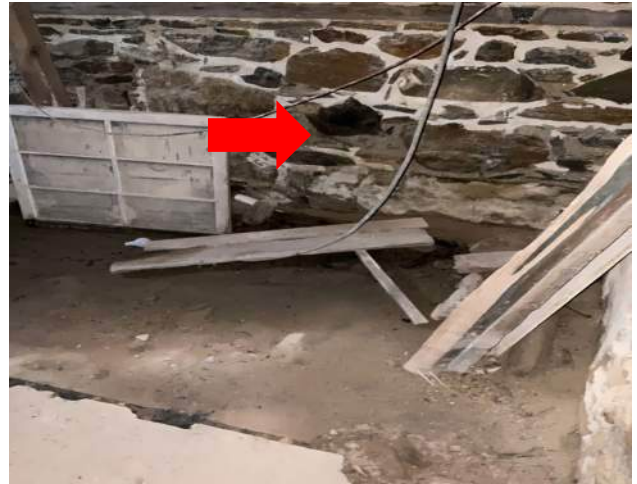
### PHOTO 12

Material: Rubble Wall Mortar (HA-07)  
Location: Brick Cottage First Floor

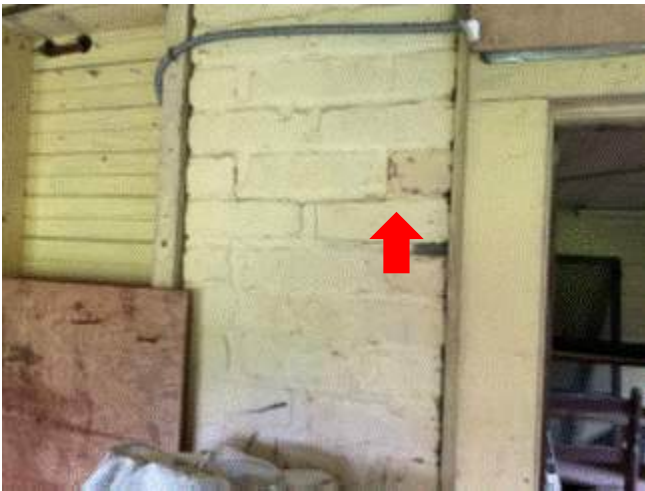
**PHOTO 13**

Material: Brick Mortar (HA-08)  
Location: Brick Cottage First Floor

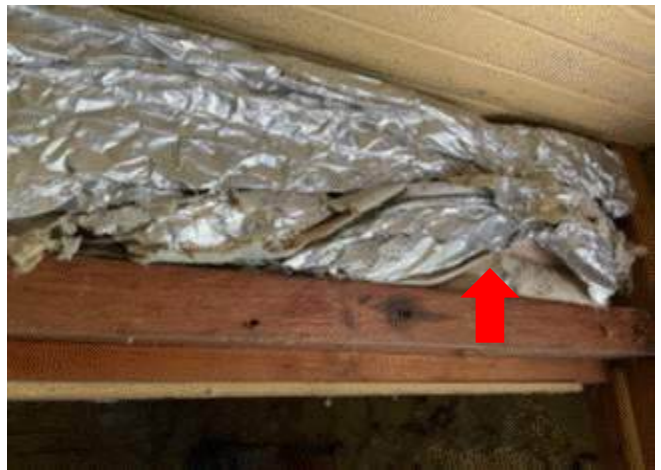
**PHOTO 14**

Material: White Paper Wall Insulation (HA-09)  
Location: Brick Cottage First Floor

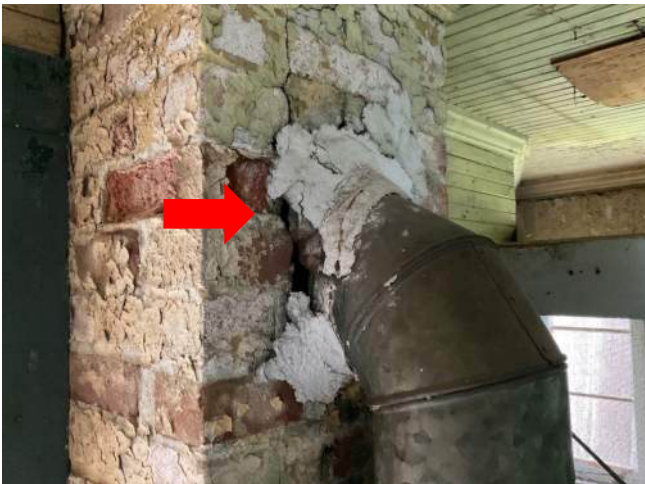
**PHOTO 15**

ACM: Flue Packing (HA-10)  
Location: Brick Cottage Boiler Room

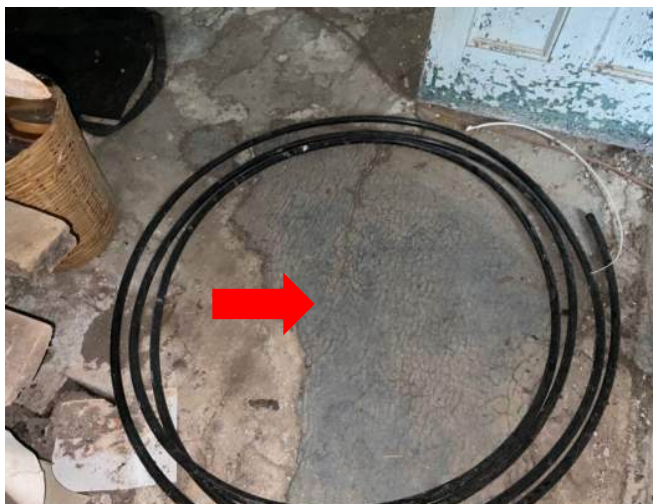
**PHOTO 16**

Material: Linoleum (HA-11)  
Location: Brick Cottage First Floor

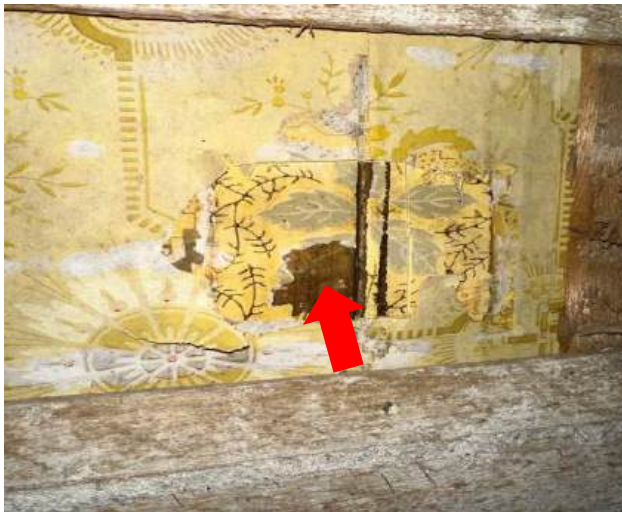
### PHOTO 17

ACM: Wallpaper (HA-12)  
Location: Brick Cottage First Floor

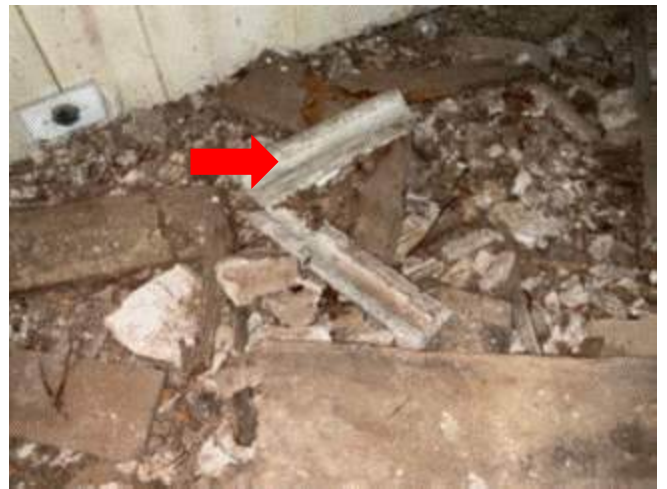
### PHOTO 18

ACM: Corrugated Pipe Insulation (HA-13)  
Location: Brick Cottage First Floor

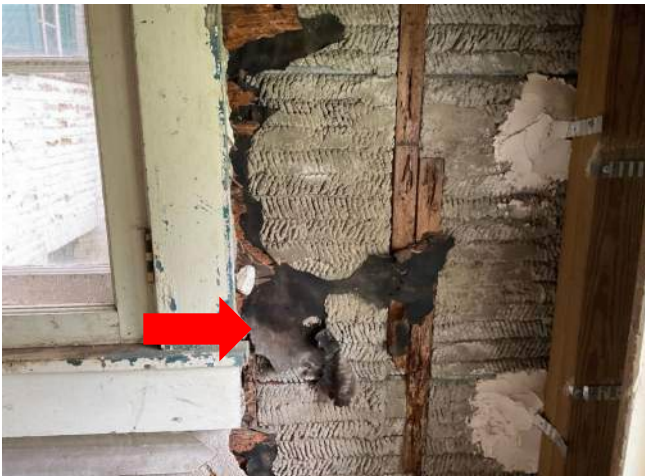
### PHOTO 19

Material: Waterproofing Membrane (HA-14)  
Location: Brick Cottage First Floor

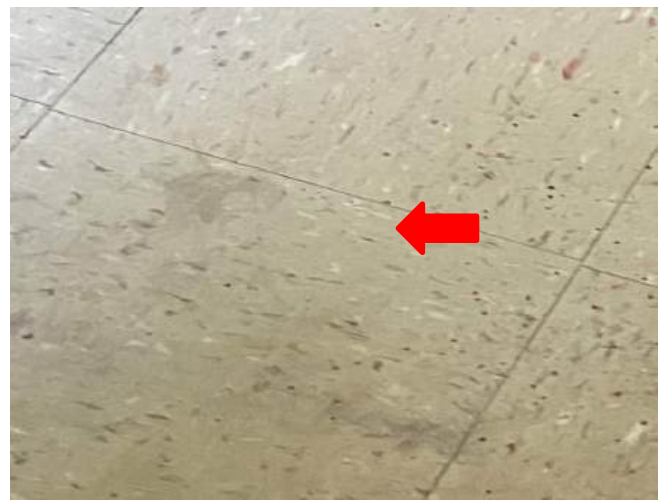
### PHOTO 20

ACM: 12"x12" Self-Stick Floor Tile (HA-15)  
Location: Brick Cottage Second Floor

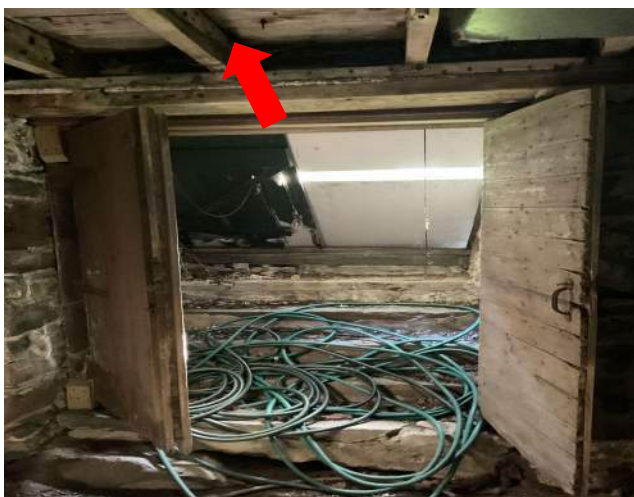
### PHOTO 21

Material: Remnant Tar Paper (HA-16)  
Location: Brick Cottage Basement

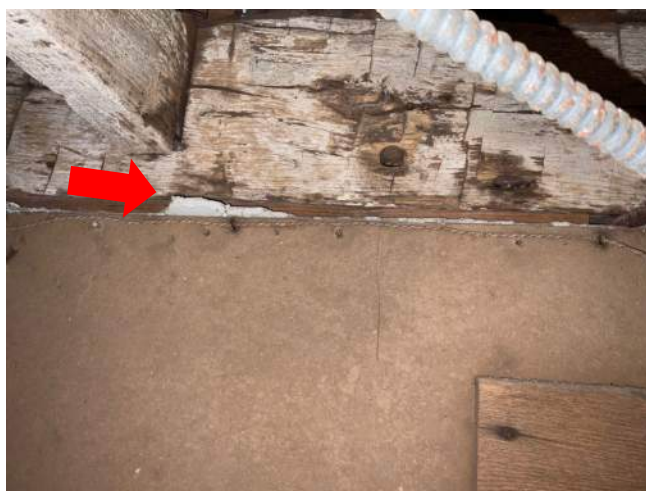
### PHOTO 22

ACM: Remnant Fibrous Paper (HA-17)  
Location: Brick Cottage Basement

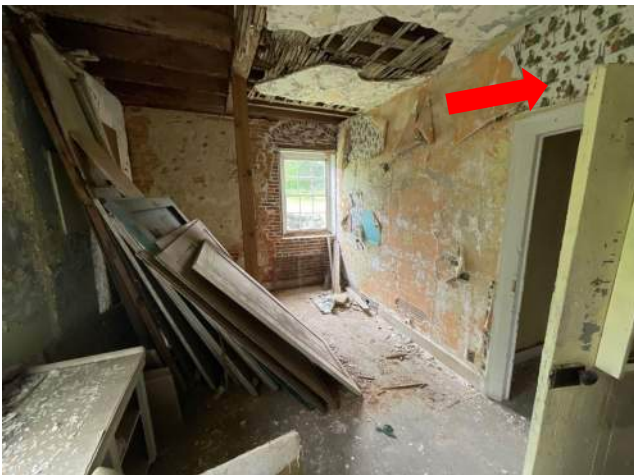
### PHOTO 23

Material: Dishware Print Wallpaper (HA-18)  
Location: Brick Cottage Room #5

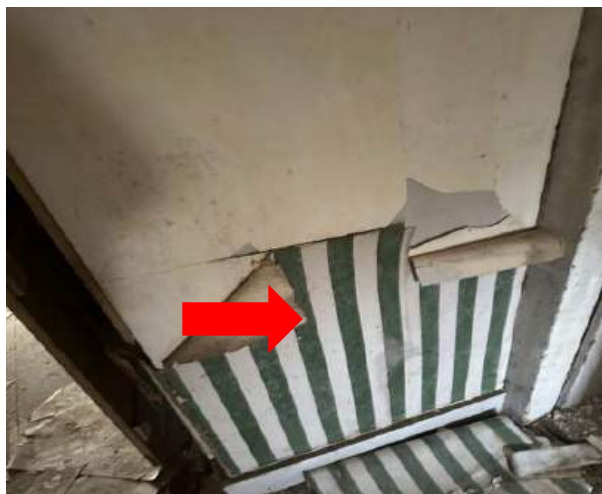
### PHOTO 24

Material: Green & White Striped Wallpaper (HA-19)  
Location: Brick Cottage 2<sup>nd</sup> Floor Main Stair Landing

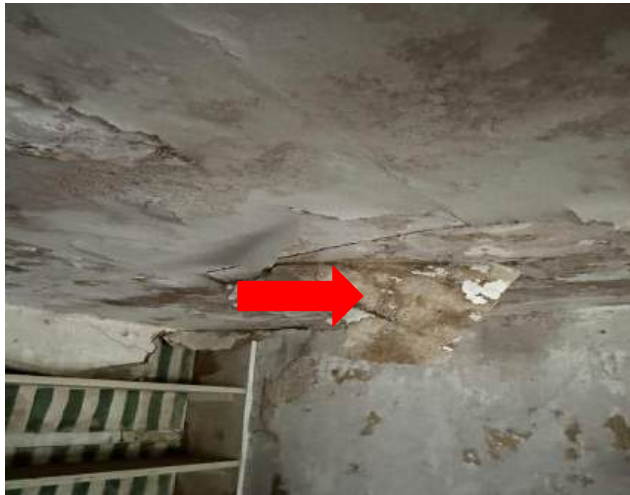
Material: White Wallpaper (HA-20)

Location: Brick Cottage 2<sup>nd</sup> Floor

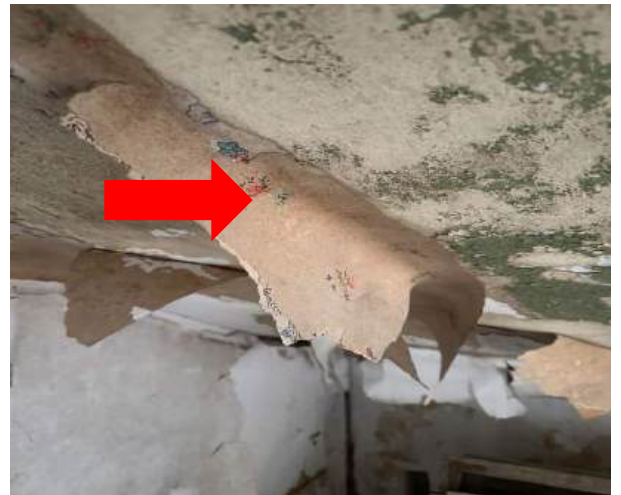
### PHOTO 26

Material: Flower Print Wallpaper (HA-21)

Location: Brick Cottage Room #13

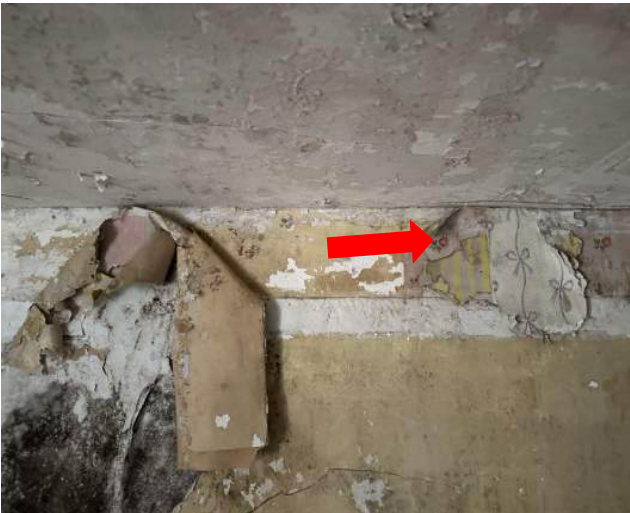
### PHOTO 27

Material: Pink Flower Print Wallpaper (HA-22)

Location: Brick Cottage Room #12

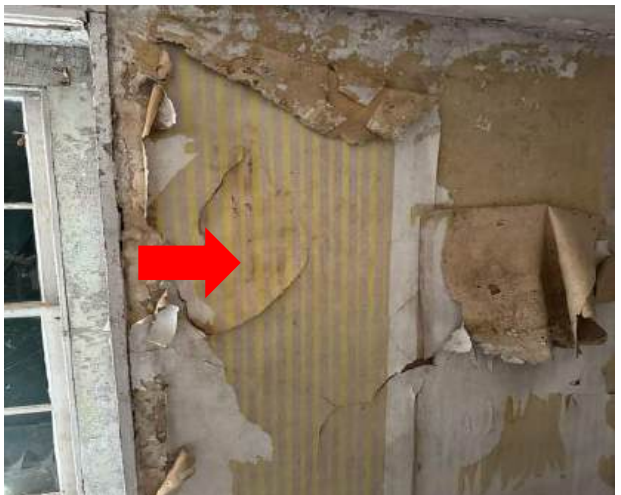
### PHOTO 28

Material: White and Yellow Stripe Wallpaper (HA-23)

Location: Brick Cottage Room #12

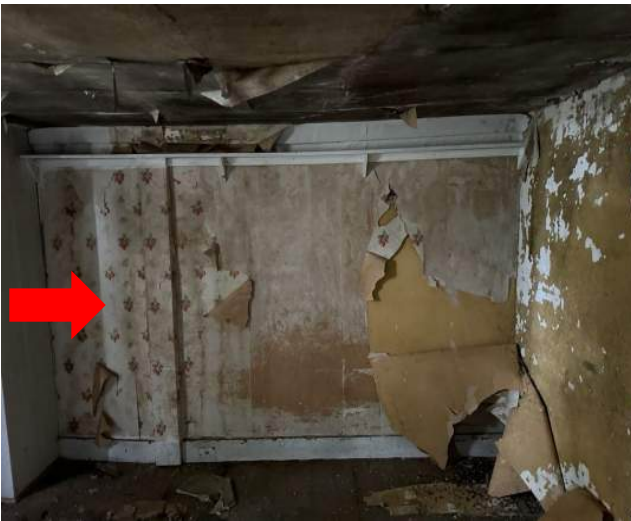
### PHOTO 29

Material: Strawberry Wallpaper (HA-24)  
Location: Brick Cottage Room #09

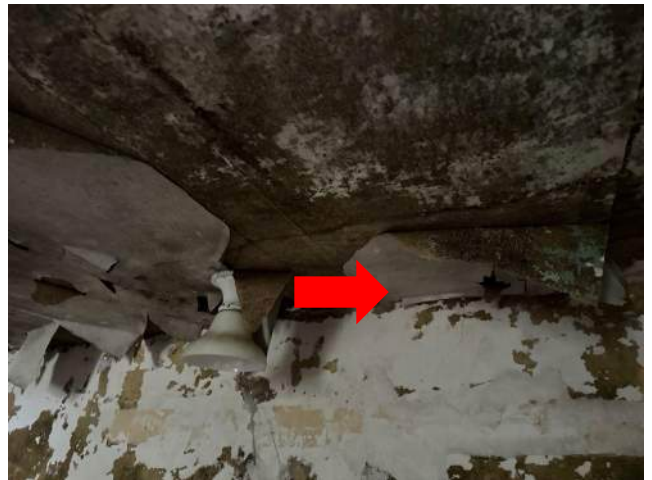
### PHOTO 30

Material: Blue Leaf Patterned Wallpaper (HA-25)  
Location: Brick Cottage Intermediate Space

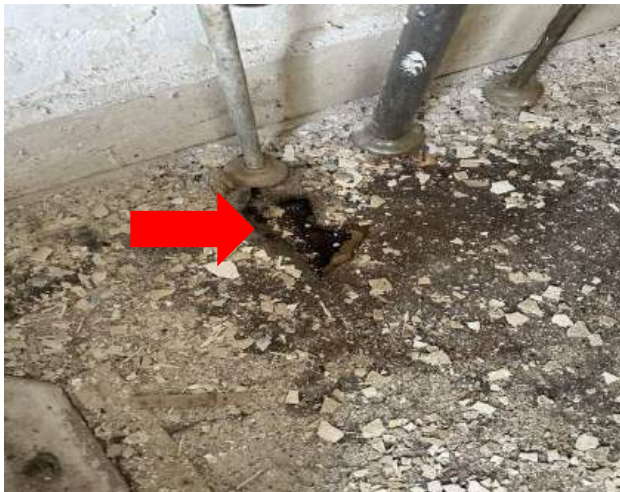
### PHOTO 31

Material: Gray Linoleum (HA-26)  
Location: Brick Cottage Intermediate Space

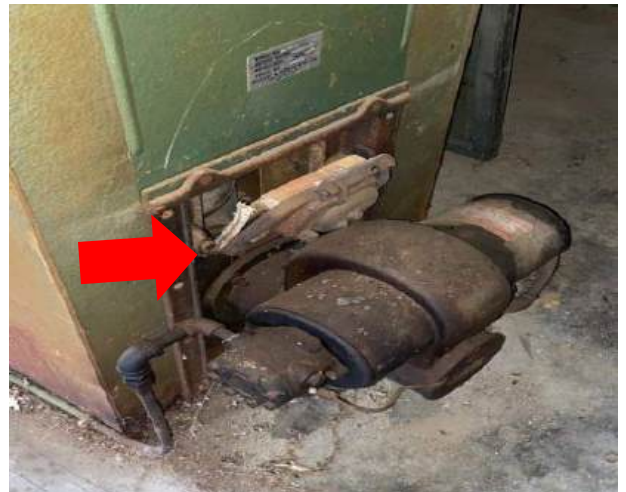
### PHOTO 32

ACM: Rope Gasket to Boiler (HA-27)  
Location: Brick Cottage First Floor

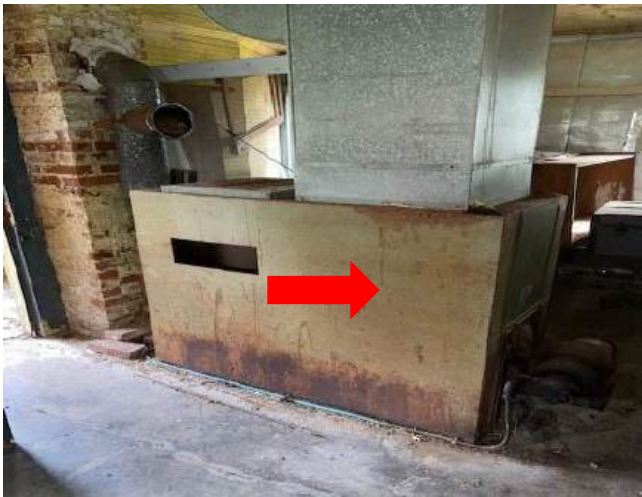
Material: Boiler Inner Box (HA-28)

Location: Brick Cottage First Floor

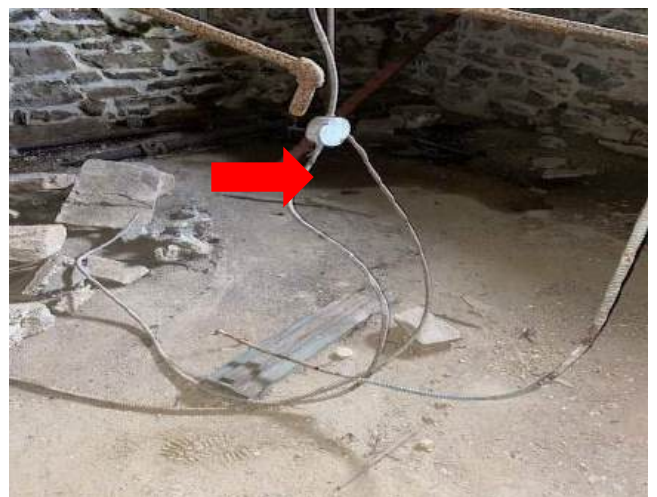
### PHOTO 34

Material: Braided Wire Insulation (HA-29)

Location: Brick Cottage

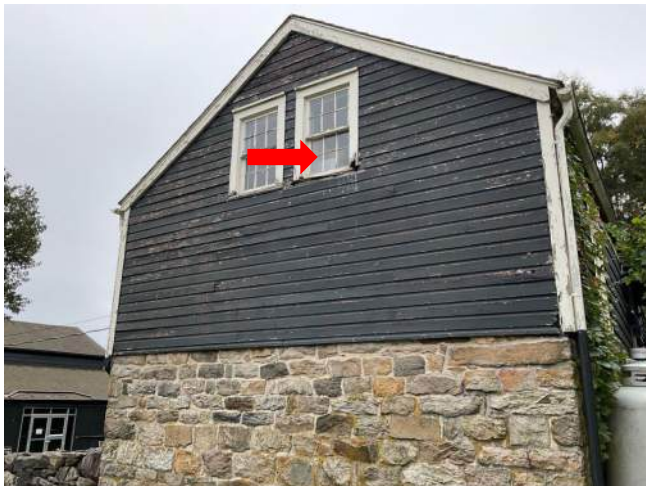
### PHOTO 35

ACM: Window Glazing (HA-CH-01)

Location: Coachman House East Side Gable Window

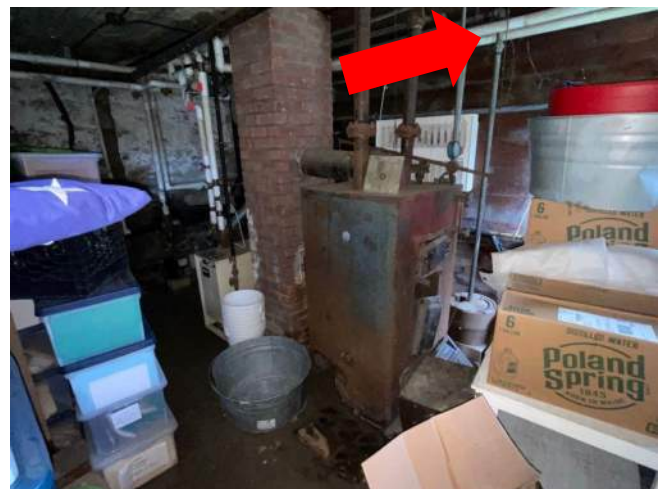
### PHOTO 36

Material: All Service Jacket to Fiberglass Pipe Insulation (HA-CH-02)

Location: Coachman House Basement

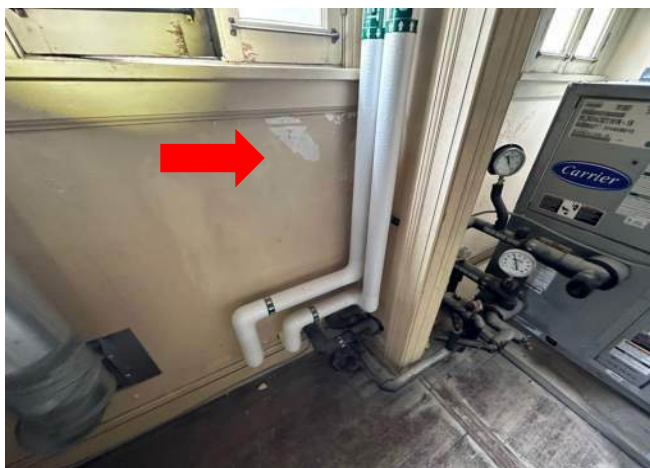
### PHOTO 37

Material: Multi-Layer Wall Plaster (HA-BH-01-L1/L2)  
Location: Bedford House - Throughout

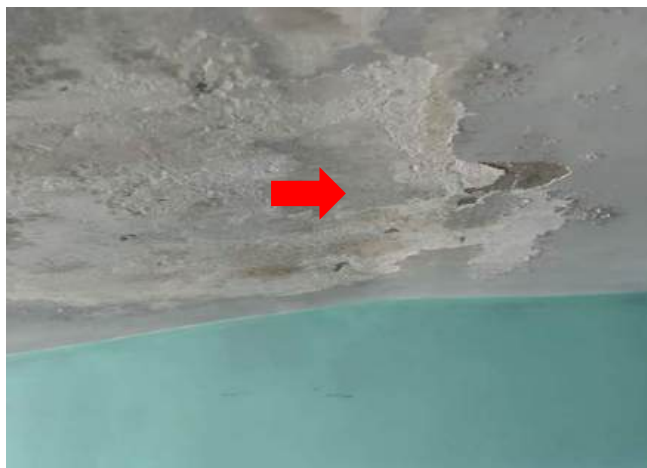
### PHOTO 38

Material: Multi-Layer Ceiling Plaster (HA-BH-02-L1/L2)  
Location: Bedford House - Throughout

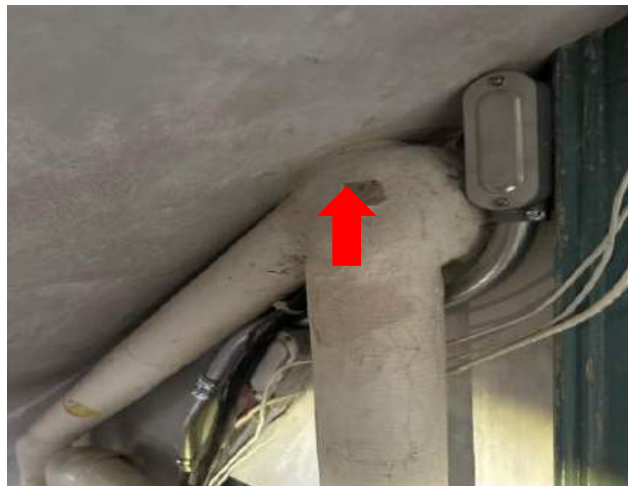
### PHOTO 39

Material: Mudded Joint Insulation (HA-BH-03-L1/L2)  
Location: Bedford House – Third Floor

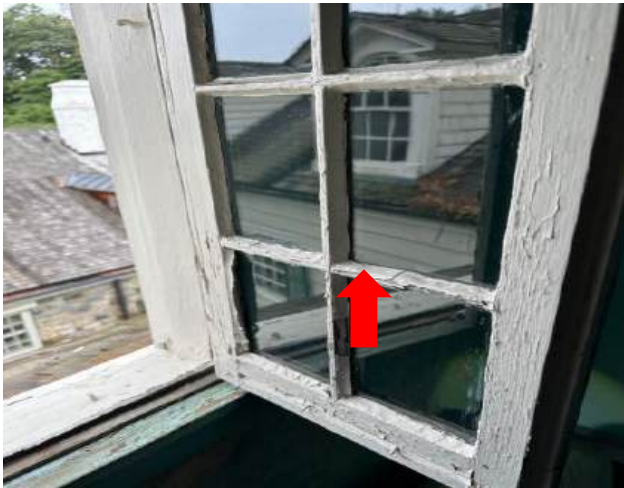
Material: Exterior Window Glazing (HA-BH-05)

Location: Bedford House - Exterior

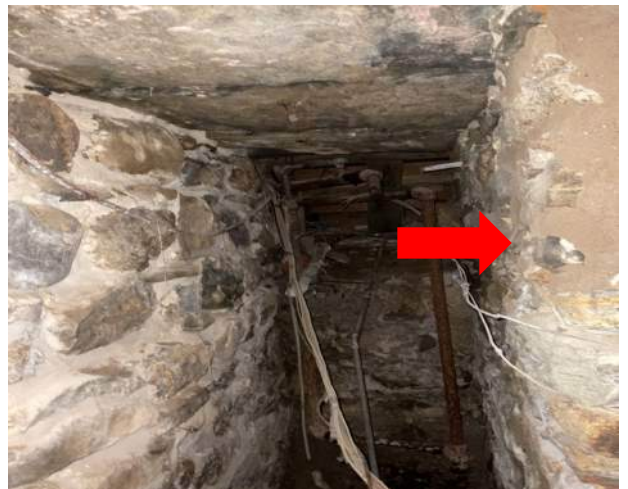
Material: Rubble Wall Mortar (HA-BH-08)

Location: Bedford House - Basement

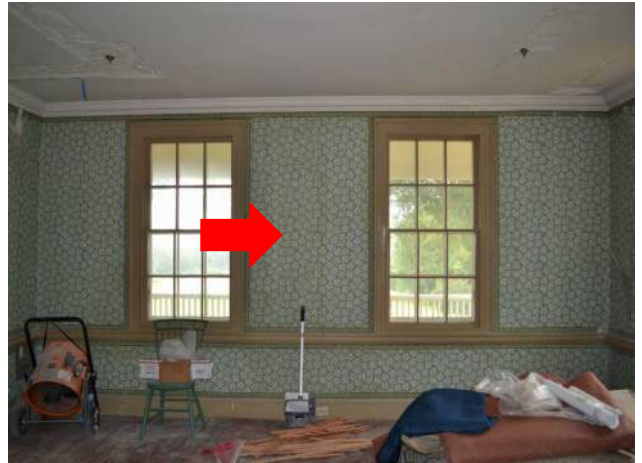
### PHOTO 46

Material: Green Fern Patterned Wallpaper (HA-BH-10)  
Location: Bedford House - 1<sup>st</sup> Floor Room B102

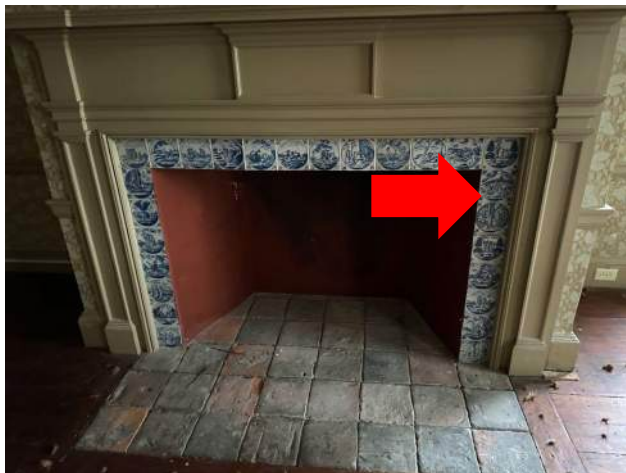
### PHOTO 47

Material: Ceramic Chimney Tile Grout and Mortar (HA-BH-11M/11G)  
Location: Bedford House – 1<sup>st</sup> Floor Room B104

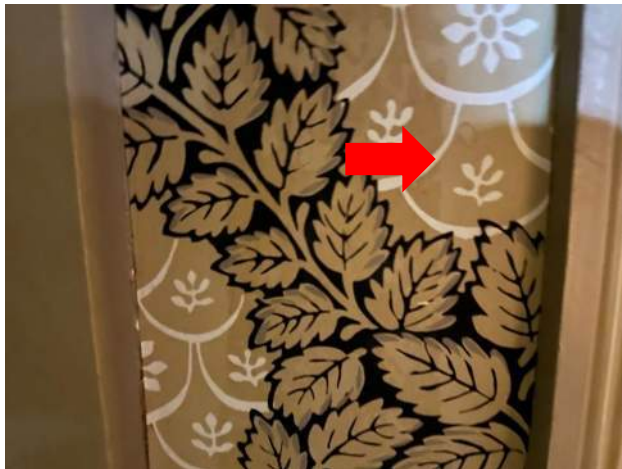
### PHOTO 49

Material: Black & Gold Leaf Patterned Wallpaper (HA-BH-13)  
Location: Bedford House – 1<sup>st</sup> Floor Room B105

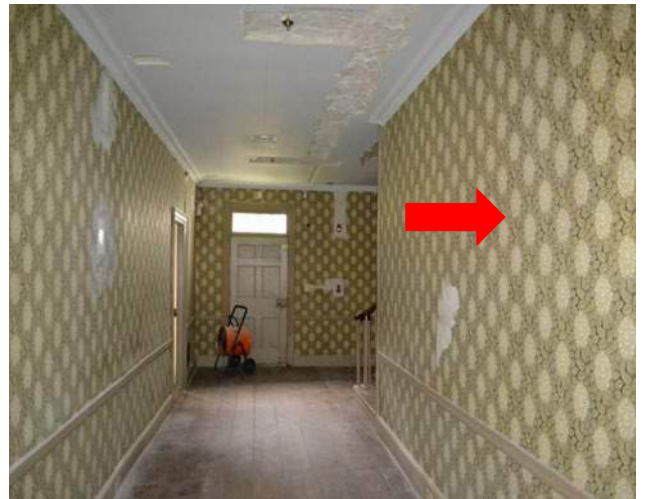
### PHOTO 50

Material: Tan Leaf Patterned Wallpaper (HA-BH-14)  
Location: Bedford House – 1<sup>st</sup> Floor Room B106

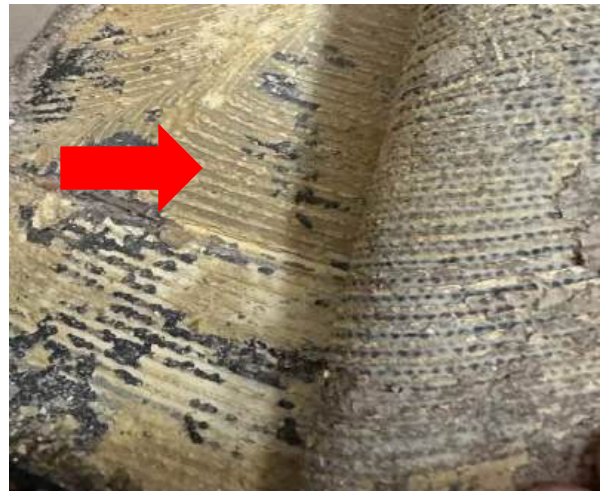
### PHOTO 54

Material: Carpet Glue (HA-BH-18)  
Location: Bedford House – 1<sup>st</sup> Floor Room B128

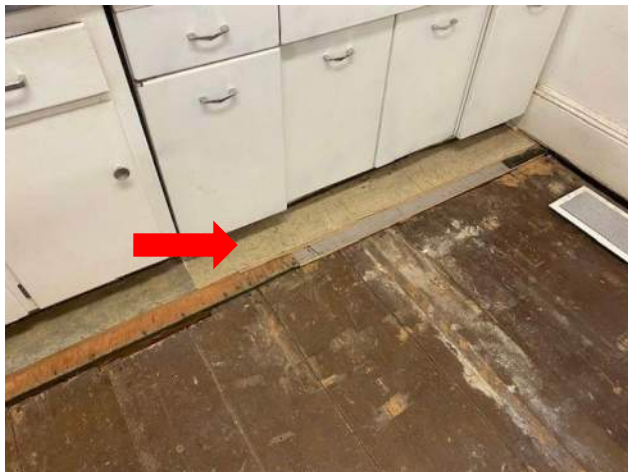
### PHOTO 55

Material: 12"x12" Tan Vinyl Floor Tile and Mastic (HA-BH-19/19M)  
Location: Bedford House – 1<sup>st</sup> Floor Room B115

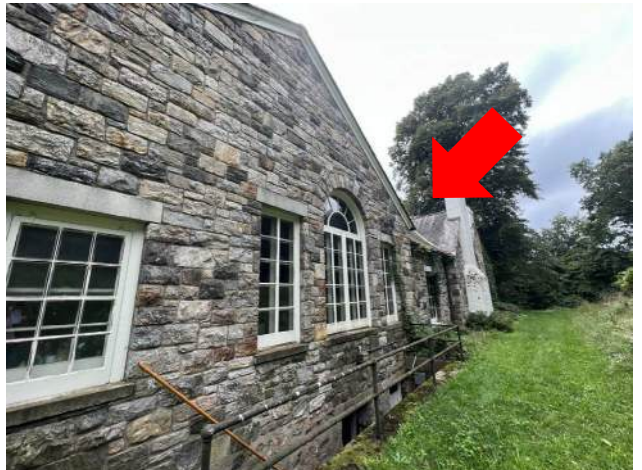
### PHOTO 56

Material: Main Roof Composite (HA-BH-20-L1/L2)  
Location: Bedford House – Main Roof
