January 30, 2018

Re: Station 14 Geotechnical
2187 Central Park Avenue
Yonkers, NY 10710
McLaren File No. 160616.04

The scope of this investigation was to determine the cause of the floor slab cracking in the truck bays and cracking of the interior wall of the station.

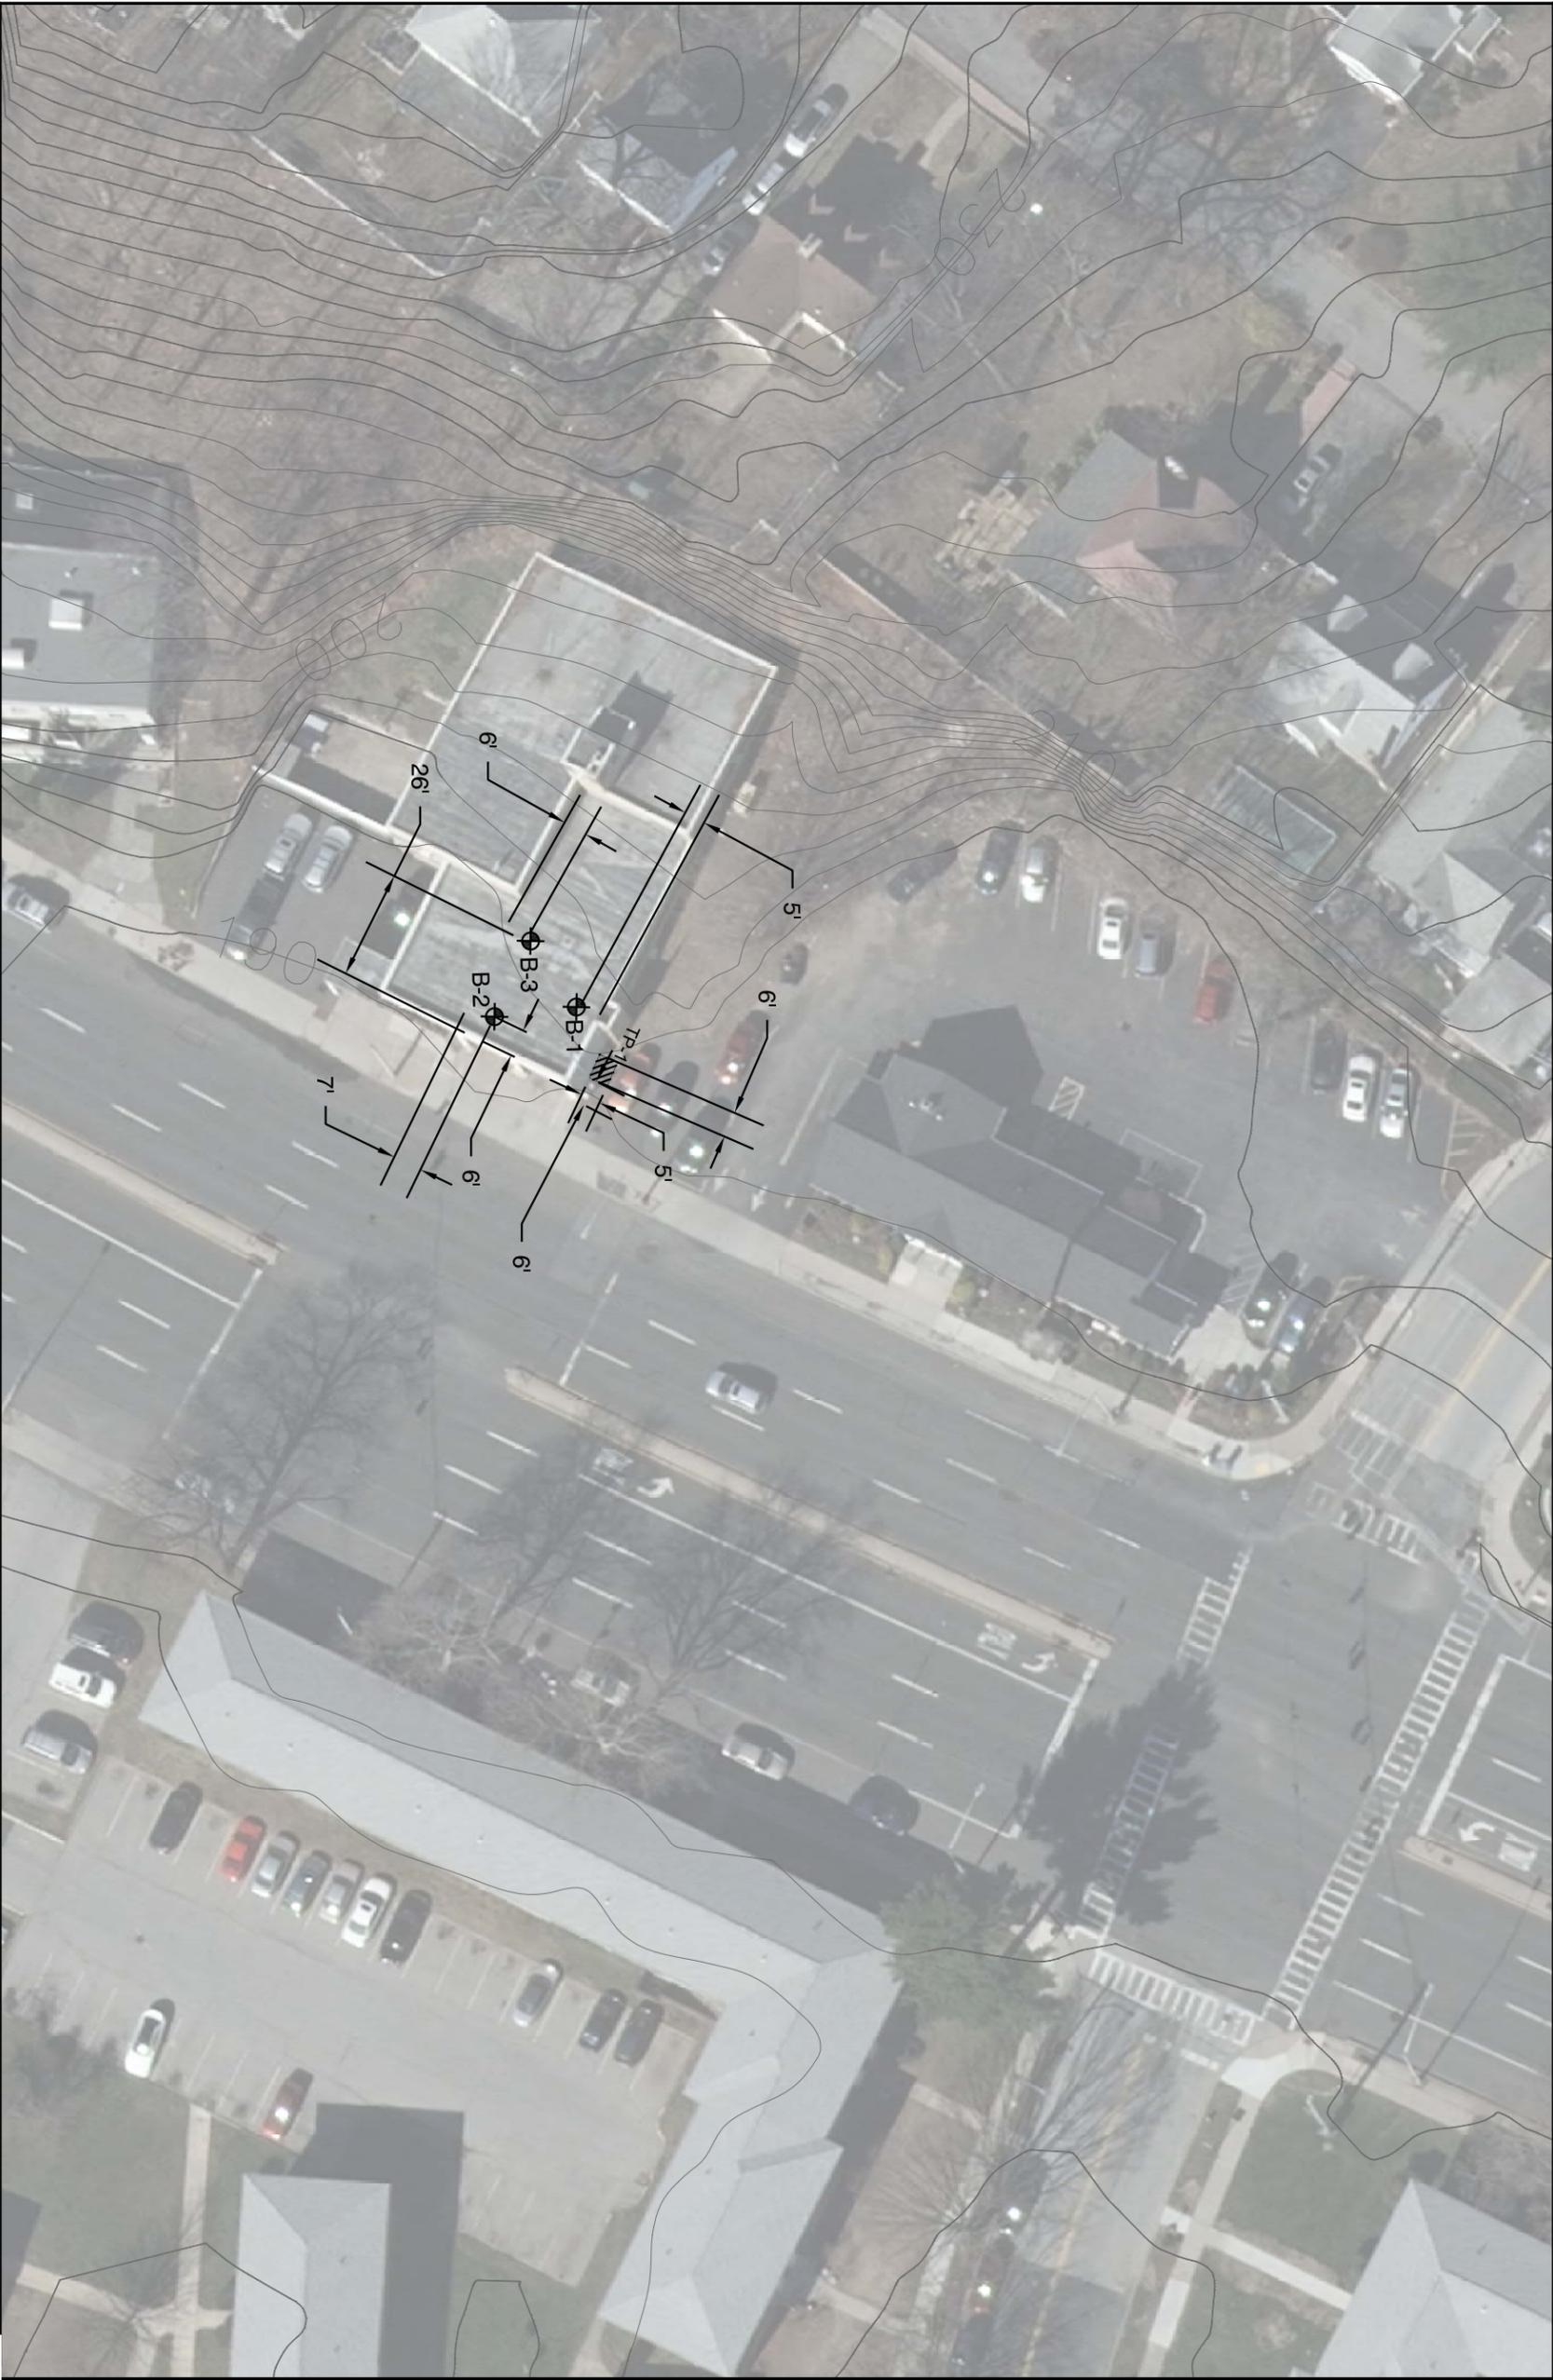
Three (3) borings and one (1) test pit were performed by Soiltesting Inc. (90 Donovan Road, Oxford CT 06478) at the site. The borings were performed inside the building, in the front area of the garage. The test pit was performed outside of the structure but adjacent to the garage front wall. (See Appendix B, Boring and Test Pit Location Plan). Borings were performed with a skid-mounted rig using hollow-stem auger casing. The test pit was hand dug to full depth with shovels and cutter mattock.

A test pit was performed adjacent to the exterior garage wall, five feet from the front of the garage. The test pit was performed in order to visually inspect the integrity of the foundation in the area of the crack in the tile façade along the interior garage wall. (See Appendix B, Boring and Test Pit Location Plan). Test Pit 1 (TP-1) was approximately 5 feet long by 4.5 feet wide by 6 feet deep. At the center line of the test pit on the inside wall, there was a vertical crack present. This crack was not visible on the outside wall.

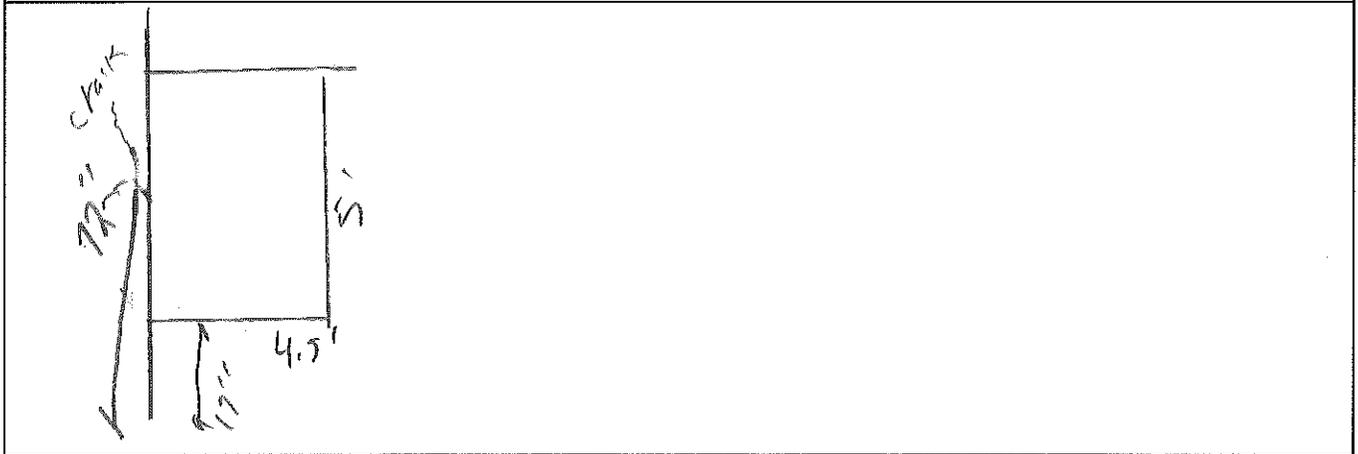
Site Sketch:

Depth	Description and Classification	Stratum Description
10'	Asphalt	
3'	light brown - brown fine sand w/ some silt, 3/4" stone	
	6" FOOTING DRAIN - CLAY PIPE	
3'	light brown - brown fine sand.

Remarks
 - Hand dug to 6' - No Foundation Footing reveal
 - Metal Bar was inserted thru the soil, Assume Bed Rock
