COUNTY OF WESTCHESTER  
NEW YORK  
DEPARTMENT OF PUBLIC WORKS  
AND TRANSPORTATION  
DIVISION OF ENGINEERING  
**ADDENDUM NO. 1**  
CONTRACT NO. 23-519  
FOR  
**ROOF, HVAC, AND ELECTRICAL UPGRADES  
DANIEL P. THOMAS MATERIAL RECOVERY FACILITY  
YONKERS, NEW YORK**

Pre-Renovation Survey for Asbestos-Containing Materials and Polychlorinated Biphenyls in Caulks and Sealants for The Roof, HVAC and Electrical Upgrade Project at The Daniel P. Thomas Material Recovery Facility

**PRE-RENOVATION SURVEY**  
**FOR**  
**ASBESTOS-CONTAINING MATERIALS AND**  
**POLYCHLORINATED BIPHENYLS IN CAULKS AND SEALANTS**  
**FOR THE**  
**ROOF, HVAC AND ELECTRICAL UPGRADE PROJECT**  
**AT THE**  
**DANIEL P. THOMAS MATERIAL RECOVERY FACILITY**  
**1A STEW LEONARD DRIVE**  
**YONKERS, NEW YORK**

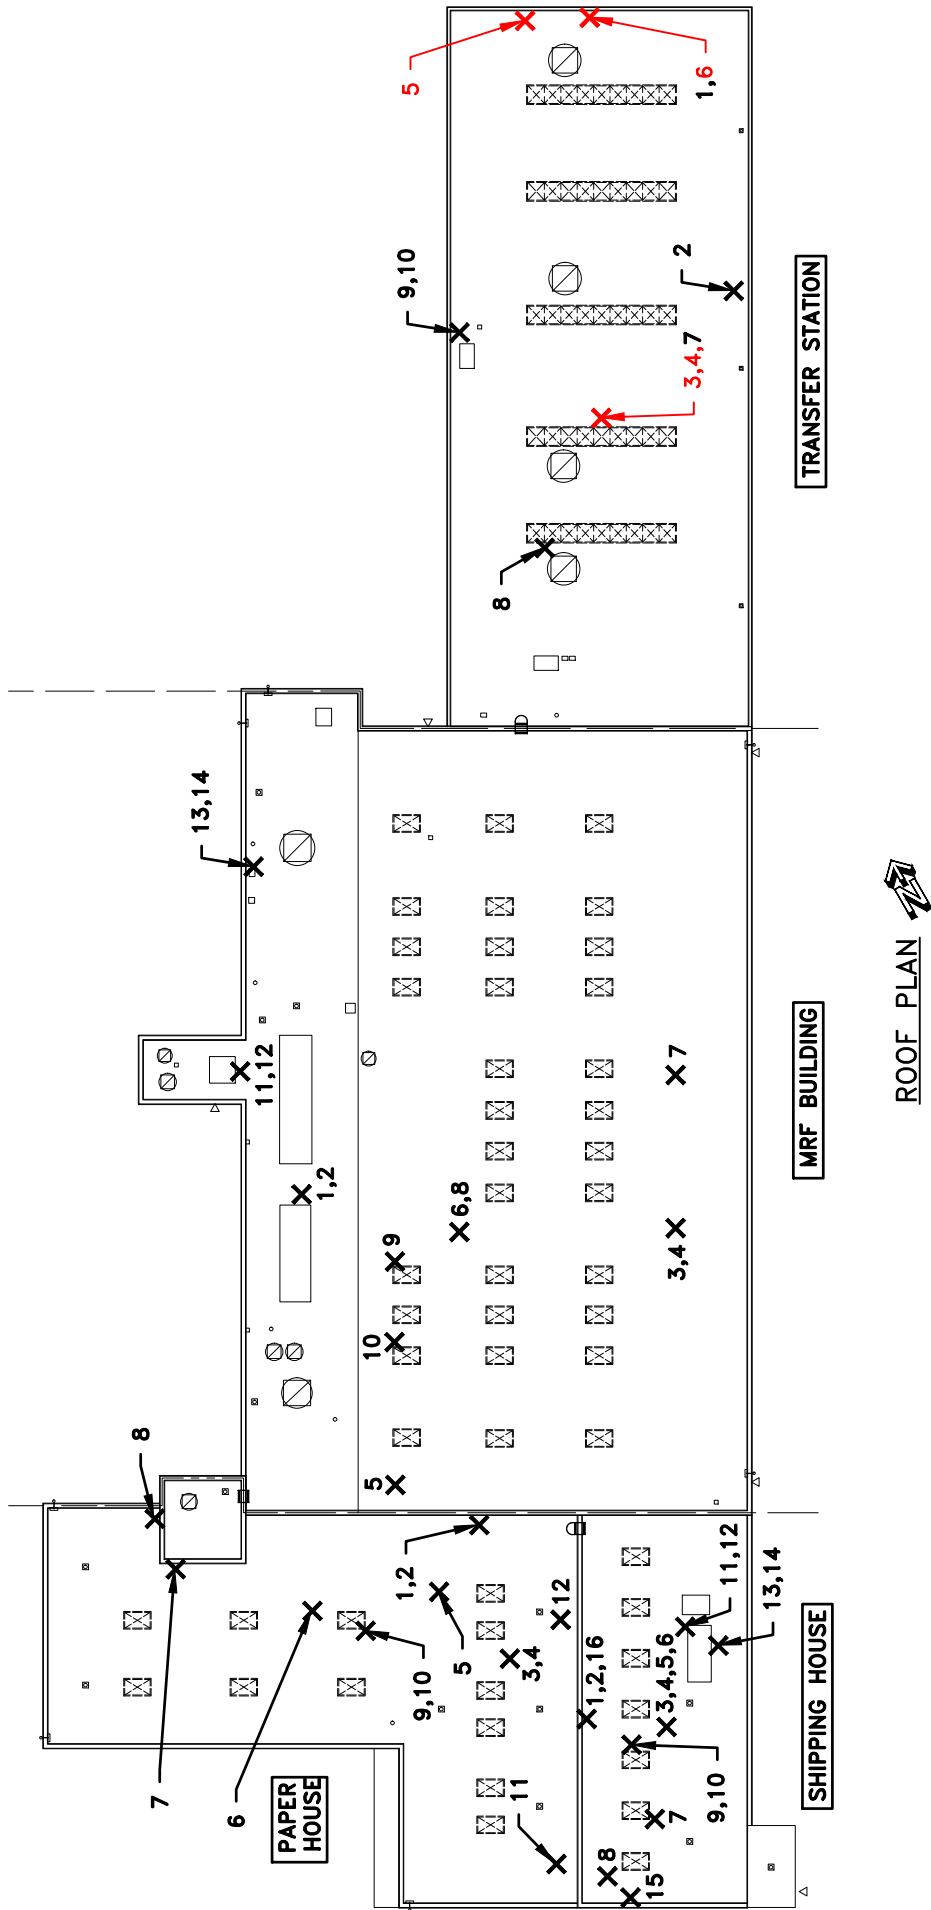
| ASBESTOS BULK SAMPLE LOCATIONS | ROOF PLAN |

X SAMPLE NUMBERS IN RED WERE IDENTIFIED TO BE ACM.

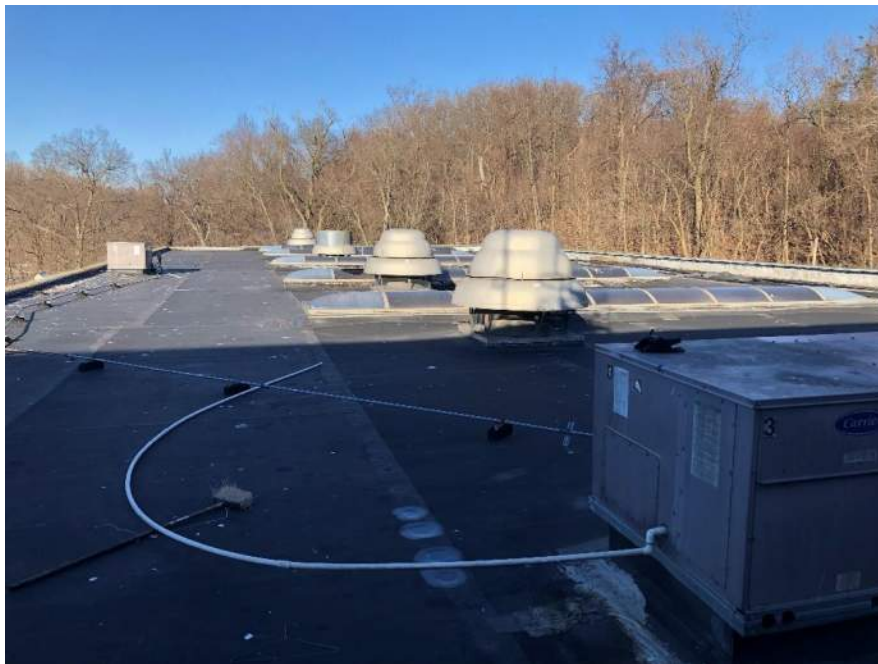
Photo 1 – Overall view of Transfer Station roof.

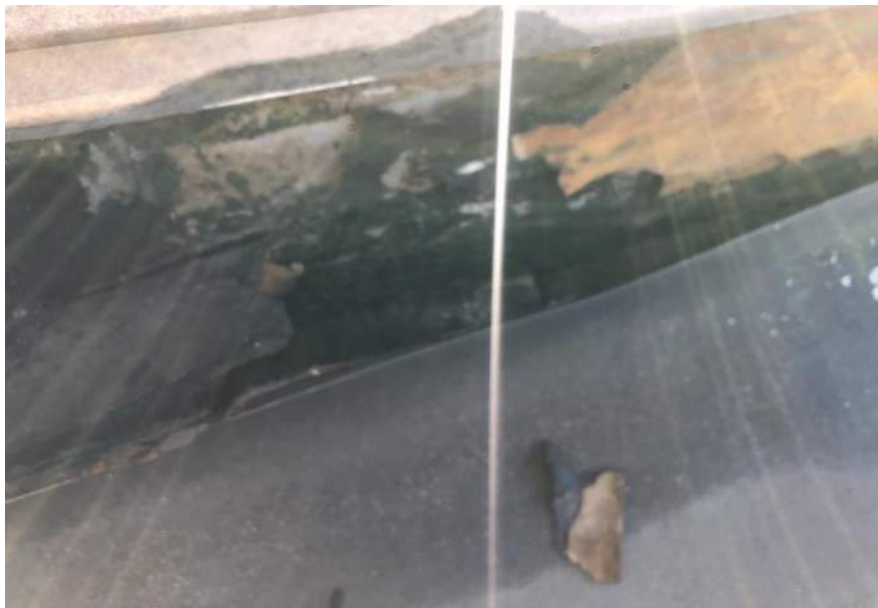
- **Black roof flashing** on the skylights. There were 5 skylights observed. Each skylight has 225 square feet of ACM roof flashing, in total there is 1,125 square feet. The flashing is non-friable and was observed to be in good condition.
- **Black roofing** under the metal roof cap at the perimeter of the roof. The roofing is non-friable and were observed to be in good condition. Approximately 630 square feet.

Photo 2 – View of asbestos-containing roof flashing around the skylights on the Transfer Station roof.

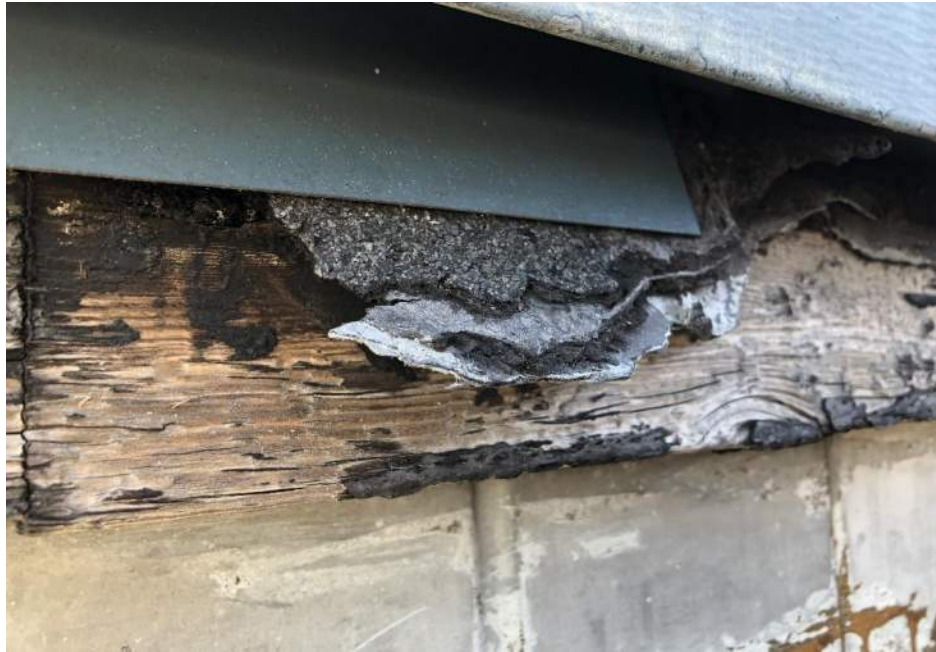
Photo 3 – View of asbestos-containing roofing under the metal cap at the perimeter of the roof on the Transfer Station roof.
