PROJECT MANUAL

NEW HAMPTON FIRE DEPARTMENT

New Fire Station

PRE-DEMOLITION SURVEY REPORT

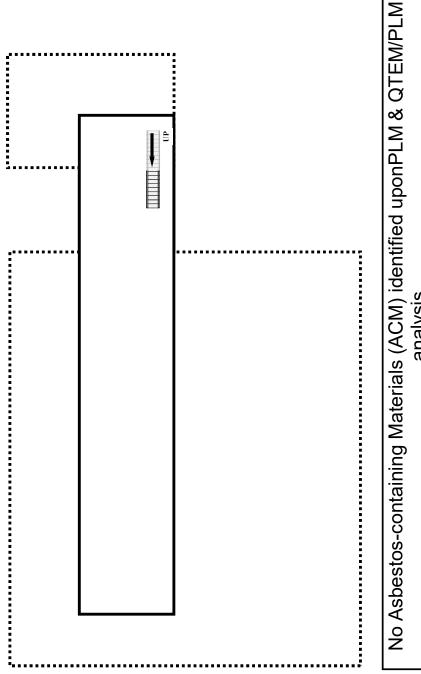
BASEMENT FLOOR PLAN ASBESTOS LOCATIONS

No Asbestos-containing Materials (ACM) identified uponPLM & QTEM/PLM analysis

Prior to conducting demolition or construction work at the building, all ACM affected/impacted by such activities shall be removed utilizing a licensed asbestos abatement contractor and NYSDOL/EPA/NYC certified personnel prior to construction/demolition activities. All work conducted should be in accordance with all legal requirements, including but not limited to U.S. Environmental Protection Agency (EPA) National Emissions Standards for Hazardous Air Pollutants (NESHAP) [40 CFR Part 61], New York State Industrial Code Rule 56 Asbestos Regulations (ICR 56) and Chapter 1 of Title 15 of the Rules of the City of New York Regulations, as applicable. Advance notification of the asbestos project to the USEPA, NYSDOL, and NYCDEP may be required.

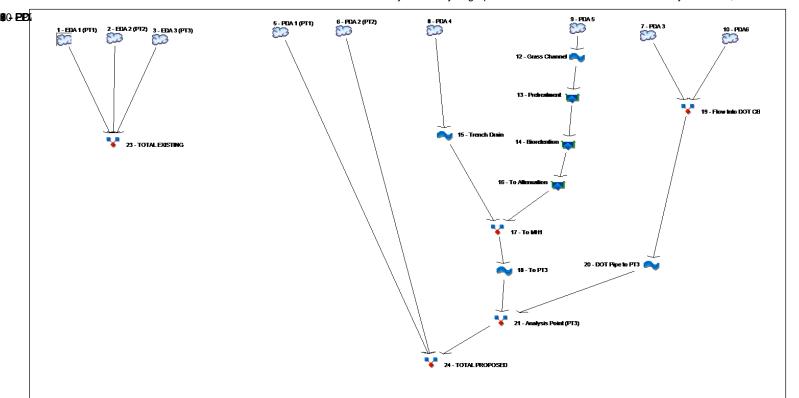
Watershed Model Schematic

<u>Hyd.</u>	<u>Origin</u>	<u>Description</u>
1	SCS Runoff	EDA 1 (PT1)
2	SCS Runoff	EDA 2 (PT2)
3	SCS Runoff	EDA 3 (PT3)
5	SCS Runoff	PDA 1 (PT1)
6	SCS Runoff	PDA 2 (PT2)
7	SCS Runoff	PDA 3
8	SCS Runoff	PDA 4
9	SCS Runoff	PDA 5
10	SCS Runoff	PDA6
12	Reach	Grass Channel
13	Reservoir	Pretreatment
14	Reservoir	Bioretention
15	Reach	Trench Drain
16	Reservoir	To Attenuation
17	Combine	To MH1
18	Reach	To PT3
19	Combine	Flow Into DOT CB
20	Reach	DOT Pipe to PT3
21	Combine	Analysis Point (PT3)
23	Combine	TOTAL EXISTING
24	Combine	TOTAL PROPOSED

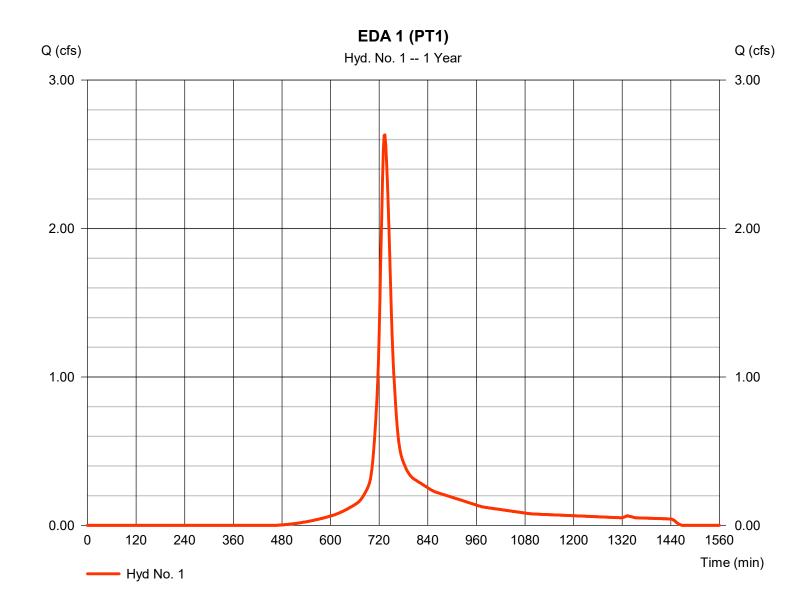
EDA 1 (PT1)

Hydrograph type = SCS Runoff Peak discharge = 2.631 cfsStorm frequency = 1 yrsTime to peak = 734 min Time interval = 2 min Hyd. volume = 11,626 cuft Drainage area = 2.120 acCurve number = 88 Basin Slope = 0.0 %Hydraulic length = 0 ftTc method Time of conc. (Tc) = 18.30 min = TR55 Total precip. = 2.65 inDistribution = Type III Storm duration = 24 hrs Shape factor = 484

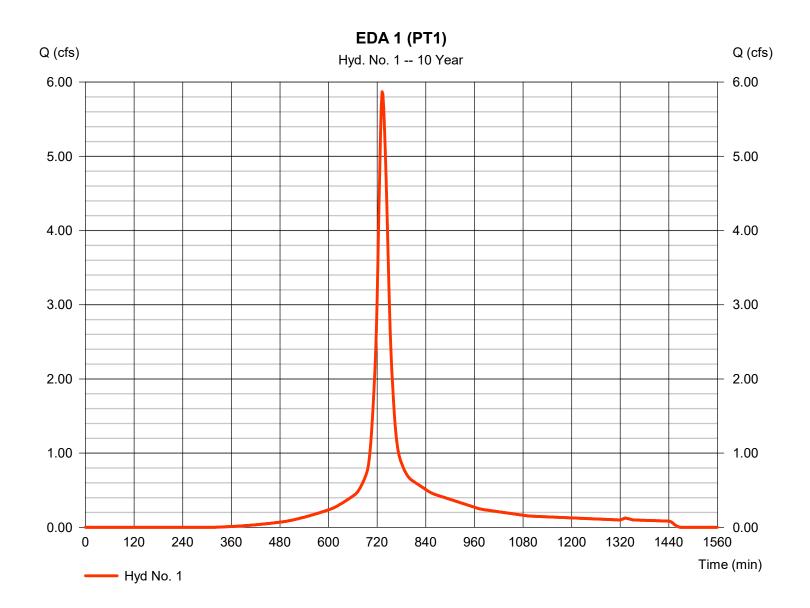
EDA 1 (PT1)

Hydrograph type = SCS Runoff Peak discharge = 5.870 cfsStorm frequency = 10 yrsTime to peak = 732 min Time interval = 2 min Hyd. volume = 26,338 cuft Drainage area Curve number = 2.120 ac= 88 Basin Slope = 0.0 %Hydraulic length = 0 ftTc method Time of conc. (Tc) = 18.30 min = TR55 Total precip. = 4.74 inDistribution = Type III Storm duration = 24 hrs Shape factor = 484

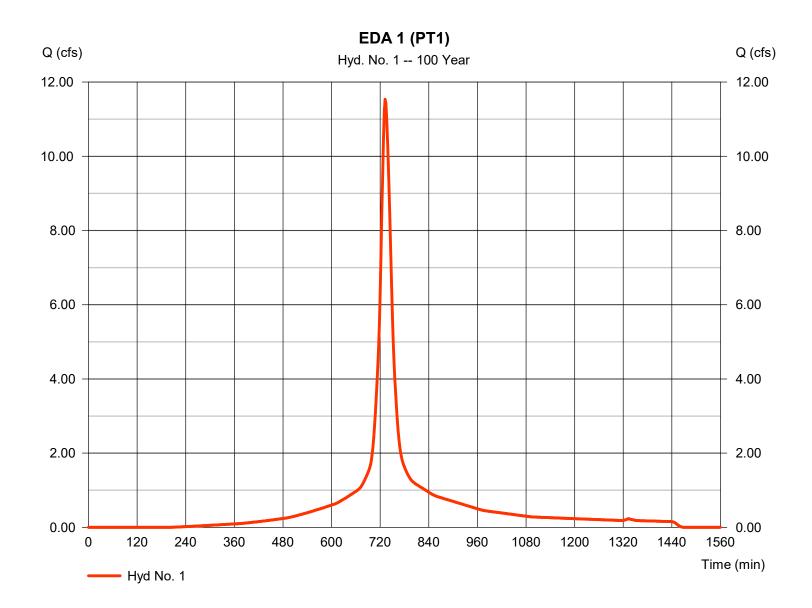
EDA 1 (PT1)

Hydrograph type = SCS Runoff Peak discharge = 11.54 cfsStorm frequency = 100 yrsTime to peak = 732 min Time interval = 2 min Hyd. volume = 53,483 cuft Drainage area Curve number = 2.120 ac= 88 Basin Slope = 0.0 %Hydraulic length = 0 ftTc method Time of conc. (Tc) = 18.30 min = TR55 Total precip. = 8.39 inDistribution = Type III Storm duration = 24 hrs Shape factor = 484
