PORT EWEN FIRE HOUSE
PORT EWEN
FIRE DEPARTMENT
ULSTER, NEW YORK

CONCRETE DETAILS

SHEET:
S300

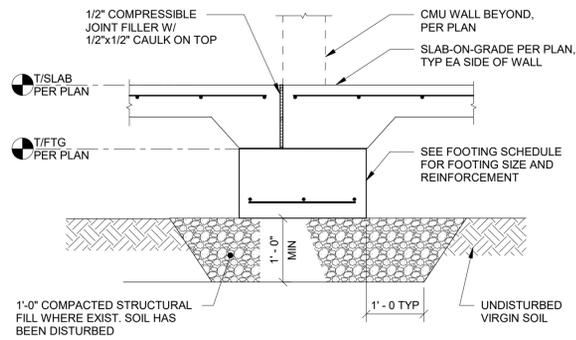
15 FOOTING AT INTERIOR MASONRY WALL OPENING
S300 N.T.S.

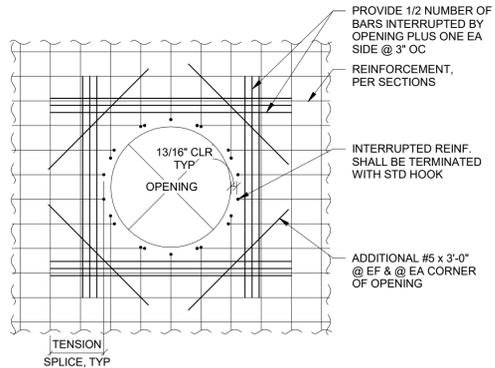
14 TYPICAL WALL SLEEVE OPENING
S300 N.T.S.

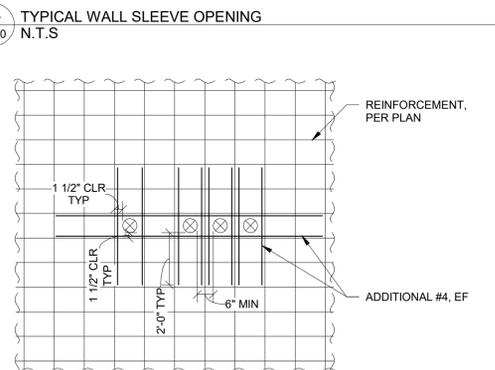
13 TYPICAL MULTIPLE WALL SLEEVE OPENING DETAIL
S300 N.T.S.

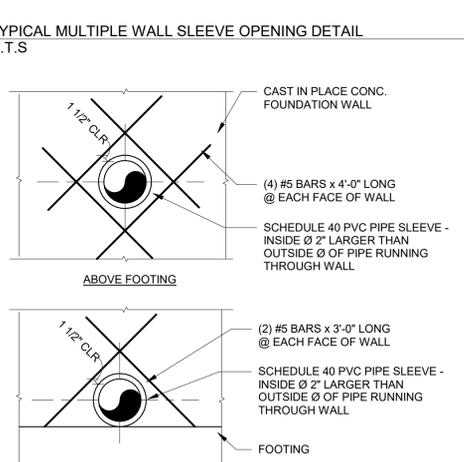
12 TYPICAL WALL REINFORCING FOR PIPE OPENING
S300 N.T.S.

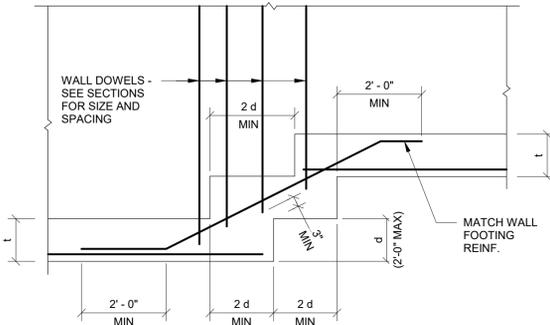
11 TYPICAL STEPPED FOOTING DETAIL
S300 N.T.S.

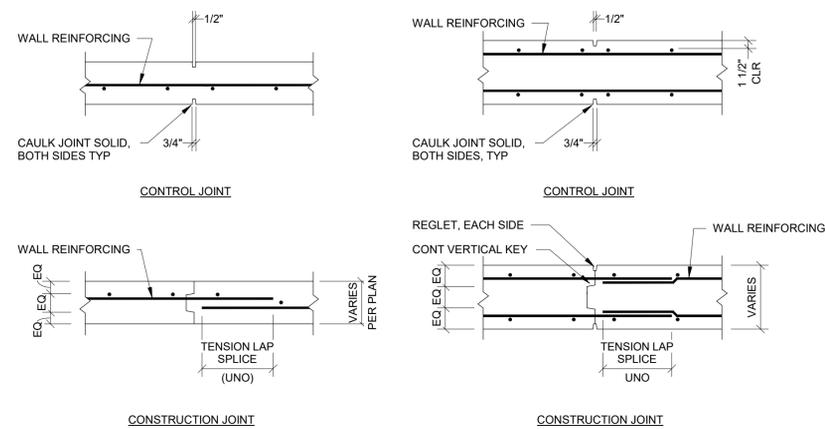
10 TYPICAL CONCRETE WALL JOINT DETAILS
S300 N.T.S.

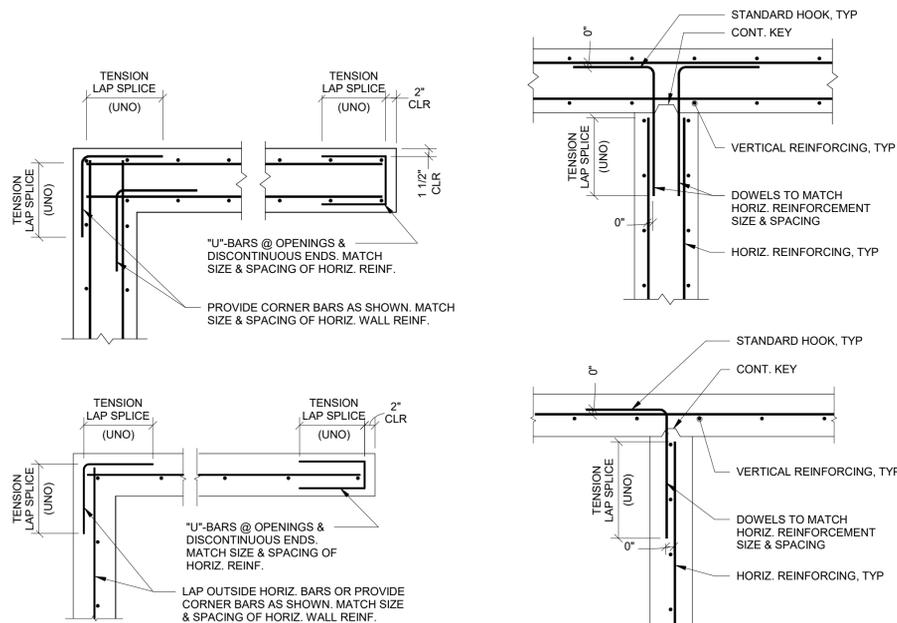
9 TYPICAL CONCRETE WALL CORNER & END DETAIL
S300 N.T.S.

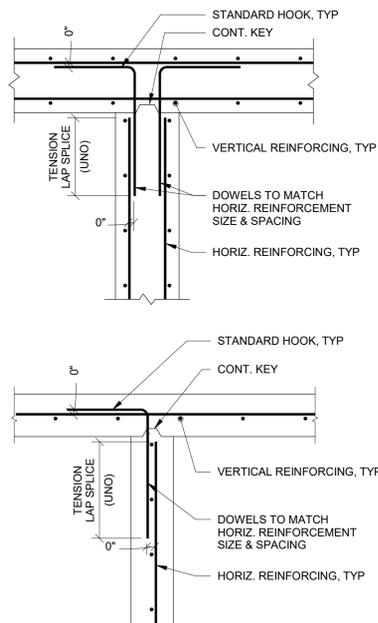
8 TYP CONCRETE WALL INTERSECTION DETAIL
S300 N.T.S.

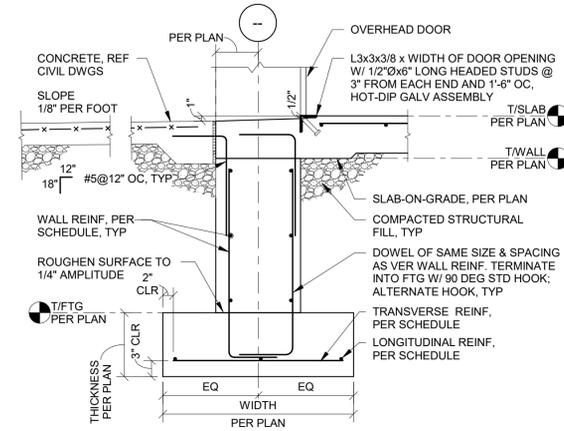
7 TYPICAL FDN DETAIL @ VEHICLE DOOR
S300 N.T.S.

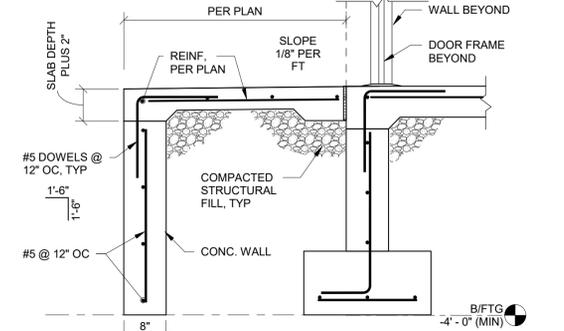
6 TYPICAL STOOP DETAIL
S300 N.T.S.

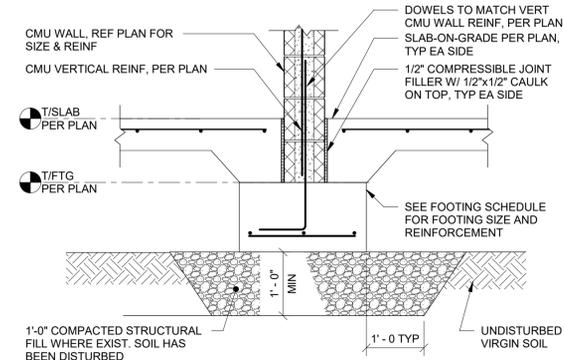
5 TYPICAL FOOTING AT INTERIOR MASONRY WALL
S300 N.T.S.

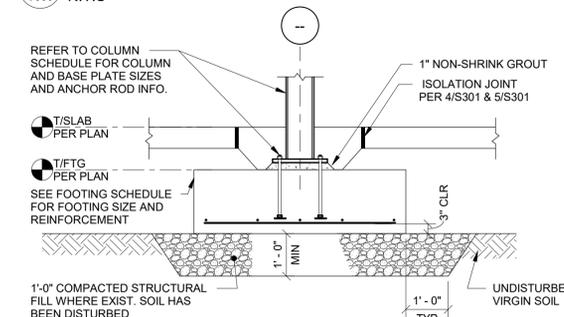
4 TYPICAL INTERIOR SPREAD FOOTING DETAIL
S300 N.T.S.

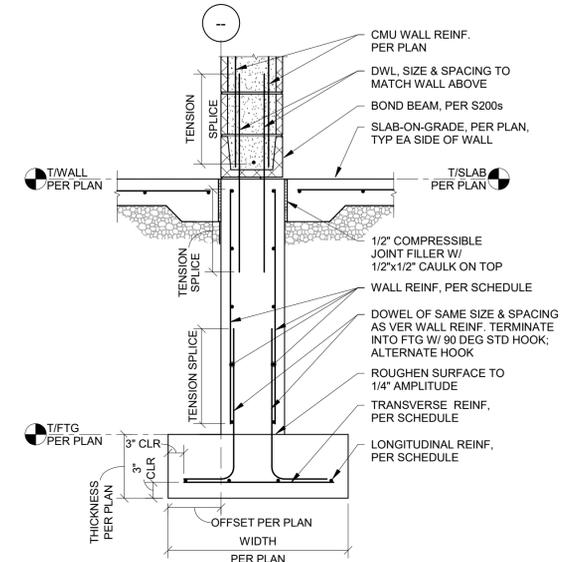
3 TYPICAL INTERIOR FOUNDATION WALL DETAIL - ALTERNATE 1
S300 N.T.S.

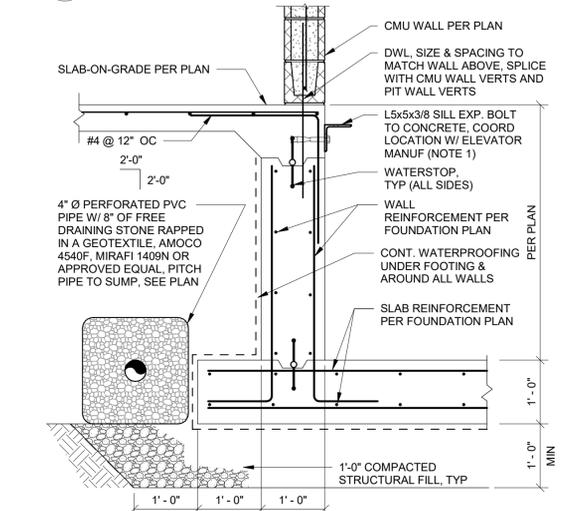
2 TYPICAL ELEVATOR PIT DETAIL
S300 N.T.S.
