# FIELD REPORT

| <b>Report No.:</b> | 1 – HVAC Scoping Visit | <b>Project Name:</b> | JPM – North Ave<br>(New Rochelle) |

| <b>Agenda of Survey</b> | Perform scoping visit of replacement of existing central air handling unit and corresponding condensing unit |

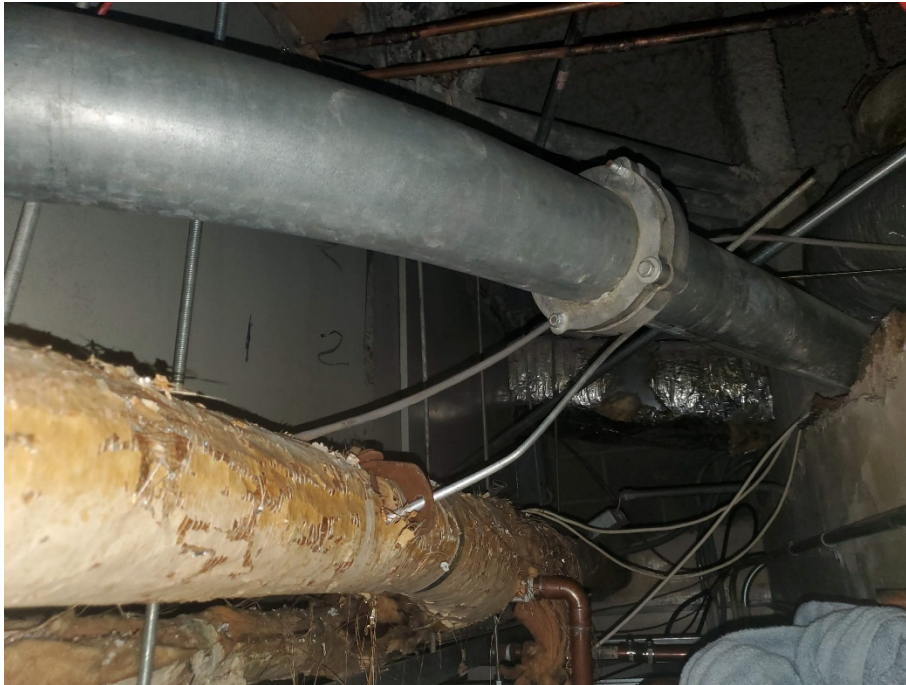
- The existing Chase Bank is served by a large air handling unit (AHU) located in the basement below of the adjacent multi-story building. The AHU was installed in the ceiling of the landlord office and was not readily accessible at the start of the site visit.

- The AHU was installed very tight to the existing deck and ceiling below, and overall access to the unit was very difficult. Due to the extreme limited conditions, a nameplate could not be located. Based on information provided from facilities, it was mentioned the AHU is rated at 30-tons.

**Photo #1 – Existing AHU in Basement Ceiling**

- The existing air handling unit looks to be at least 20 years and is assumed to have passed its expected lifespan. As a result, the AHU should be removed and replaced.

- The existing configuration does not allow sufficient maintenance access and the AHU should not be a like-for-like replacement. To better provide maintenance access, one option is to negotiate with the landlord to take over the office where the AHU is installed. The existing AHU can be removed in sections and the existing office can be retrofitted into a new mechanical room to provide the necessary access for a future AHU. A new, floor-mounted AHU can be provided and installed. This would allow sufficient space for all future maintenance and to reconnect the new supply and return connections from the AHU to the existing duct risers to the Chase Bank space. There is an old Break Room previously serving the bank that is no longer being used within the basement space that could then be retrofitted to be the new landlord office in exchange to provide the mechanical room for the AHU. This is the least invasive option as it minimizes the impact to the existing HVAC system.

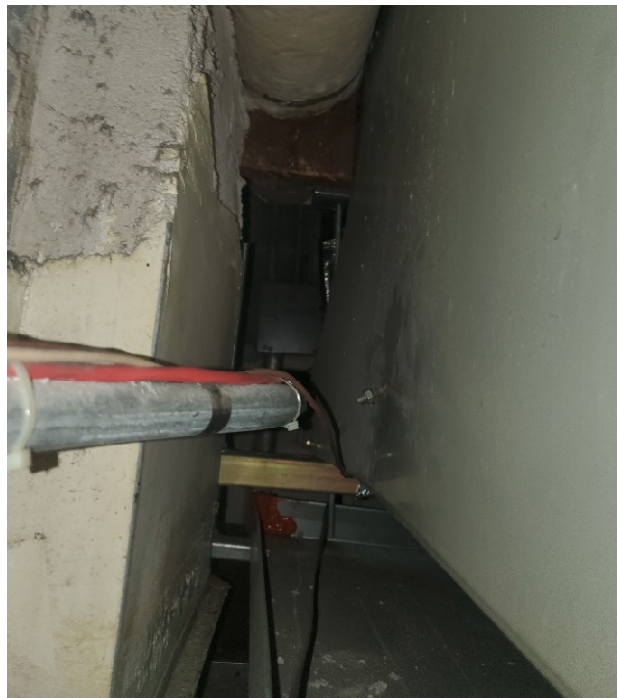
- Per the facilities personnel on site, they are not able to properly access and maintain the AHU. This includes changing of filters, replacement of belts, and other maintenance items.

**Photo #2 – Available Space for Maintenance Access**

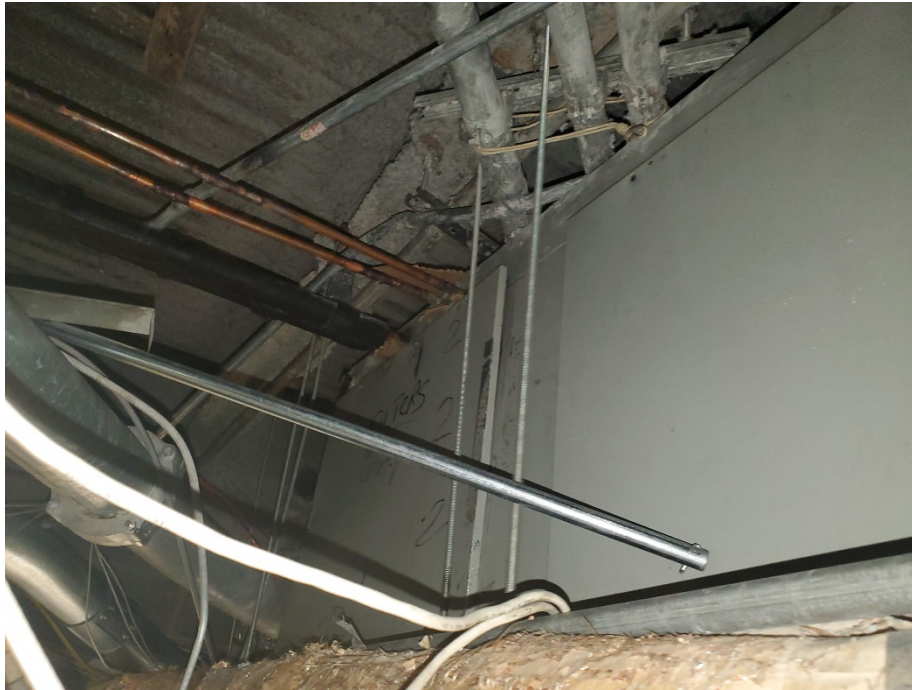
**Photo #3 – Blocked Filter Access**

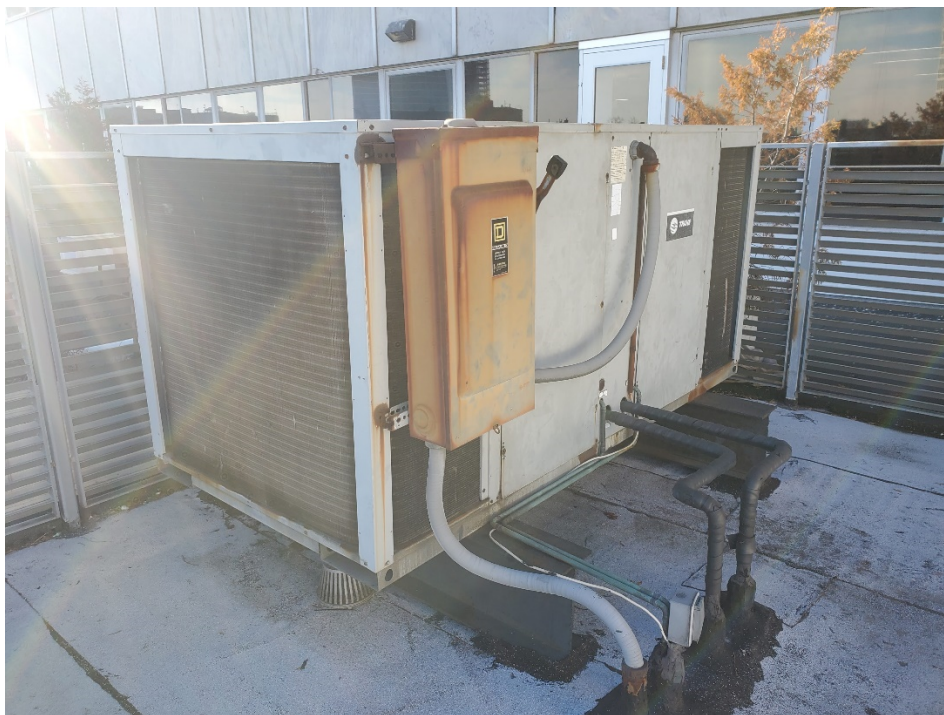
- The corresponding condensing unit (Trane M# TTA240B300BA, S# G17198748) is located on the roof of the Chase Bank, which is approximately 3 stories above grade. The CU is rated at 20-tons. The condensing unit is in poor condition and is approximately 31 years old.

- The condensing unit was installed on steel dunnage on the roof adjacent to a roof patio. There was no direct roof access from the Chase Bank space. An extension ladder is needed on the top

**Photo #4 – Condensing Unit on Roof**

- The condensing unit can be easily replaced with a direct replacement. There is sufficient space on the roof and rigging of a new unit is possible.
- Ultimately, the preferred recommendation from Core States Group is to provide and install an all new Variable Refrigerant Flow (VRF) system to serve the entire Chase Bank. The current HVAC system is very old and should be removed. The VRF system would remove the dependency on the base-building steam plant and is capable of providing electric heating with the removal of the large AHU and corresponding condensing unit. The VRF system utilizes individual fan coil units (FCUs) that are slim and can be easily installed above the ceiling within the Chase Bank space. This also provides direct access to the HVAC systems within the bank and no longer

- The condensing unit can be replaced like-for-like as there is adequate room on the roof for a new unit and this unit can be re-fed from the existing 125A/3P circuit breaker in panel MDP.

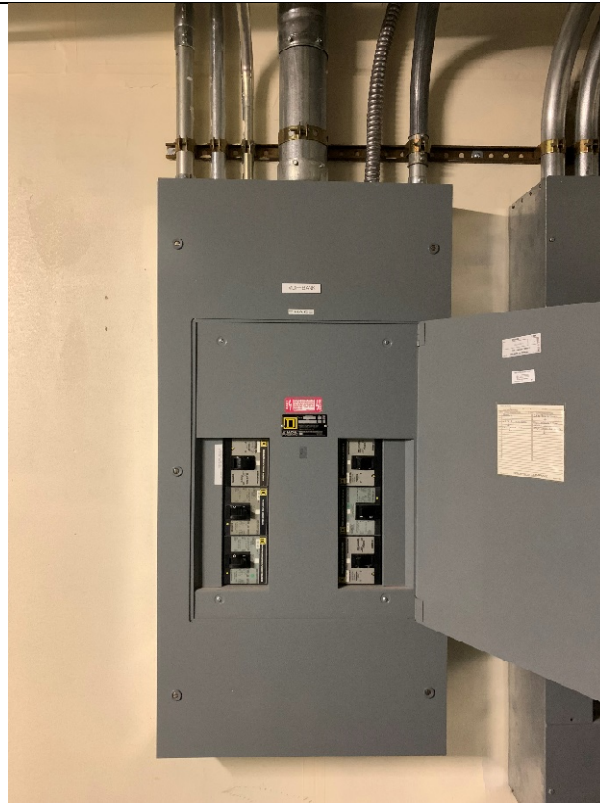
- The existing rooftop A/C unit and basement AHU are fed from Chase panel MDP. This panel is located in the base building basement electrical room, which is adjacent to the landlord office alluded to above. The rooftop A/C unit is fed from a 125A/3P circuit breaker in MDP. The basement AHU is fed from a 20A/3P circuit breaker in MDP.
- The existing front entry doors are not ADA compliant as they do not have a 10" kickplate or door opener.

**Photo #5 – Chase MDP Located in Base Building Basement Electrical Room**

- If the proposed and recommended VRF system should be installed, the existing rooftop condensing unit and basement AHU will be removed, therefore electrical space in MDP will be available to connect to. The new VRF condensing unit shall be connected to MDP and a breaker shall be installed based on the size of the unit. The corresponding fan coil units can either be connected to one breaker in MDP pending electrical ratings (though not preferred) or fed from electrical within the branch. Electrical capacity in panelboards within the branch will have to be verified in field by an electrician to determine if connection can be made. Pending the size of the units, it's possible that MDP can handle a new breaker to feed a dedicated load center to feed the proposed fan coil units for the VRF system within the Chase branch.

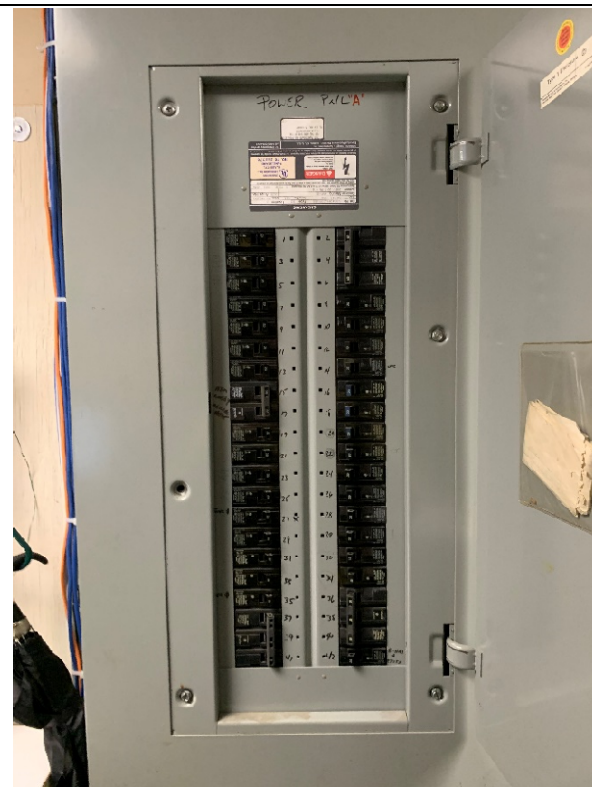
**Photo #6 – Panel A Located within Chase Bank Space**

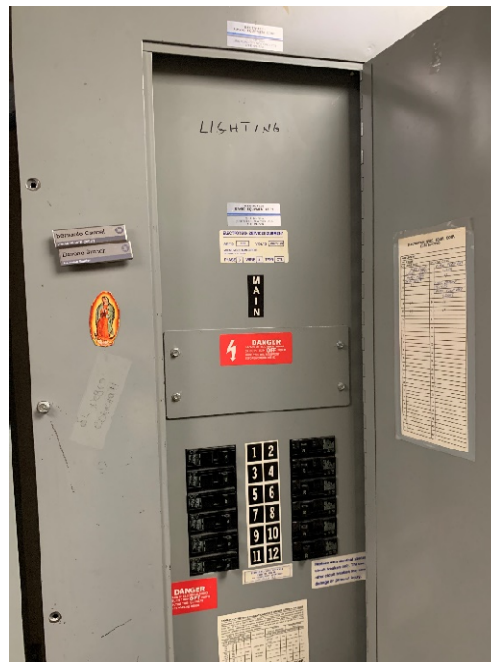
**Photo #7 – Lighting Panel Located within Chase Bank Space**

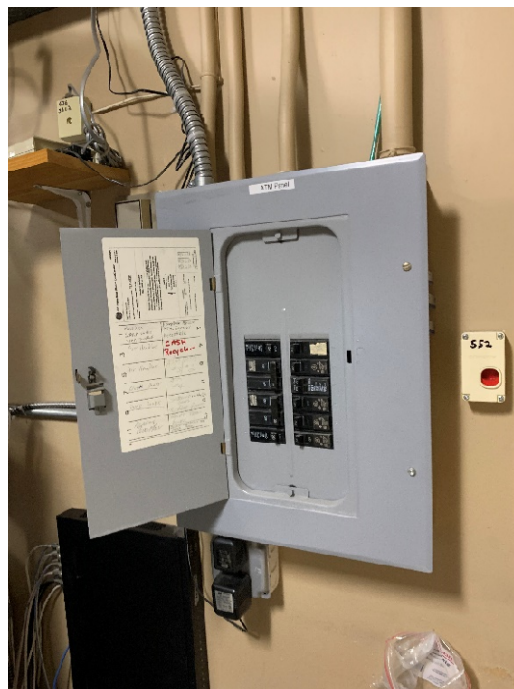
**Photo #8 – ATM Panel Located within ATM Room of Chase Bank Space**
