WHITE PLAINS CITY SCHOOL DISTRICT
HIGH SCHOOL ADDITION
SED CONTROL NO. 66-22-00-01-0-016-030
CONTRACT C - CIVIL AND SITE WORK
CONTRACT G - GENERAL CONSTRUCTION WORK
CONTRACT M - HEATING VENTILATION AND AIR CONDITIONING WORK
CONTRACT P - PLUMBING WORK
CONTRACT E - ELECTRICAL WORK

FRONT END DOCUMENTS

TECHNICAL SPECIFICATIONS

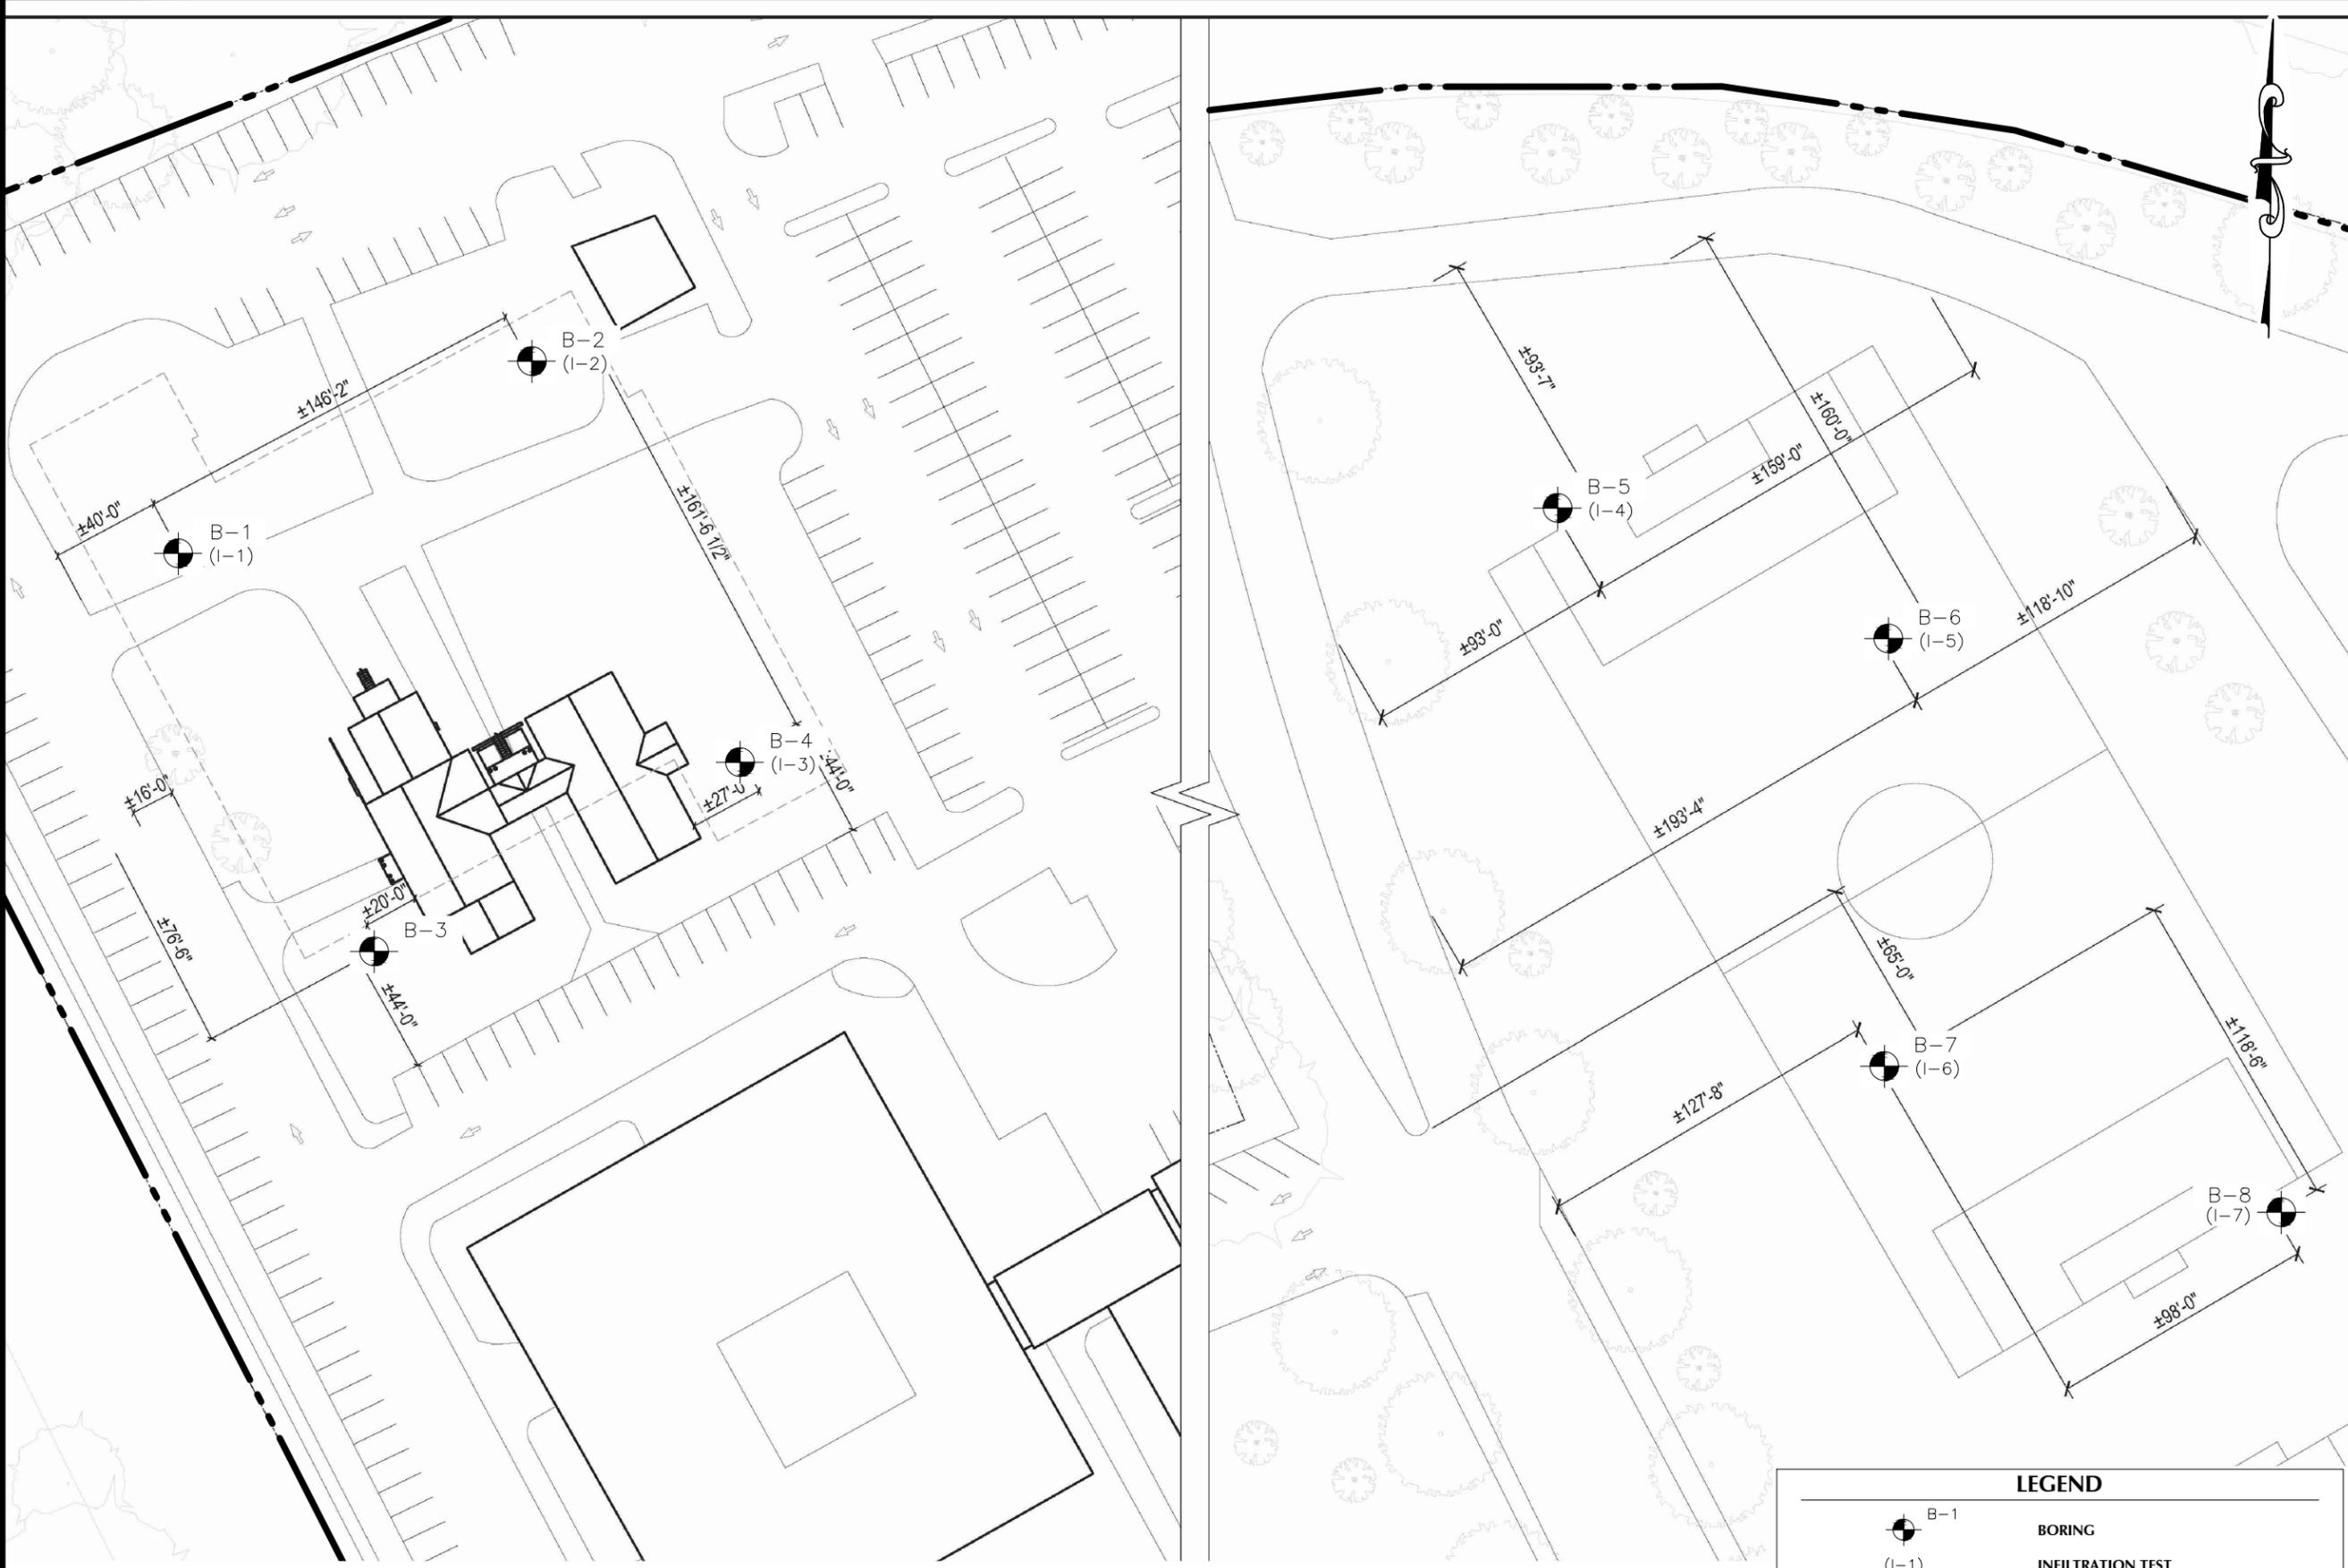
THIS PLAN IS BASED ON A SEPTEMBER 2022 WHITE PLAINS CITY SCHOOL DISTRICT HIGH SCHOOL SOIL BORING PLAN PREPARED BY H2M ARCHITECTS & ENGINEERS & ALL SITE LOCATIONS ARE APPROXIMATE.

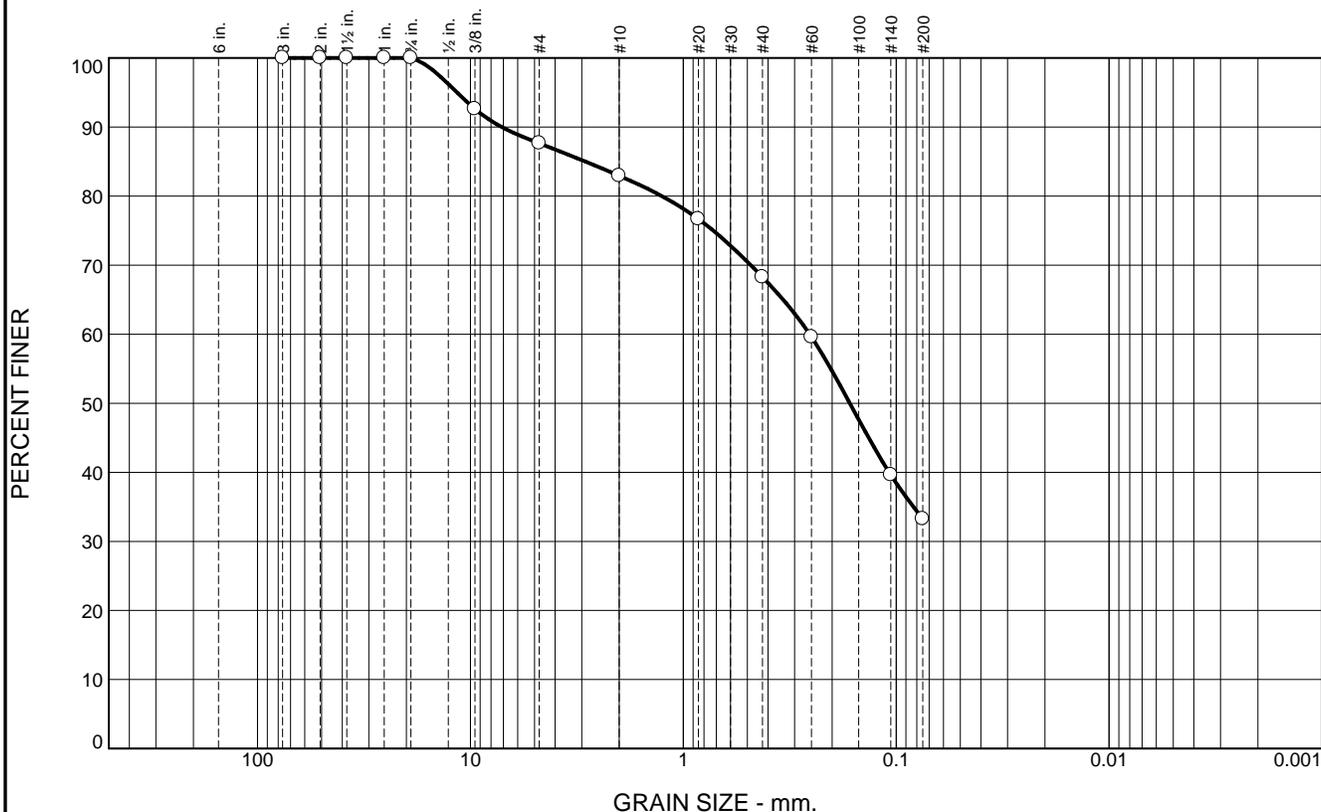
Particle Size Distribution Report

% +3"	% Gravel		% Sand			% Fines	
	Coarse	Fine	Coarse	Medium	Fine	Silt	Clay
0.0	0.0	12.4	4.7	14.6	35.1	33.2

SIEVE SIZE	PERCENT FINER	SPEC.* PERCENT	PASS? (X=NO)
3	100.0		
2	100.0		
1.5	100.0		
1	100.0		
.75	100.0		
.375	92.6		
#4	87.6		
#10	82.9		
#20	76.7		
#40	68.3		
#60	59.6		
#140	39.6		
#200	33.2

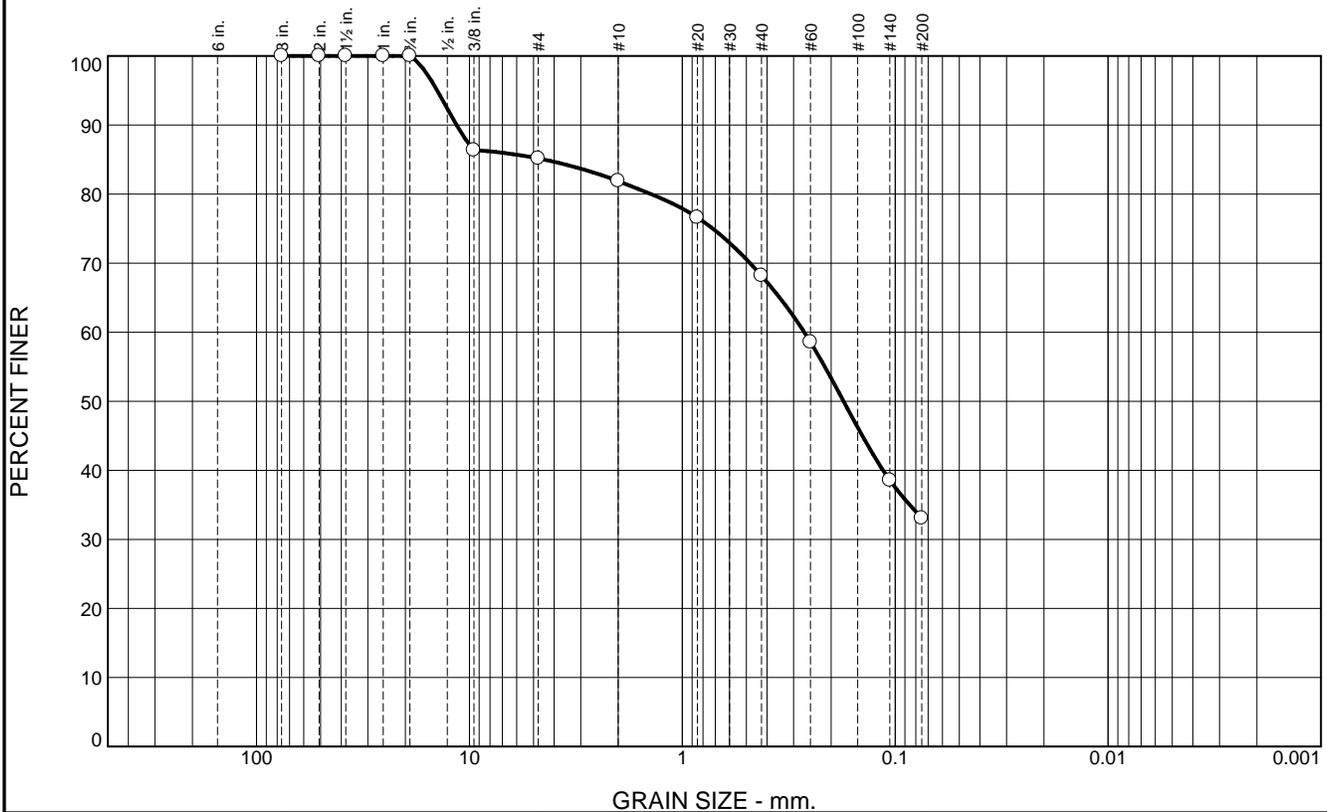
Particle Size Distribution Report

% +3"	% Gravel		% Sand			% Fines	
	Coarse	Fine	Coarse	Medium	Fine	Silt	Clay
0.0	0.0	14.9	3.2	13.7	35.1	33.1

SIEVE SIZE	PERCENT FINER	SPEC.* PERCENT	PASS? (X=NO)
3	100.0		
2	100.0		
1.5	100.0		
1	100.0		
.75	100.0		
.375	86.4		
#4	85.1		
#10	81.9		
#20	76.6		
#40	68.2		
#60	58.6		
#140	38.6		
#200	33.1

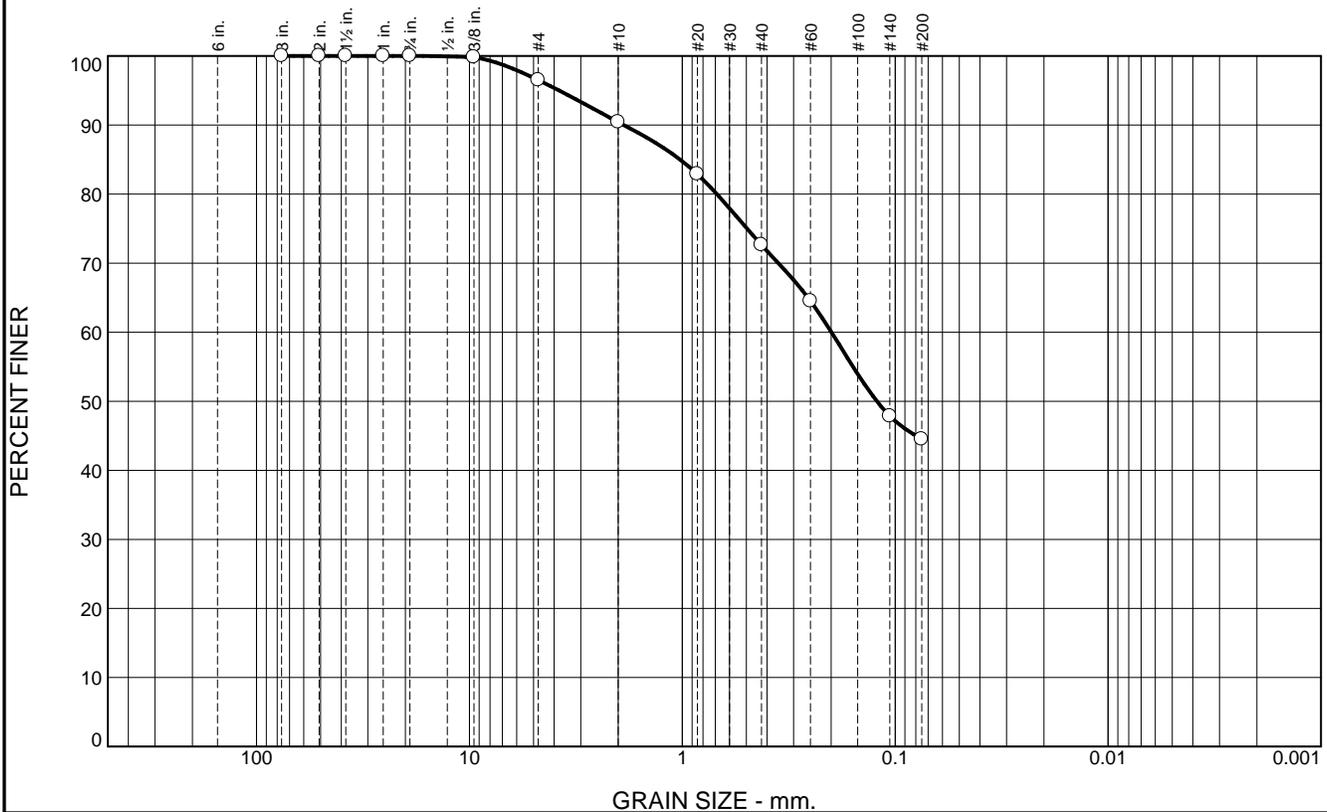
Particle Size Distribution Report

% +3"	% Gravel		% Sand			% Fines	
	Coarse	Fine	Coarse	Medium	Fine	Silt	Clay
0.0	0.0	3.5	6.1	17.8	28.1	44.5

SIEVE SIZE	PERCENT FINER	SPEC.* PERCENT	PASS? (X=NO)
3	100.0		
2	100.0		
1.5	100.0		
1	100.0		
.75	100.0		
.375	99.8		
#4	96.5		
#10	90.4		
#20	82.9		
#40	72.6		
#60	64.5		
#140	47.9		
#200	44.5

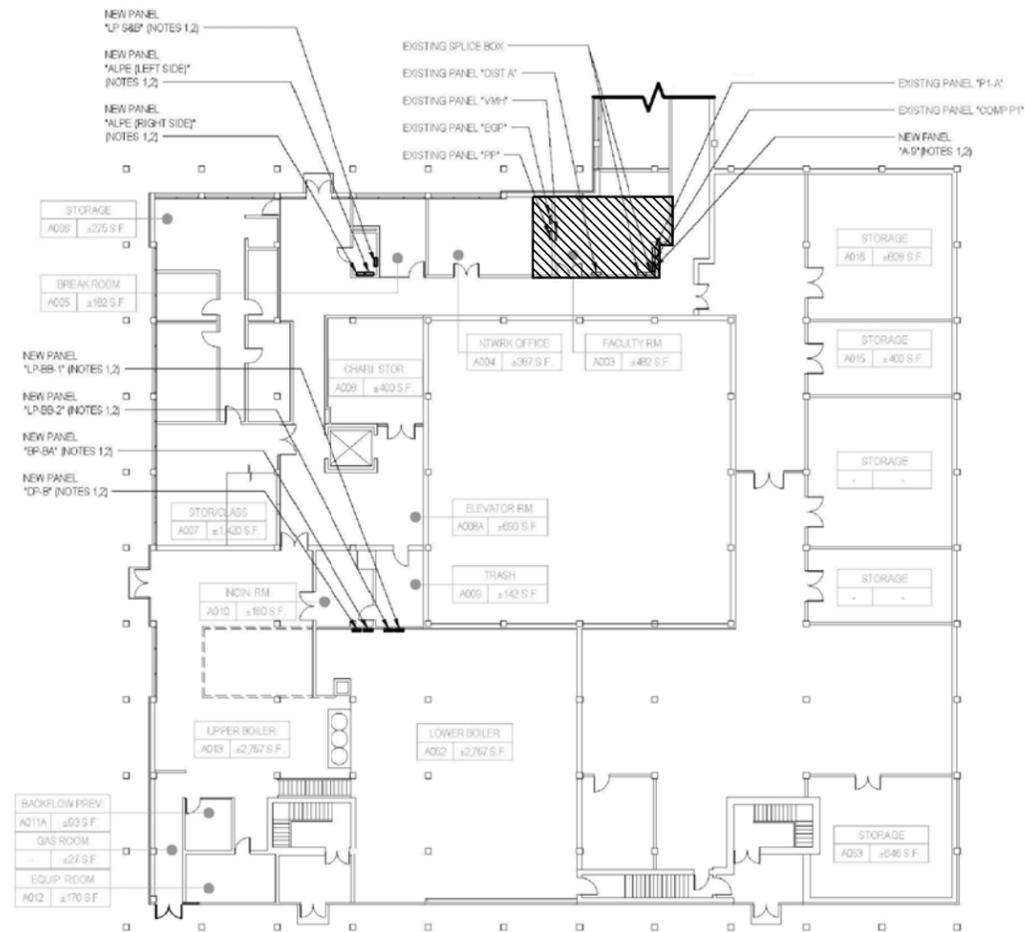
1 BUILDING "A" - GROUND FLOOR PLAN
ACM003 SCALE: NOT TO SCALE

- EXISTING STEP DOWN TRANSFORMER
- EXISTING PANEL "DIST B"
- EXISTING PANEL "LP-3"
- EXISTING PANEL "PP-K"
- EXISTING PANEL "KP-2"
- EXISTING PANEL "KP-1A"
- EXISTING PANEL "KP-1"
- EXISTING PANEL "B-1 SECT 1"
- EXISTING PANEL "B-1 SECT 2"

LOCATION OF ASSUMED ASBESTOS CONTAINING BRAIDED ELECTRICAL WIRING ASSOCIATED WITH EXISTING PANELS & CONDUITS

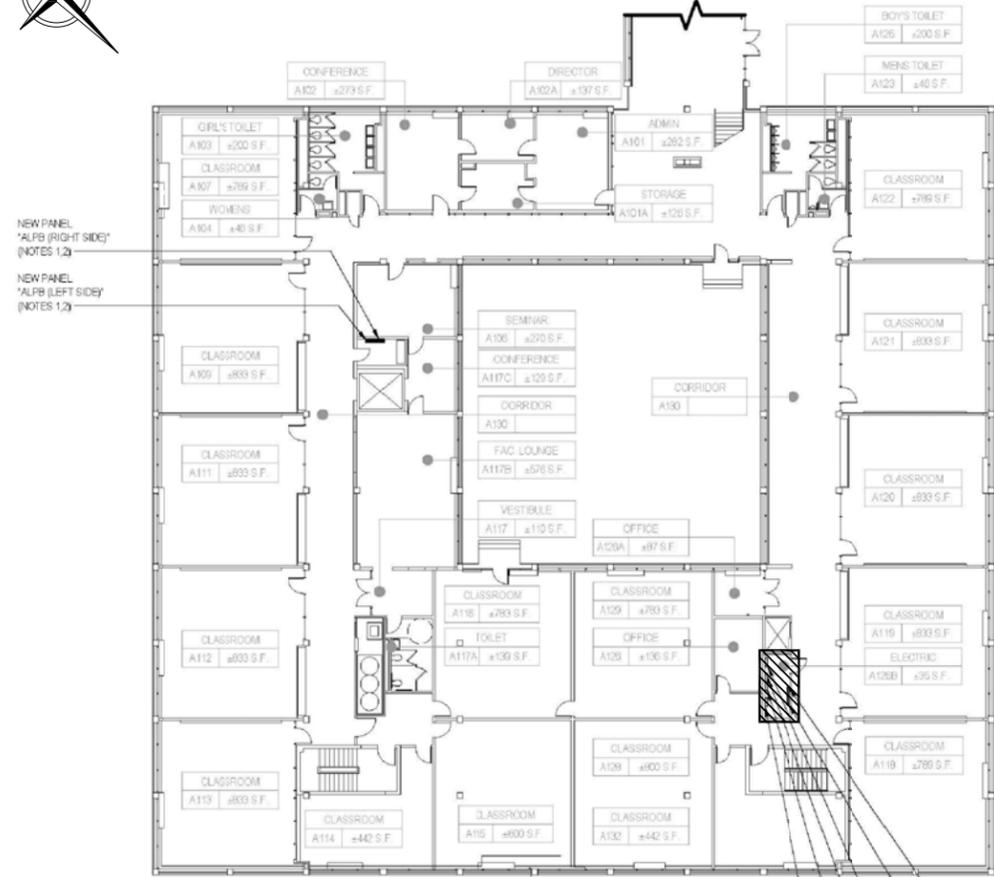
1 BUILDING "A" - FIRST FLOOR PLAN
 ACM008 SCALE: NOT TO SCALE

LEGEND
 LOCATION OF ASSUMED ASBESTOS CONTAINING BRAIDED ELECTRICAL WIRING ASSOCIATED WITH EXISTING PANELS & CONDUITS

- NEW PANEL "ALFA (LEFT SIDE)" (NOTES 1,2)
- NEW PANEL "ALFA (RIGHT SIDE)" (NOTES 1,2)
- EXISTING PANEL "DP-1A"
- EXISTING PANEL "PP-2A"
- EXISTING PANEL "PP-1A"
- EXISTING PANEL "LP-1"

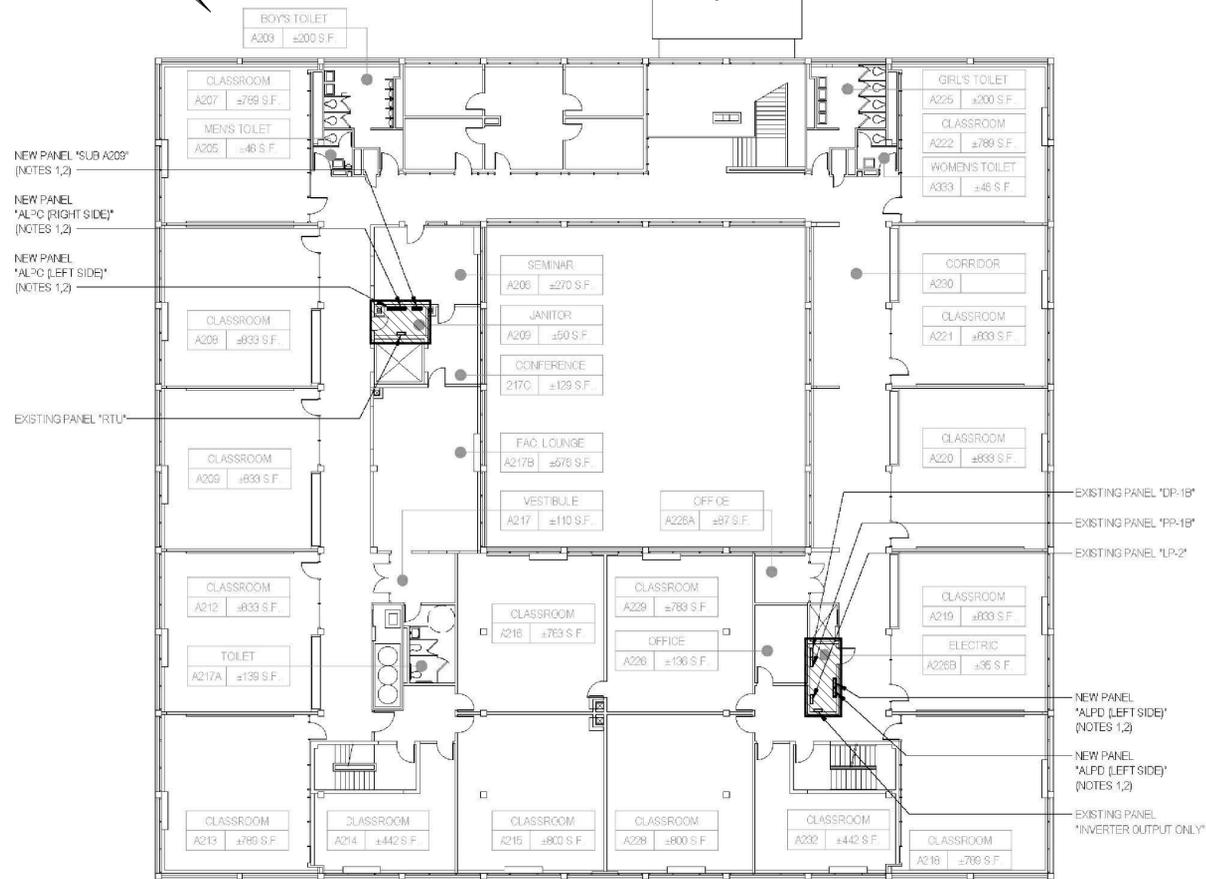
1 BUILDING "A" - SECOND FLOOR PLAN
 ACM012 SCALE: NOT TO SCALE

LEGEND
 LOCATION OF ASSUMED ASBESTOS CONTAINING BRAIDED ELECTRICAL WIRING ASSOCIATED WITH EXISTING PANELS & CONDUITS

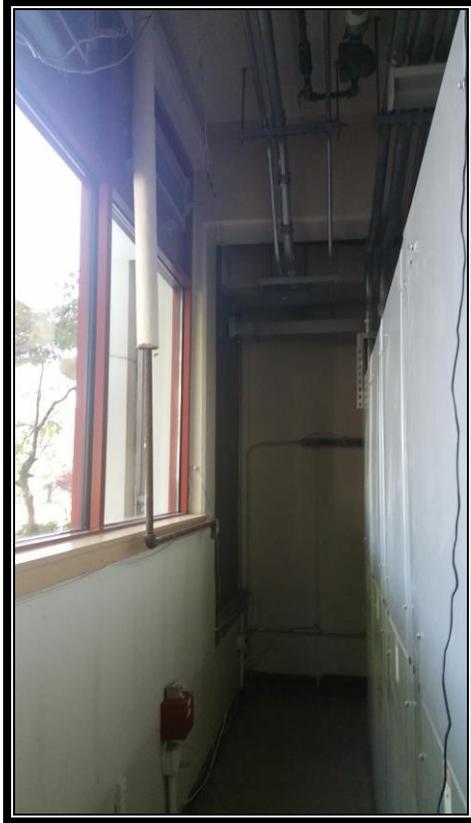
Photograph 3: Inside Electrical Room – Materials found inside the Electrical Room which may be affected by SOW were Non-ACM sheetrock, joint compound, fittings insulation, wrap around fiberglass pipe, cinderblock and 1'x1' pinhole ceiling tiles with mastic.

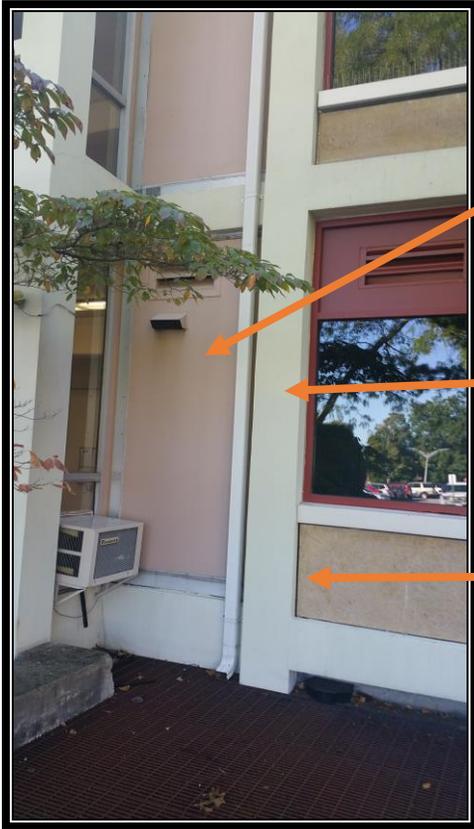
Metal Panel (non-suspect) with assoc.
Exterior Caulking (assumed ACM).

Concrete (non-suspect)

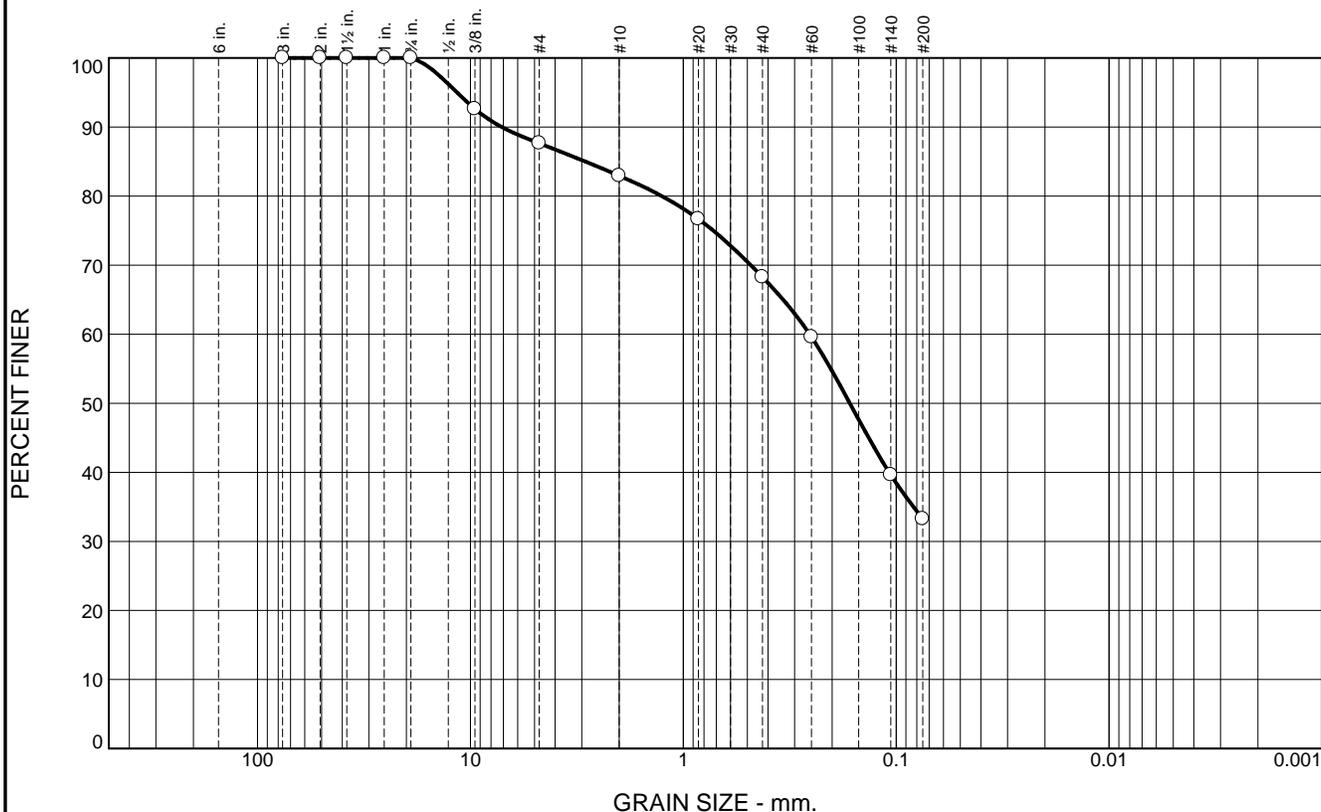
Particle Size Distribution Report

% +3"	% Gravel		% Sand			% Fines	
	Coarse	Fine	Coarse	Medium	Fine	Silt	Clay
0.0	0.0	12.4	4.7	14.6	35.1	33.2

SIEVE SIZE	PERCENT FINER	SPEC.* PERCENT	PASS? (X=NO)
3	100.0		
2	100.0		
1.5	100.0		
1	100.0		
.75	100.0		
.375	92.6		
#4	87.6		
#10	82.9		
#20	76.7		
#40	68.3		
#60	59.6		
#140	39.6		
#200	33.2

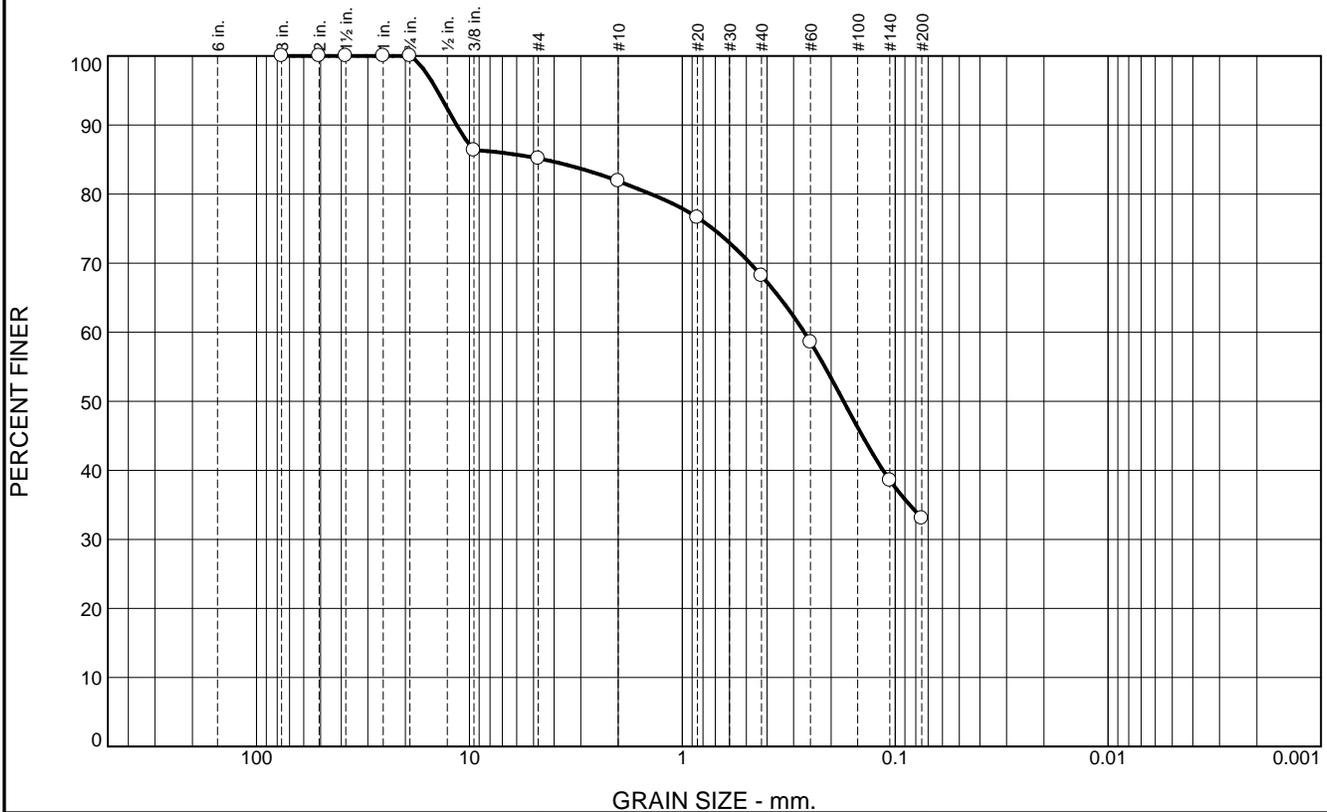
Particle Size Distribution Report

% +3"	% Gravel		% Sand			% Fines	
	Coarse	Fine	Coarse	Medium	Fine	Silt	Clay
0.0	0.0	14.9	3.2	13.7	35.1	33.1

SIEVE SIZE	PERCENT FINER	SPEC.* PERCENT	PASS? (X=NO)
3	100.0		
2	100.0		
1.5	100.0		
1	100.0		
.75	100.0		
.375	86.4		
#4	85.1		
#10	81.9		
#20	76.6		
#40	68.2		
#60	58.6		
#140	38.6		
#200	33.1

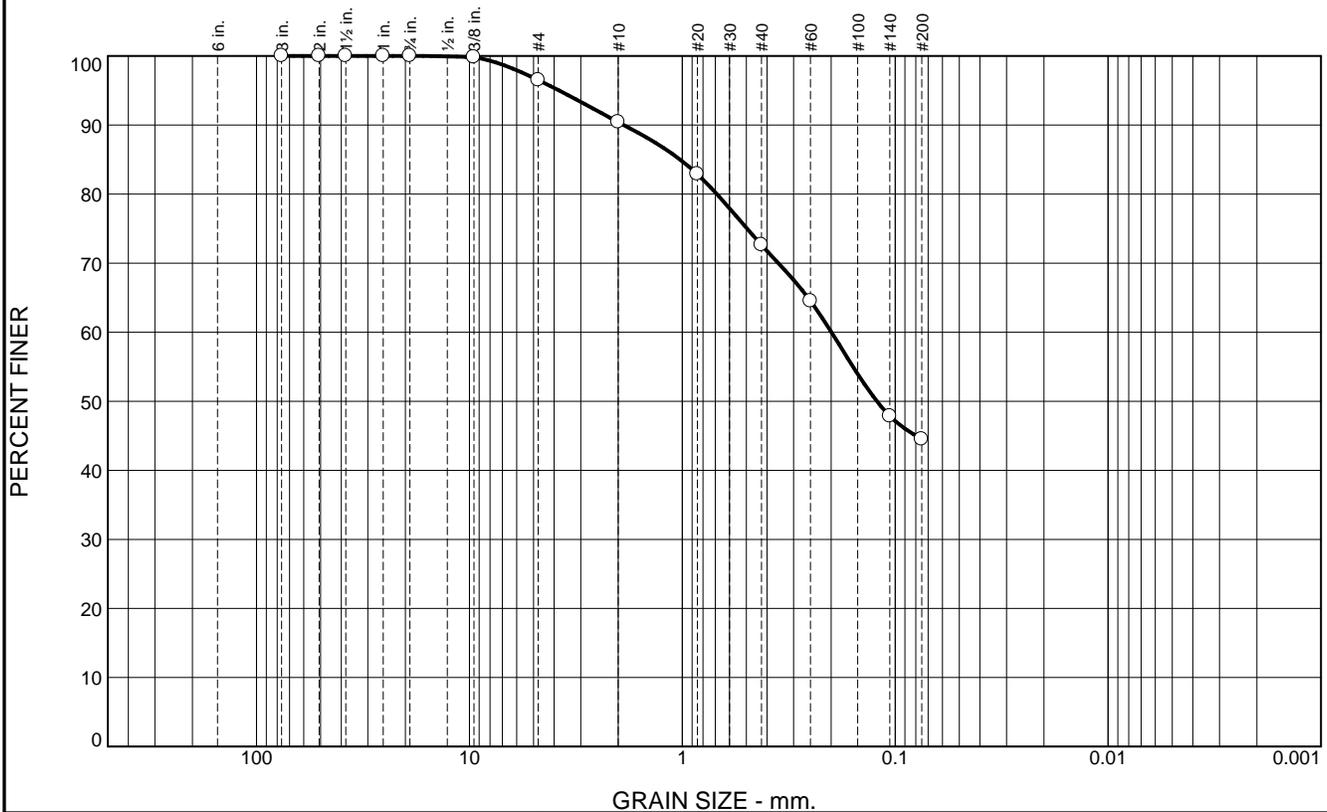
Particle Size Distribution Report

% +3"	% Gravel		% Sand			% Fines	
	Coarse	Fine	Coarse	Medium	Fine	Silt	Clay
0.0	0.0	3.5	6.1	17.8	28.1	44.5
