Limited Phase II

Environmental Site Assessment

250 Lafayette Avenue

NP&V Job # 15288

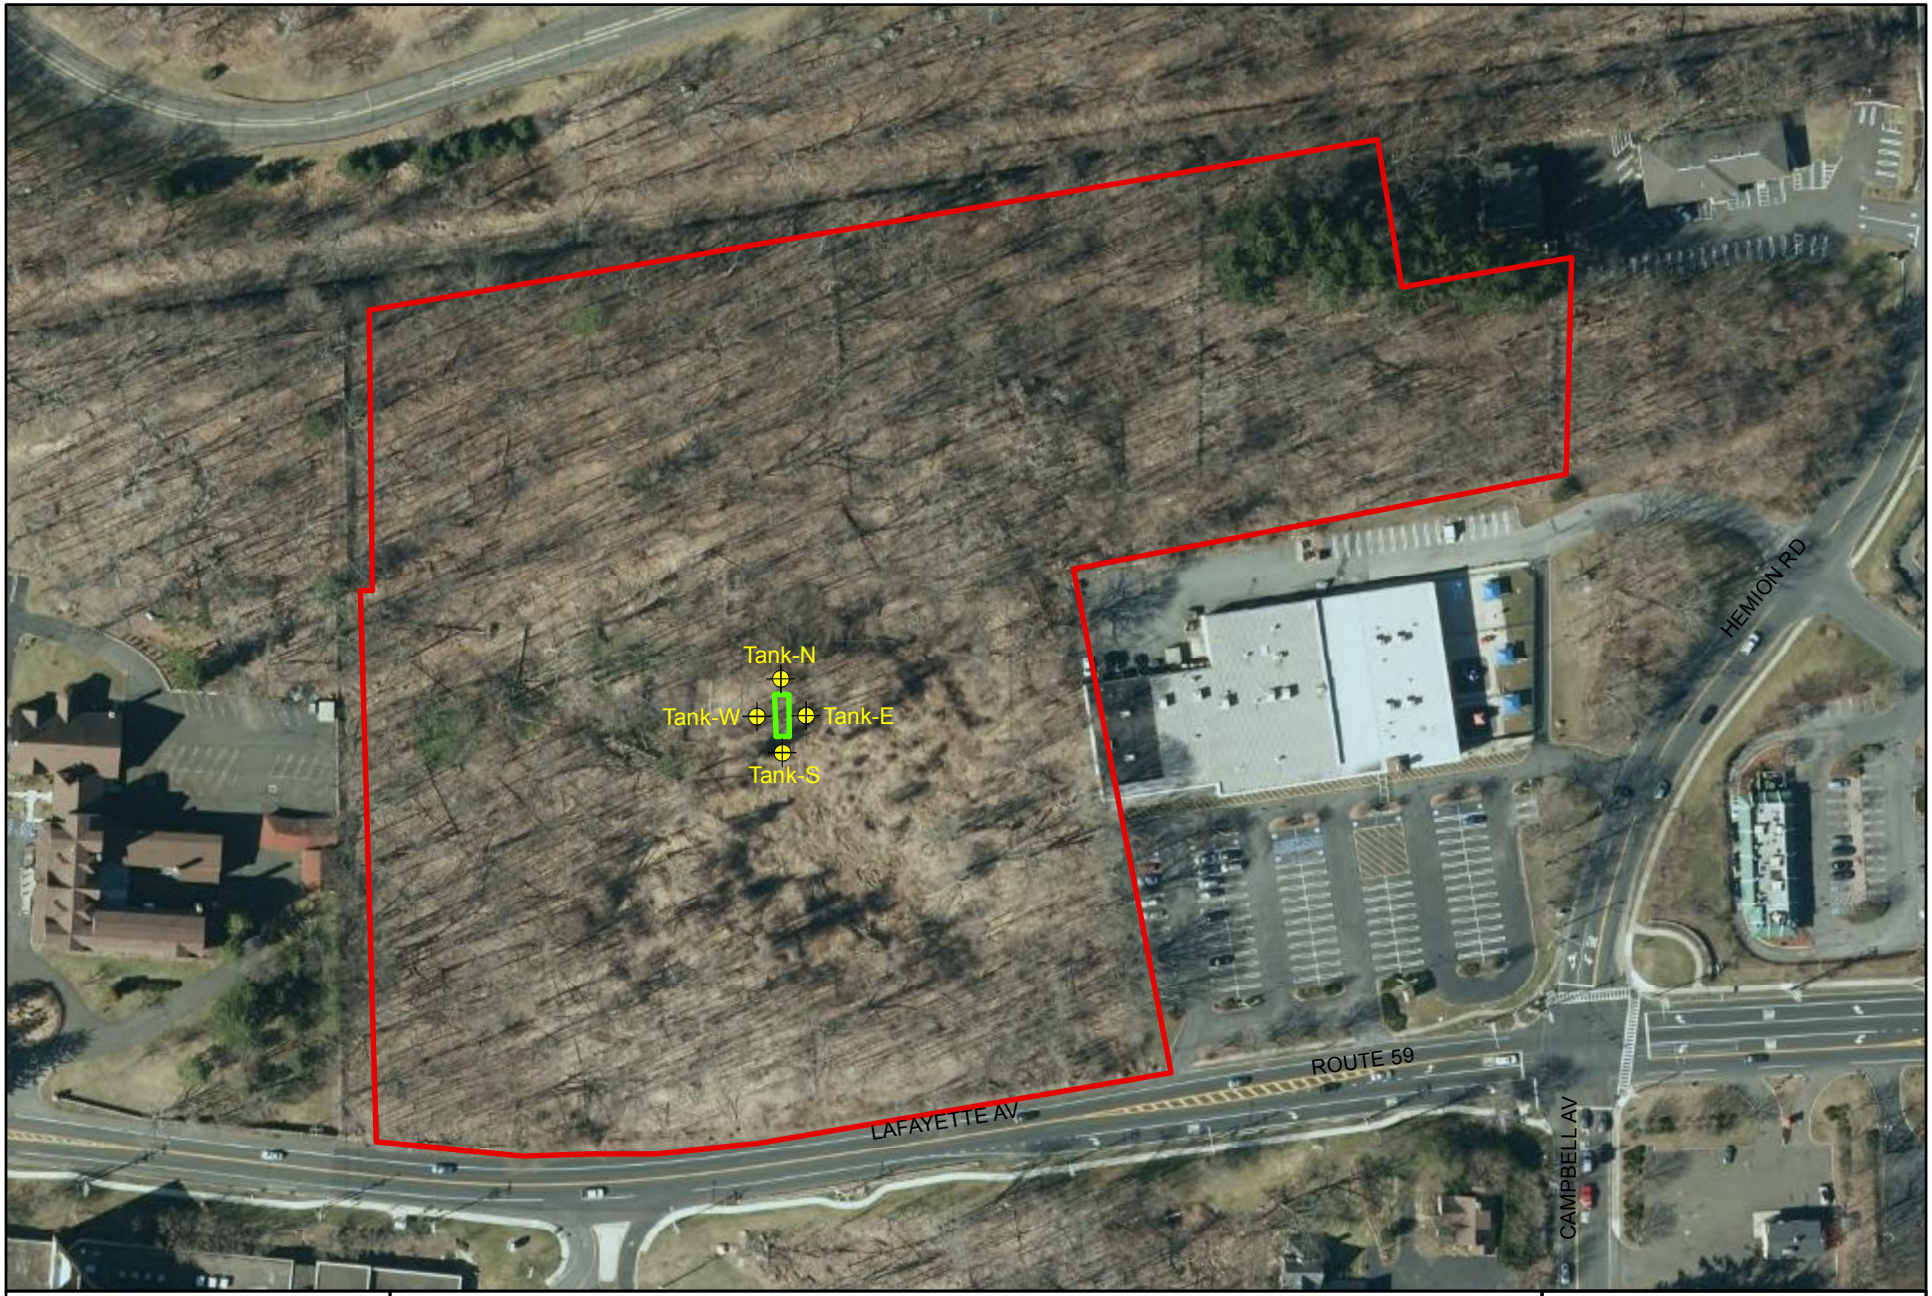
FIGURE 1
SAMPLE LOCATION MAP

Four (4) soil probes were installed around the detected anomaly which was suspected of being an underground storage tank. **Figure 1** provides a map identifying the location of the above referenced soil probes and underground storage tank. The soil probes were installed using a Power Probe sampling apparatus Model 9100, in order to collect soil samples which provide a representation of the subsurface soil at depths that ranged from zero to four (0-4) feet, four to eight (4-8) feet, eight to twelve (8-12) feet and twelve to sixteen (12-16) feet below existing grade. A headspace analysis sample was taken for each of the twelve (12) soil samples collected (4 per probe location) and the sample with the highest headspace reading from each probe location was sent to a certified laboratory for analysis.

The soil sample collected from the site was containerized and labeled for identification purposes. The labels were coded to correspond to the location from which the samples were secured. **Table 1** provides an index of how the samples were coded during labeling. **Figure 1** provides a map of the sample identifications and locations.

SAMPLE LOCATION	SAMPLE ID CODE
Sample collected from soils adjacent to the east side of the tank	Tank-E
