ASBESTOS & LEAD PAINT SURVEY REPORT

**HARLEM LINE
HARTSDALE STATION
HARTSDALE, NY 10530**

**PROJECT: CAPITAL – HARLEM LINE – HARTSDALE STATION:
PEDESTRIAN OVERPASS, PLATFORMS & STAIRCASES REPAIRS**

EPM's Project No. 18041-2

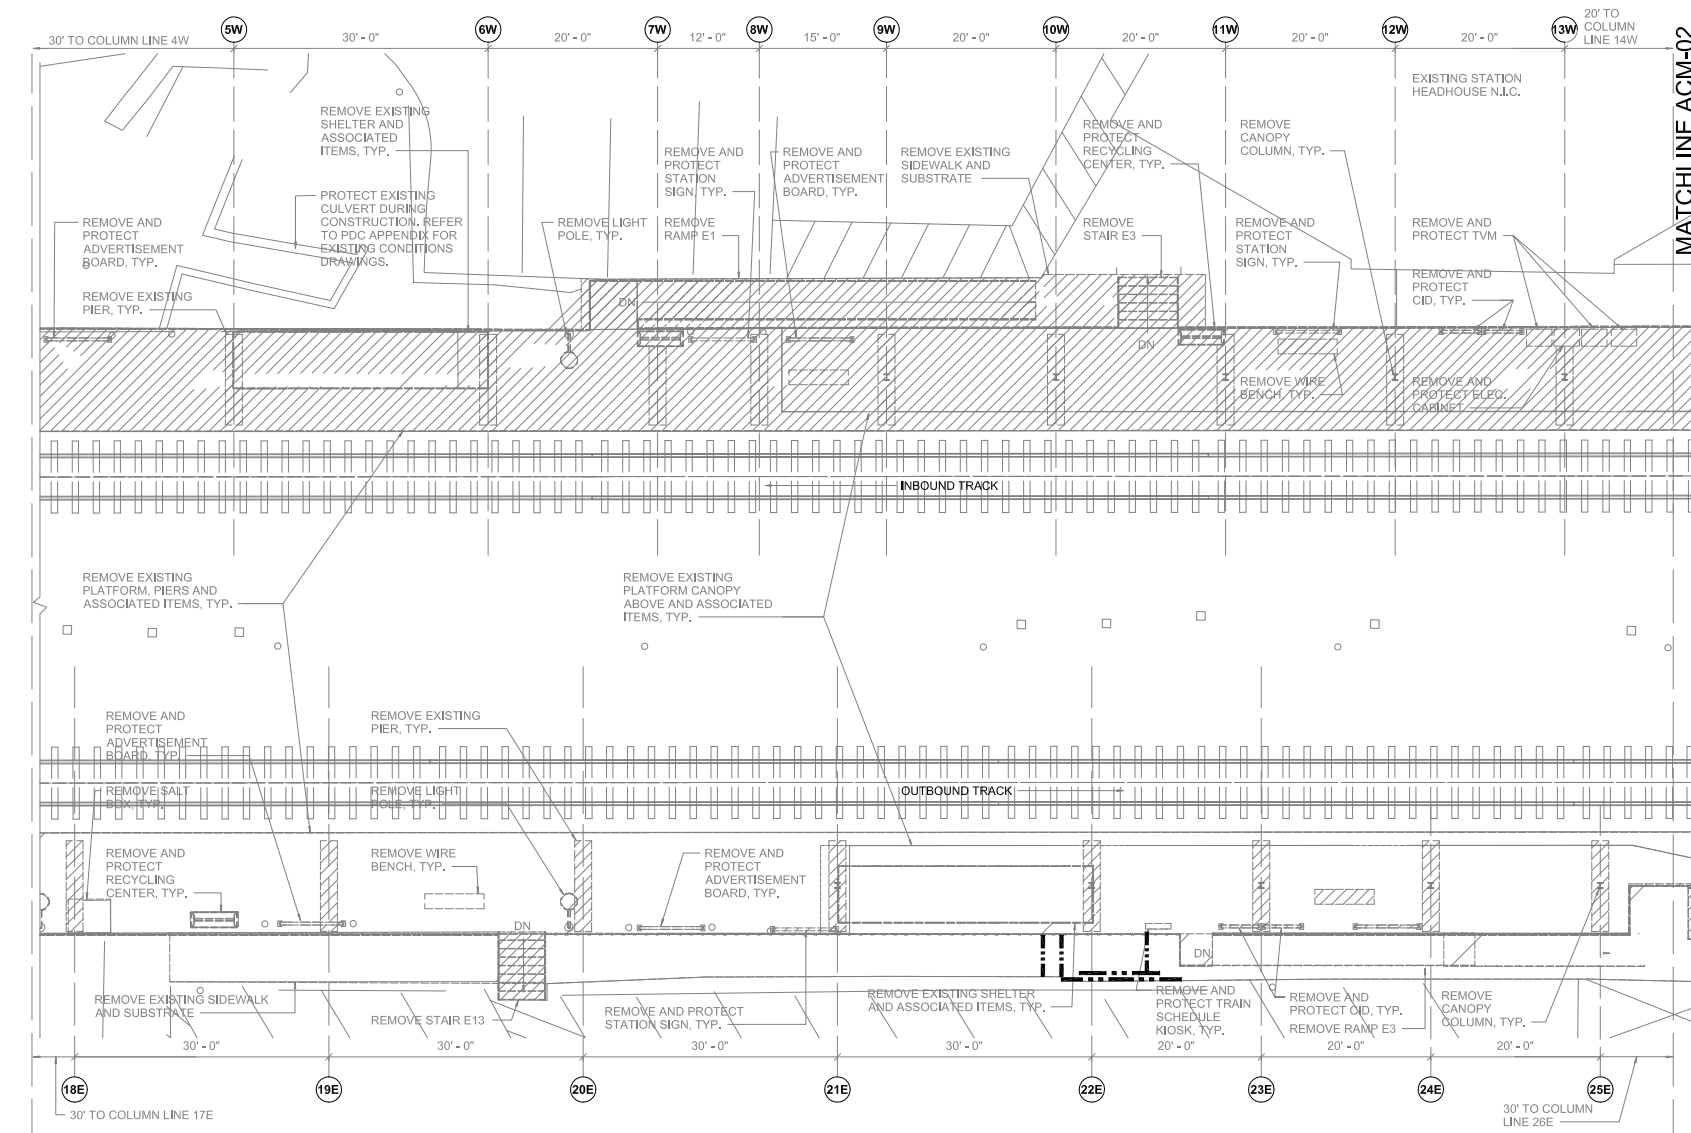
1 STATION PLAN 1 OF 2
NOT TO SCALE

Asbestos Bulk Sample Location Schematic

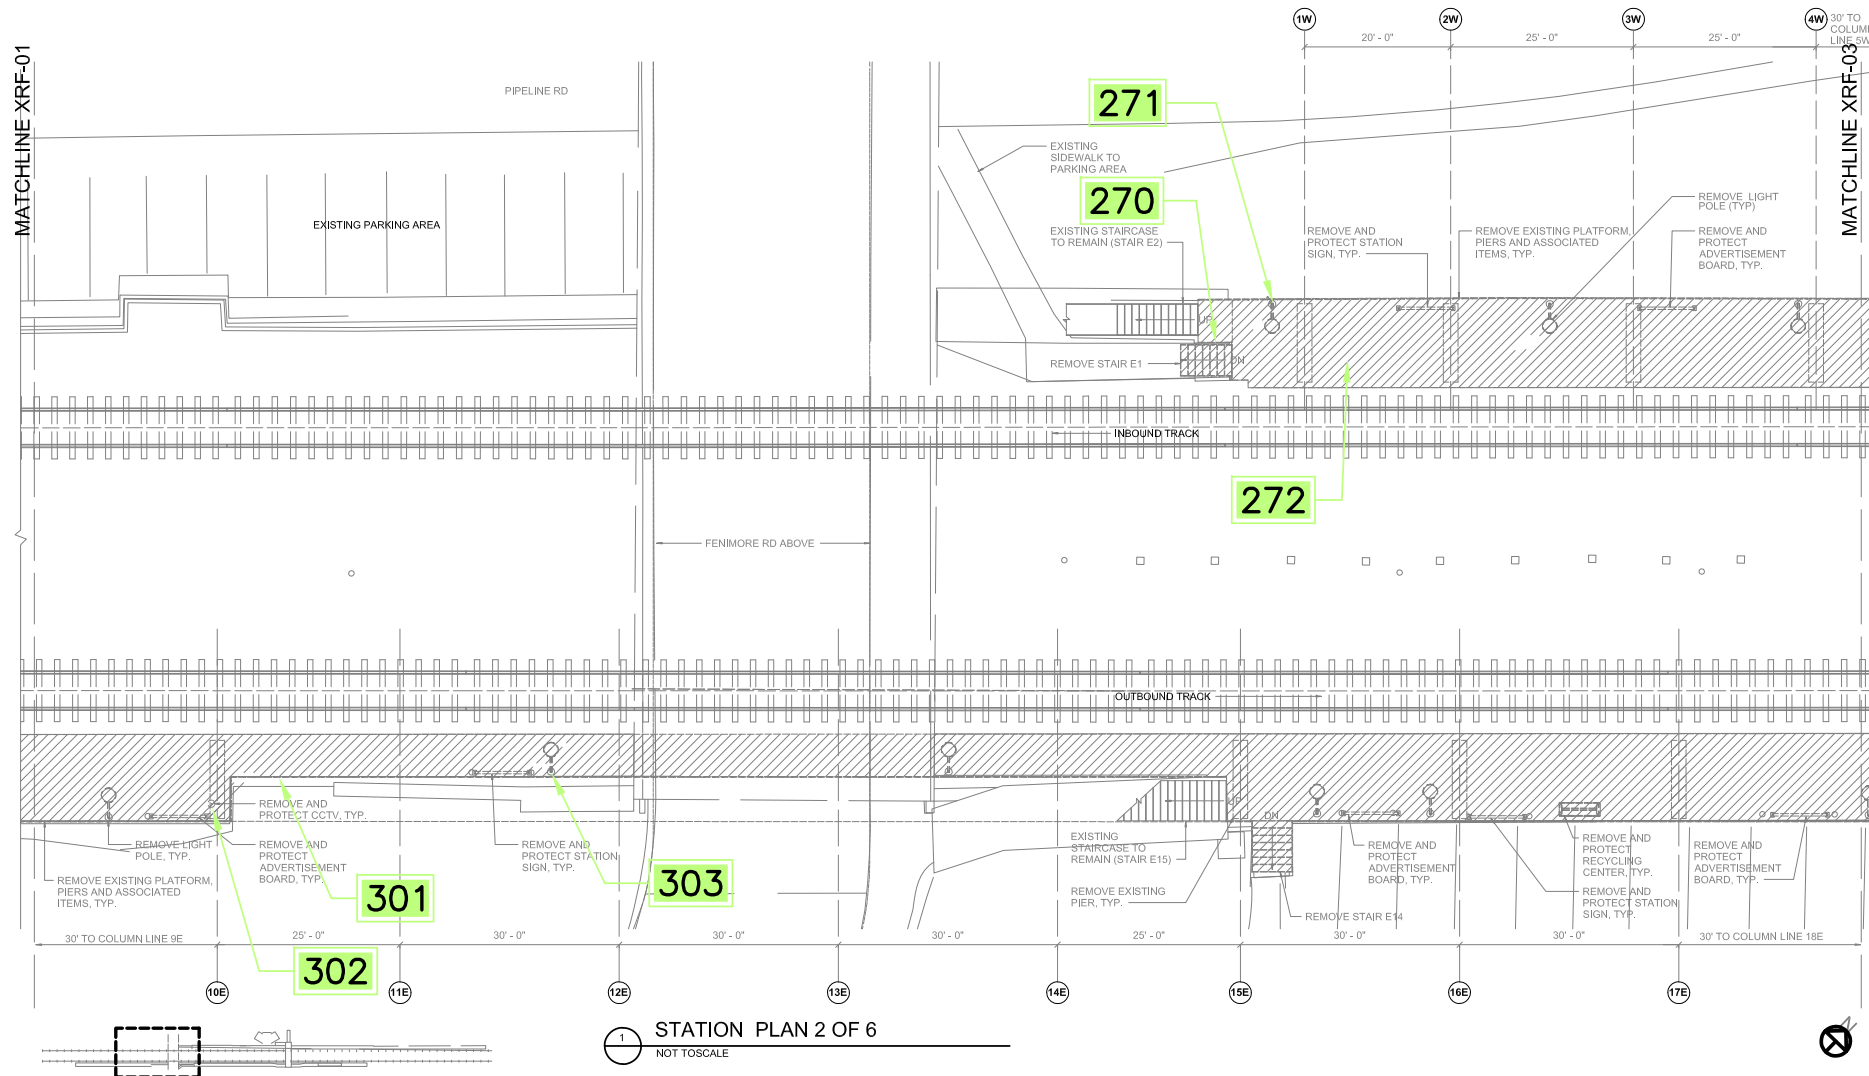
XRF-01

- XRF READING NO. LEAD RESULT
= 0.00 (NON-DETECTABLE LEAD)
- XRF READING NO. LEAD RESULT
≥ 0.01 mg/cm² (LEAD CONTAINING)

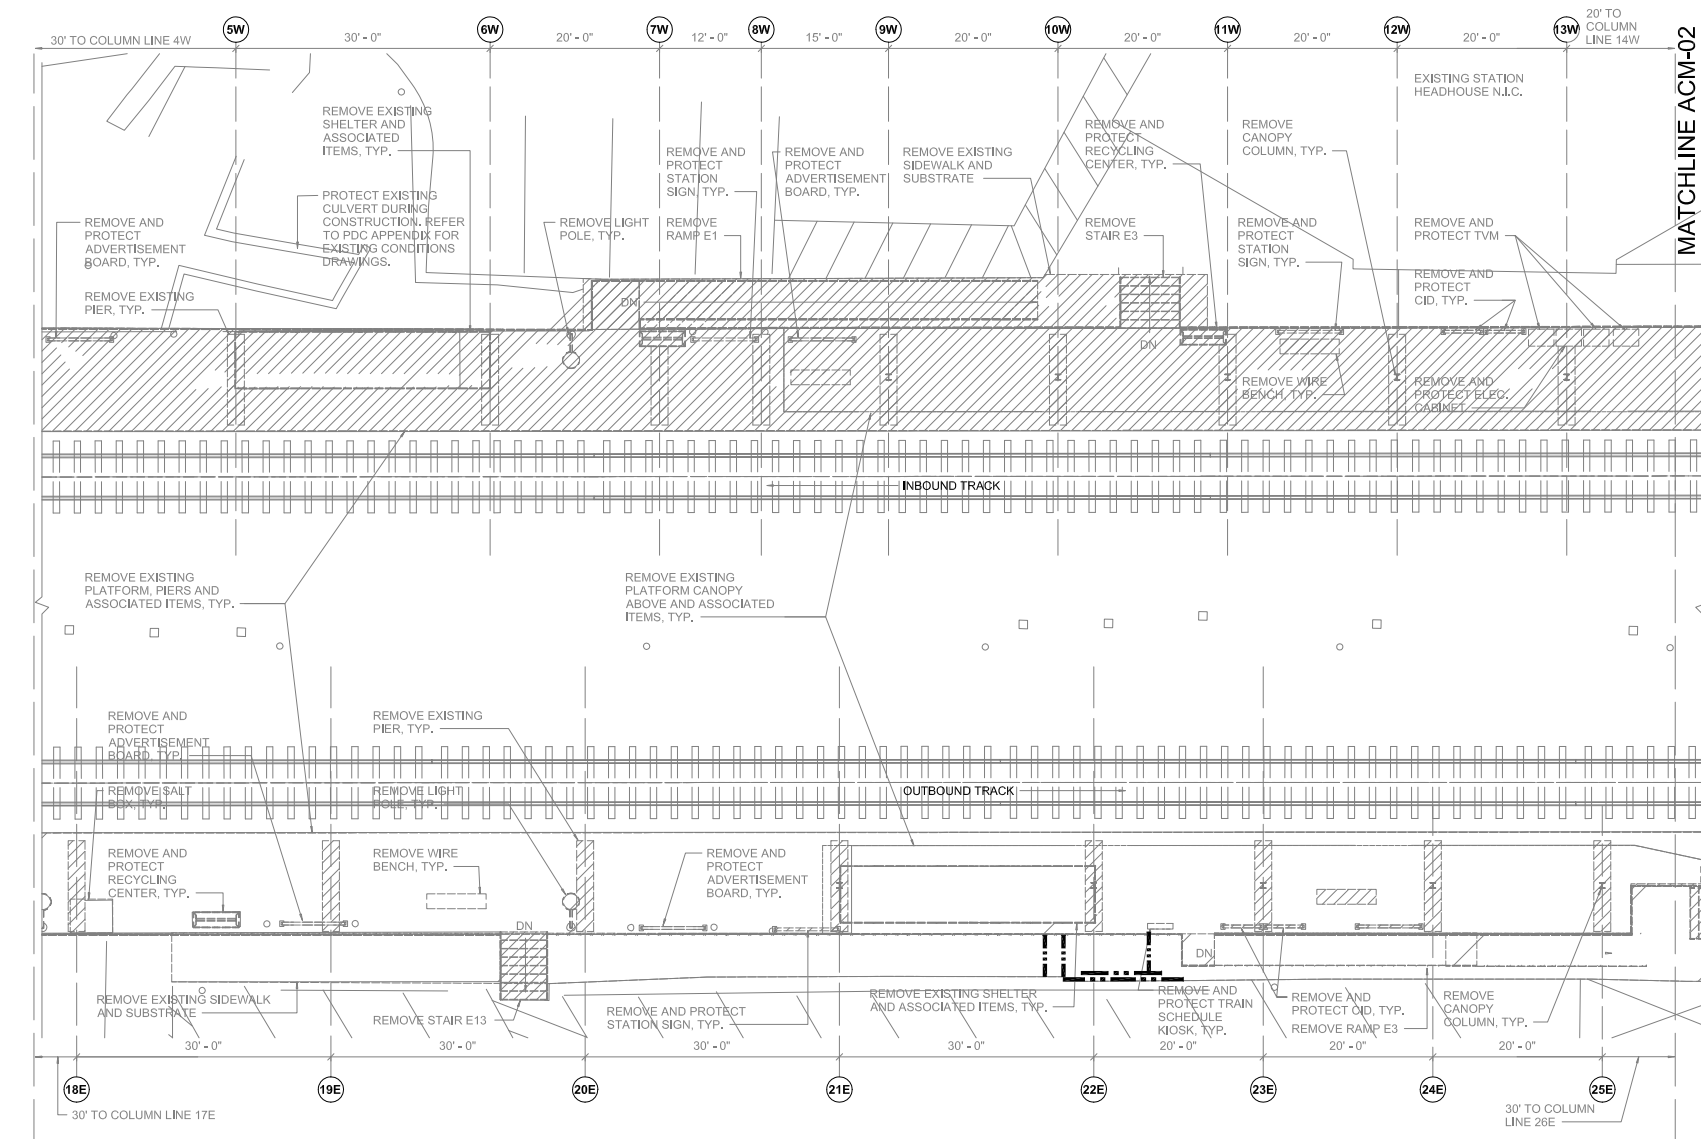
1 STATION PLAN 1 OF 2
NOT TO SCALE

APPENDIX G
Asbestos Containing Materials Location Schematics

All asbestos containing materials and lead-painted surfaces with the potential to be impacted by the scope of work should be abated in accordance with all applicable federal, state and local regulations, including Metro-North Railroad Specifications for The Treatment of Lead-Based Painted Surfaces, 29 CFR 1926.62 Occupational Safety and Health Administration Lead in Construction, USEPA regulations, OSHA regulations, and NIOSH recommendations.
