Tremco Roof Condition Assessment

North Rockland High School

June 27th, 2021

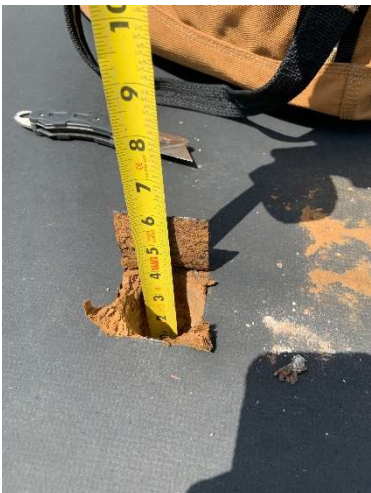
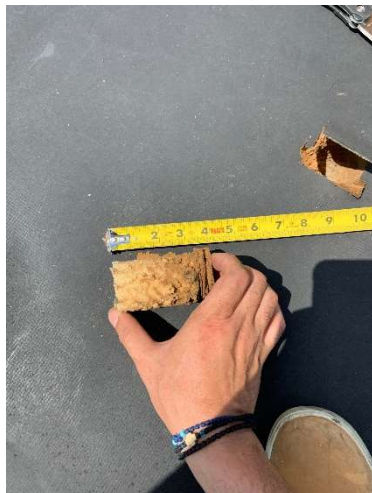
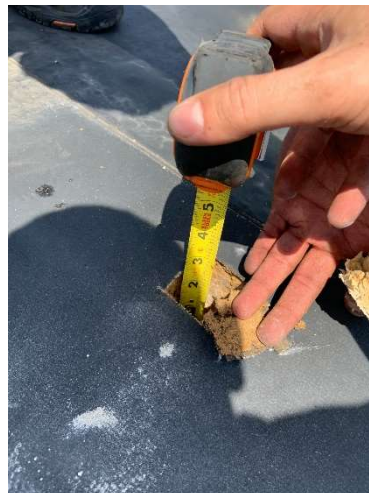
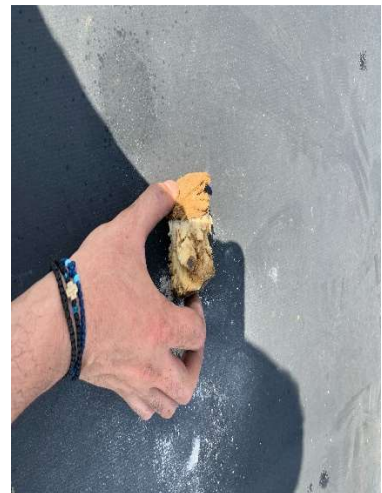
- EPDM
- 3" Iso
- ½" coverboard
- Sloped Lightweight Concrete deck

- EPDM
- 2 ½" Iso
- ½" coverboard
- Sloped Lightweight Concrete deck

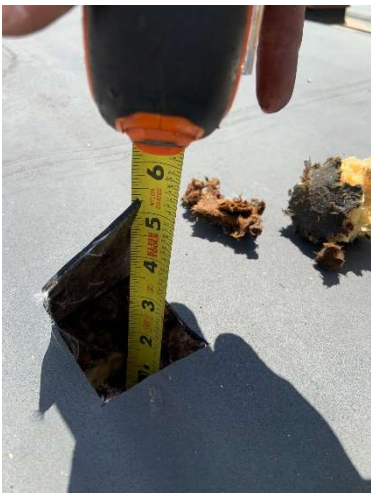
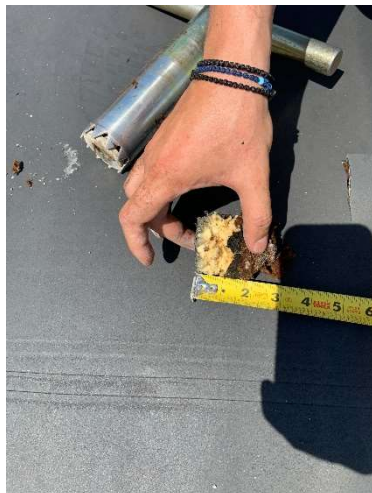
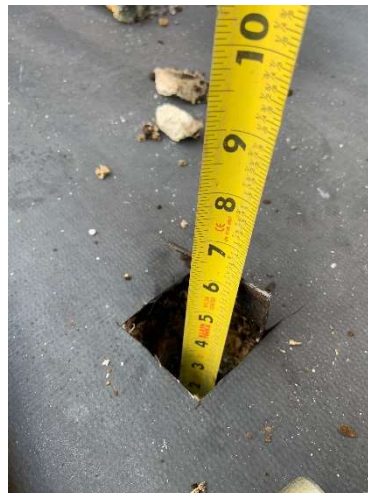
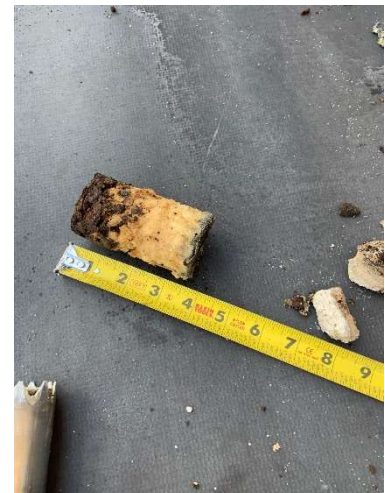
- EPDM
- 2" Iso
- ½" coverboard
- Sloped Lightweight Concrete deck

- EPDM
- 3" Iso
- ½" coverboard
- Sloped Lightweight Concrete deck

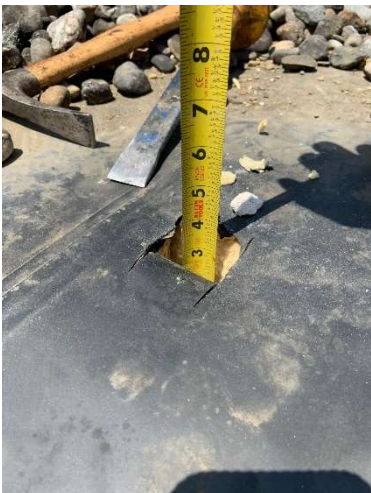
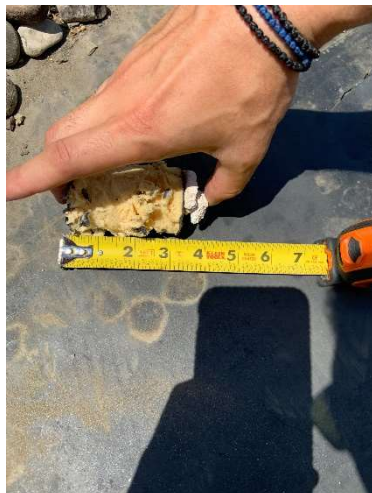
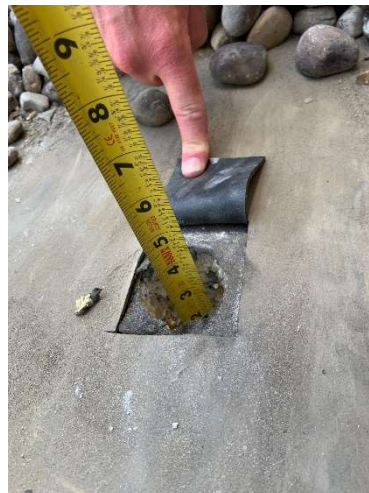
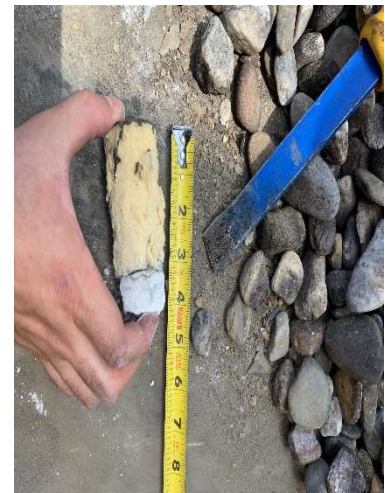
- Ballasted EPDM
- 3" Iso
- 1/2" coverboard
- Sloped Lightweight Concrete deck

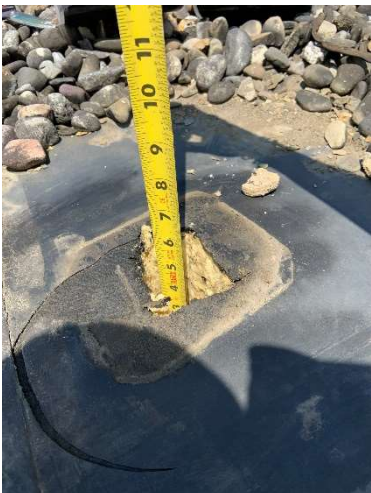
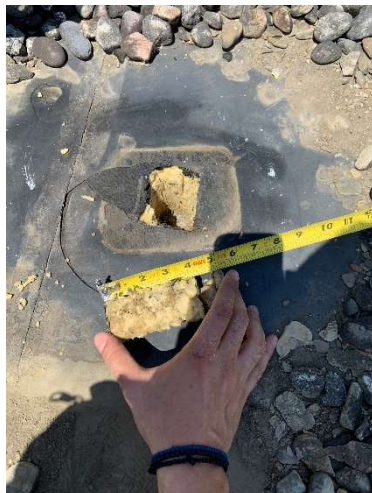
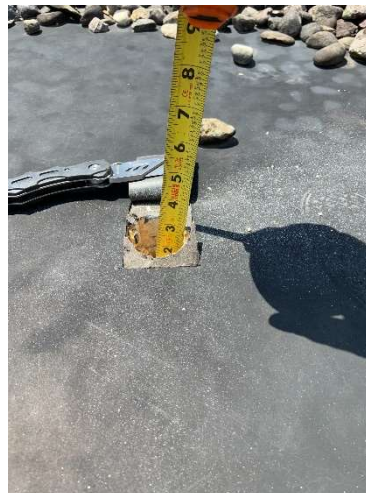
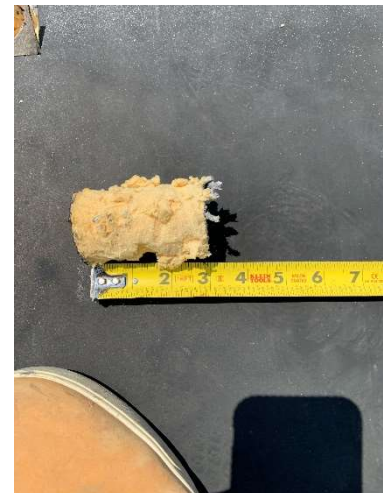
- Ballasted EPDM
- 5" Iso
- ½" coverboard
- Sloped Lightweight Concrete deck

- Ballasted EPDM
- 3" Iso
- ½" coverboard
- Sloped Lightweight Concrete deck

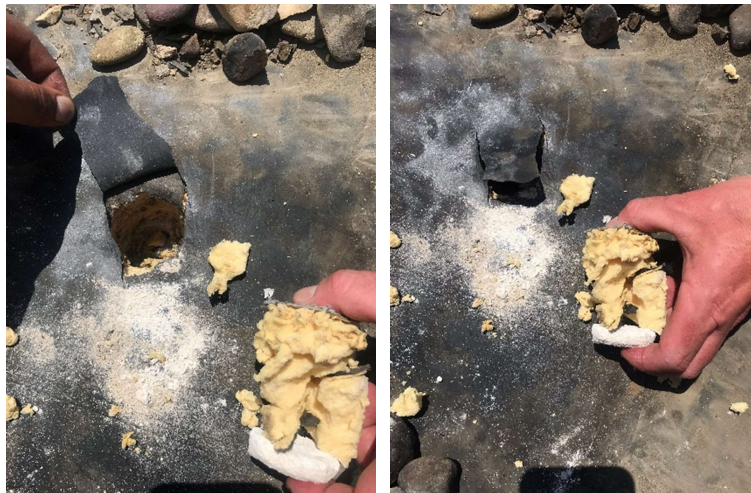
- Ballasted EPDM
- 3" Iso
- ½" coverboard
- Sloped Lightweight Concrete deck

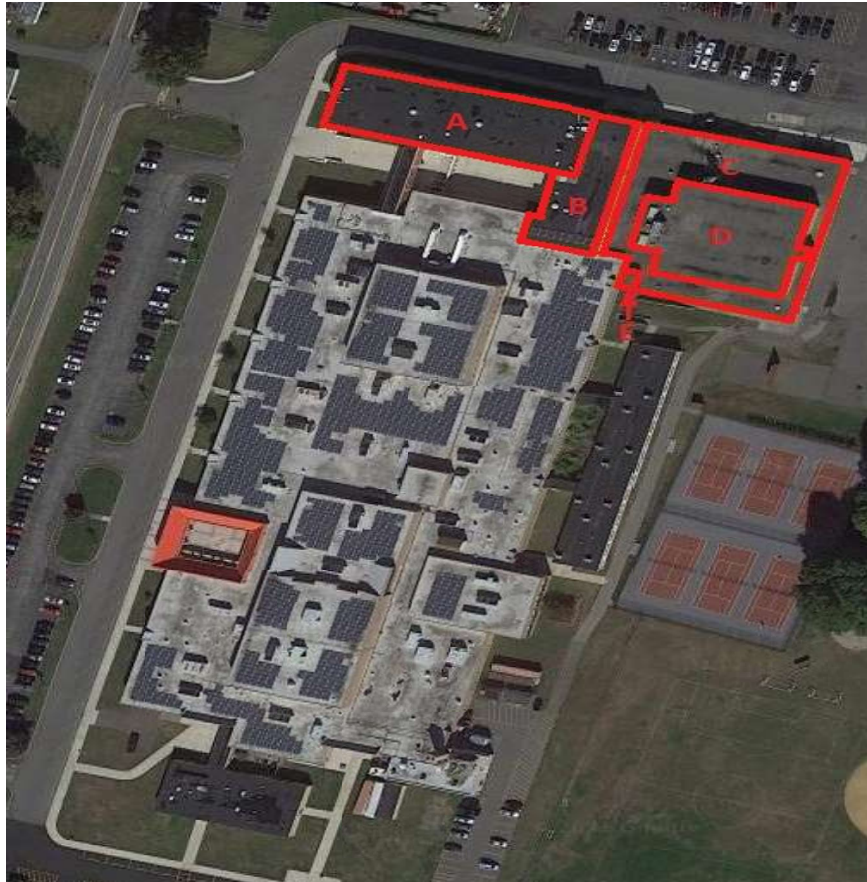
Building Overview

Yellow = Potentially Restorable

Red= Replaceable
