**LIMITED HAZARDOUS MATERIALS SURVEY
CAMP BUCKNER REVITALIZATION
USMA MILITARY RESERVATION
HIGHLAND MILLS, NY
Contract #: W912-DS-18-AE-0007
Task Order #: W912-DS-19-F00XX**

December 26, 2019

Architect-Engineering Services in Support of the Camp Buckner Revitalization
United States Military Academy West Point Military Reservation, Highland Mills, NY
Hazardous Materials Survey
Task Order W912DS19F00XX
Contract Solicitation W912DS-18-AE-0007

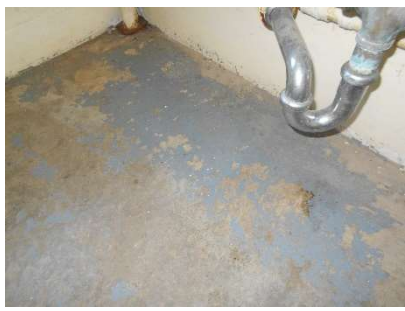
Condition	Deteriorated		
	Location	Building 1612
