Valley Central School District 2023 Capital Project - Phase 1

Limited Hazardous Material Pre-Renovation Survey Report

2023 Capital Projects – Phase 1

**RE: Limited Hazardous Material Pre-Renovation Survey Report
Berea Elementary School - 2023 Capital Projects, Phase 1
944 New York State Route 17K, Montgomery, New York 12549
AECC Project Number: 23-075**

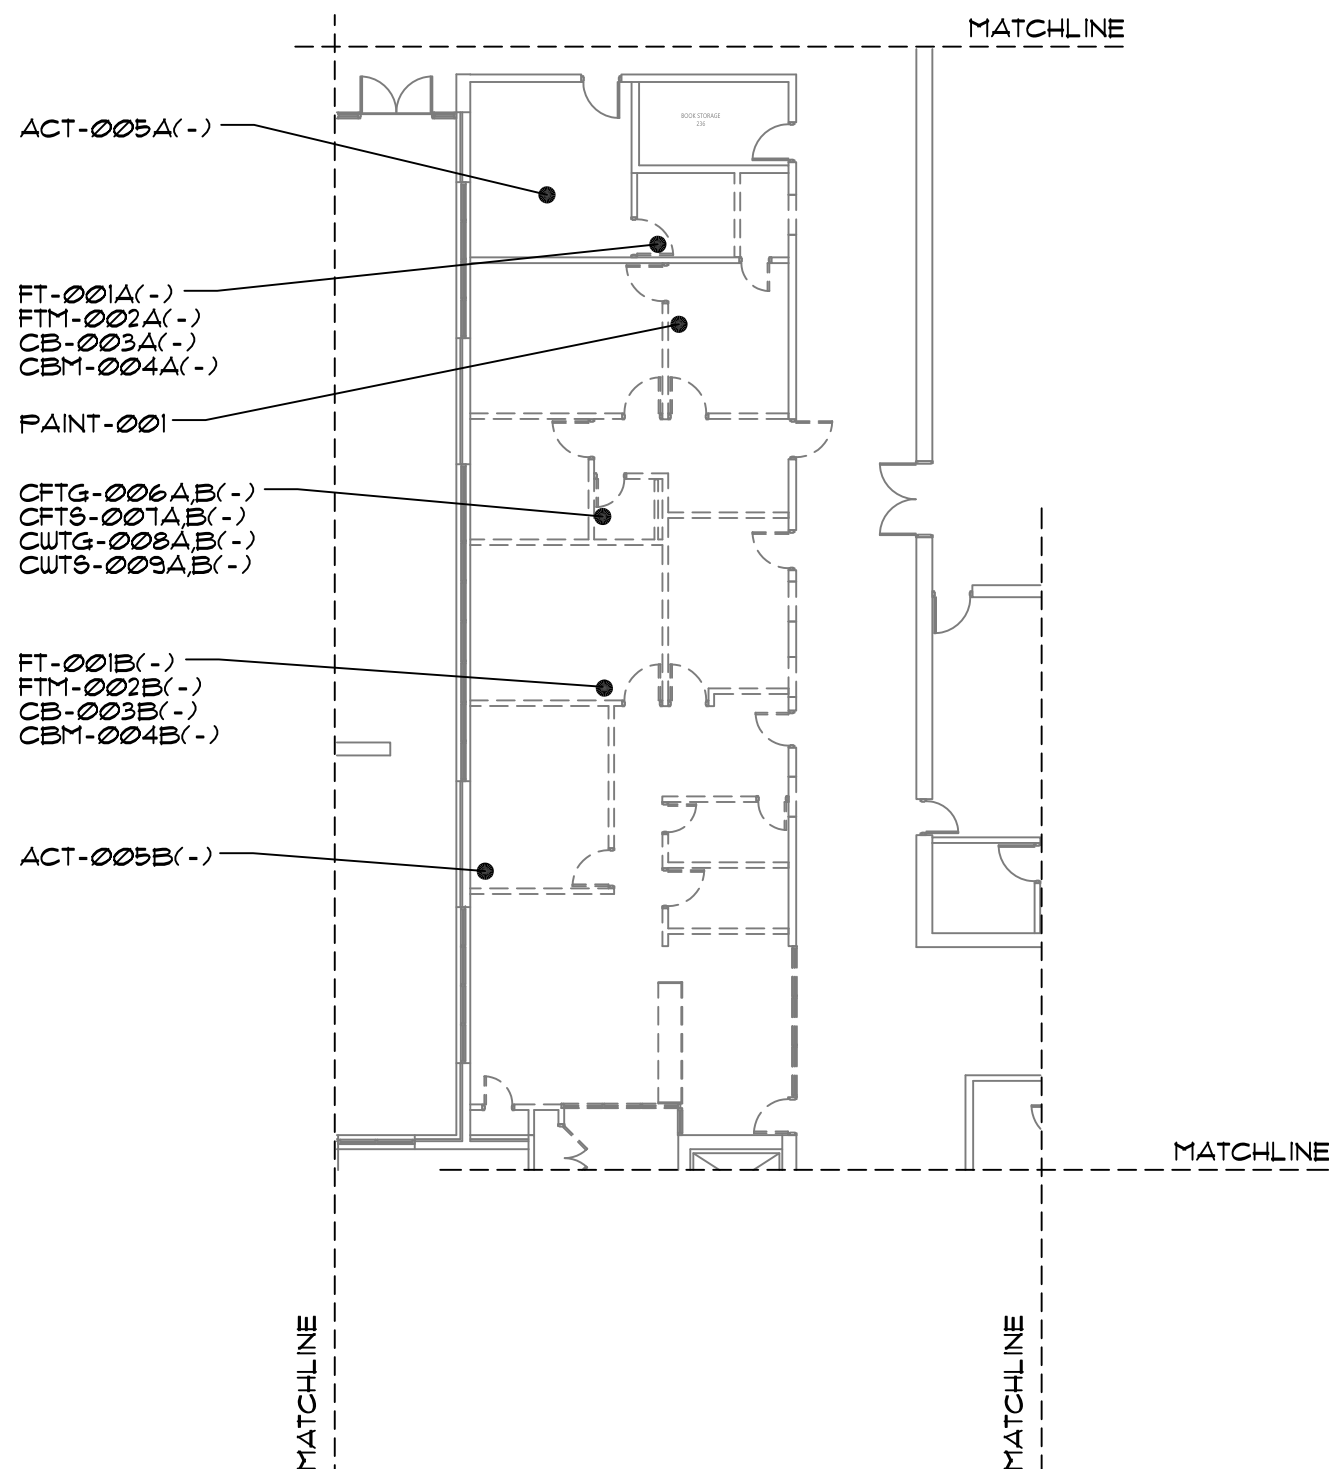
ACM / PACM DESCRIPTION	ACM / PACM LOCATION(S)	ESTIMATED QUANTITY	MATERIAL CONDITION
Black Sink Basin Mastic (SM-014)	1st Floor - Copy Room & Office Kitchen	8 SF	NF, Intact
Chalkboard / Corkboard Mastic (PACM)	1st Floor - Kindergarten Classrooms	446 SF	NF, Intact

CB PRESUMED ASBESTOS-CONTAINING CHALKBOARD / CORKBOARD MASTIC
