March 2, 2023

**Re: ND-2023-1QACM-Limited Asbestos Inspection Report
Chase Bank Branch – Vernon Hills Scarsdale
676 White Plains Road
Scarsdale, New York 10583
OVP # 48100R006846**

Apex Project No.: JPM001-0418070-23002979-047

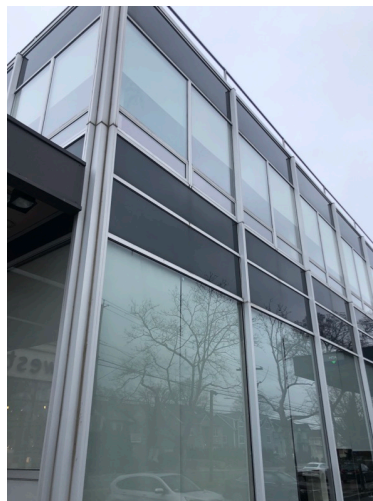
Photograph: 1
Description:

Exterior view of the Chase Bank branch located at 676 White Plains Road, Scarsdale, New York.
