Project Title:
Philipse Manor Hall State Historic Site:
Construction of Elevator/Restroom
Addition, Interior and Exterior
Rehabilitation and Site Enhancements

Project Location:
29 Warburton Ave, Yonkers, NY 10701

Sheet Title:
Existing Conditions Plan

Drawing Number:
L100

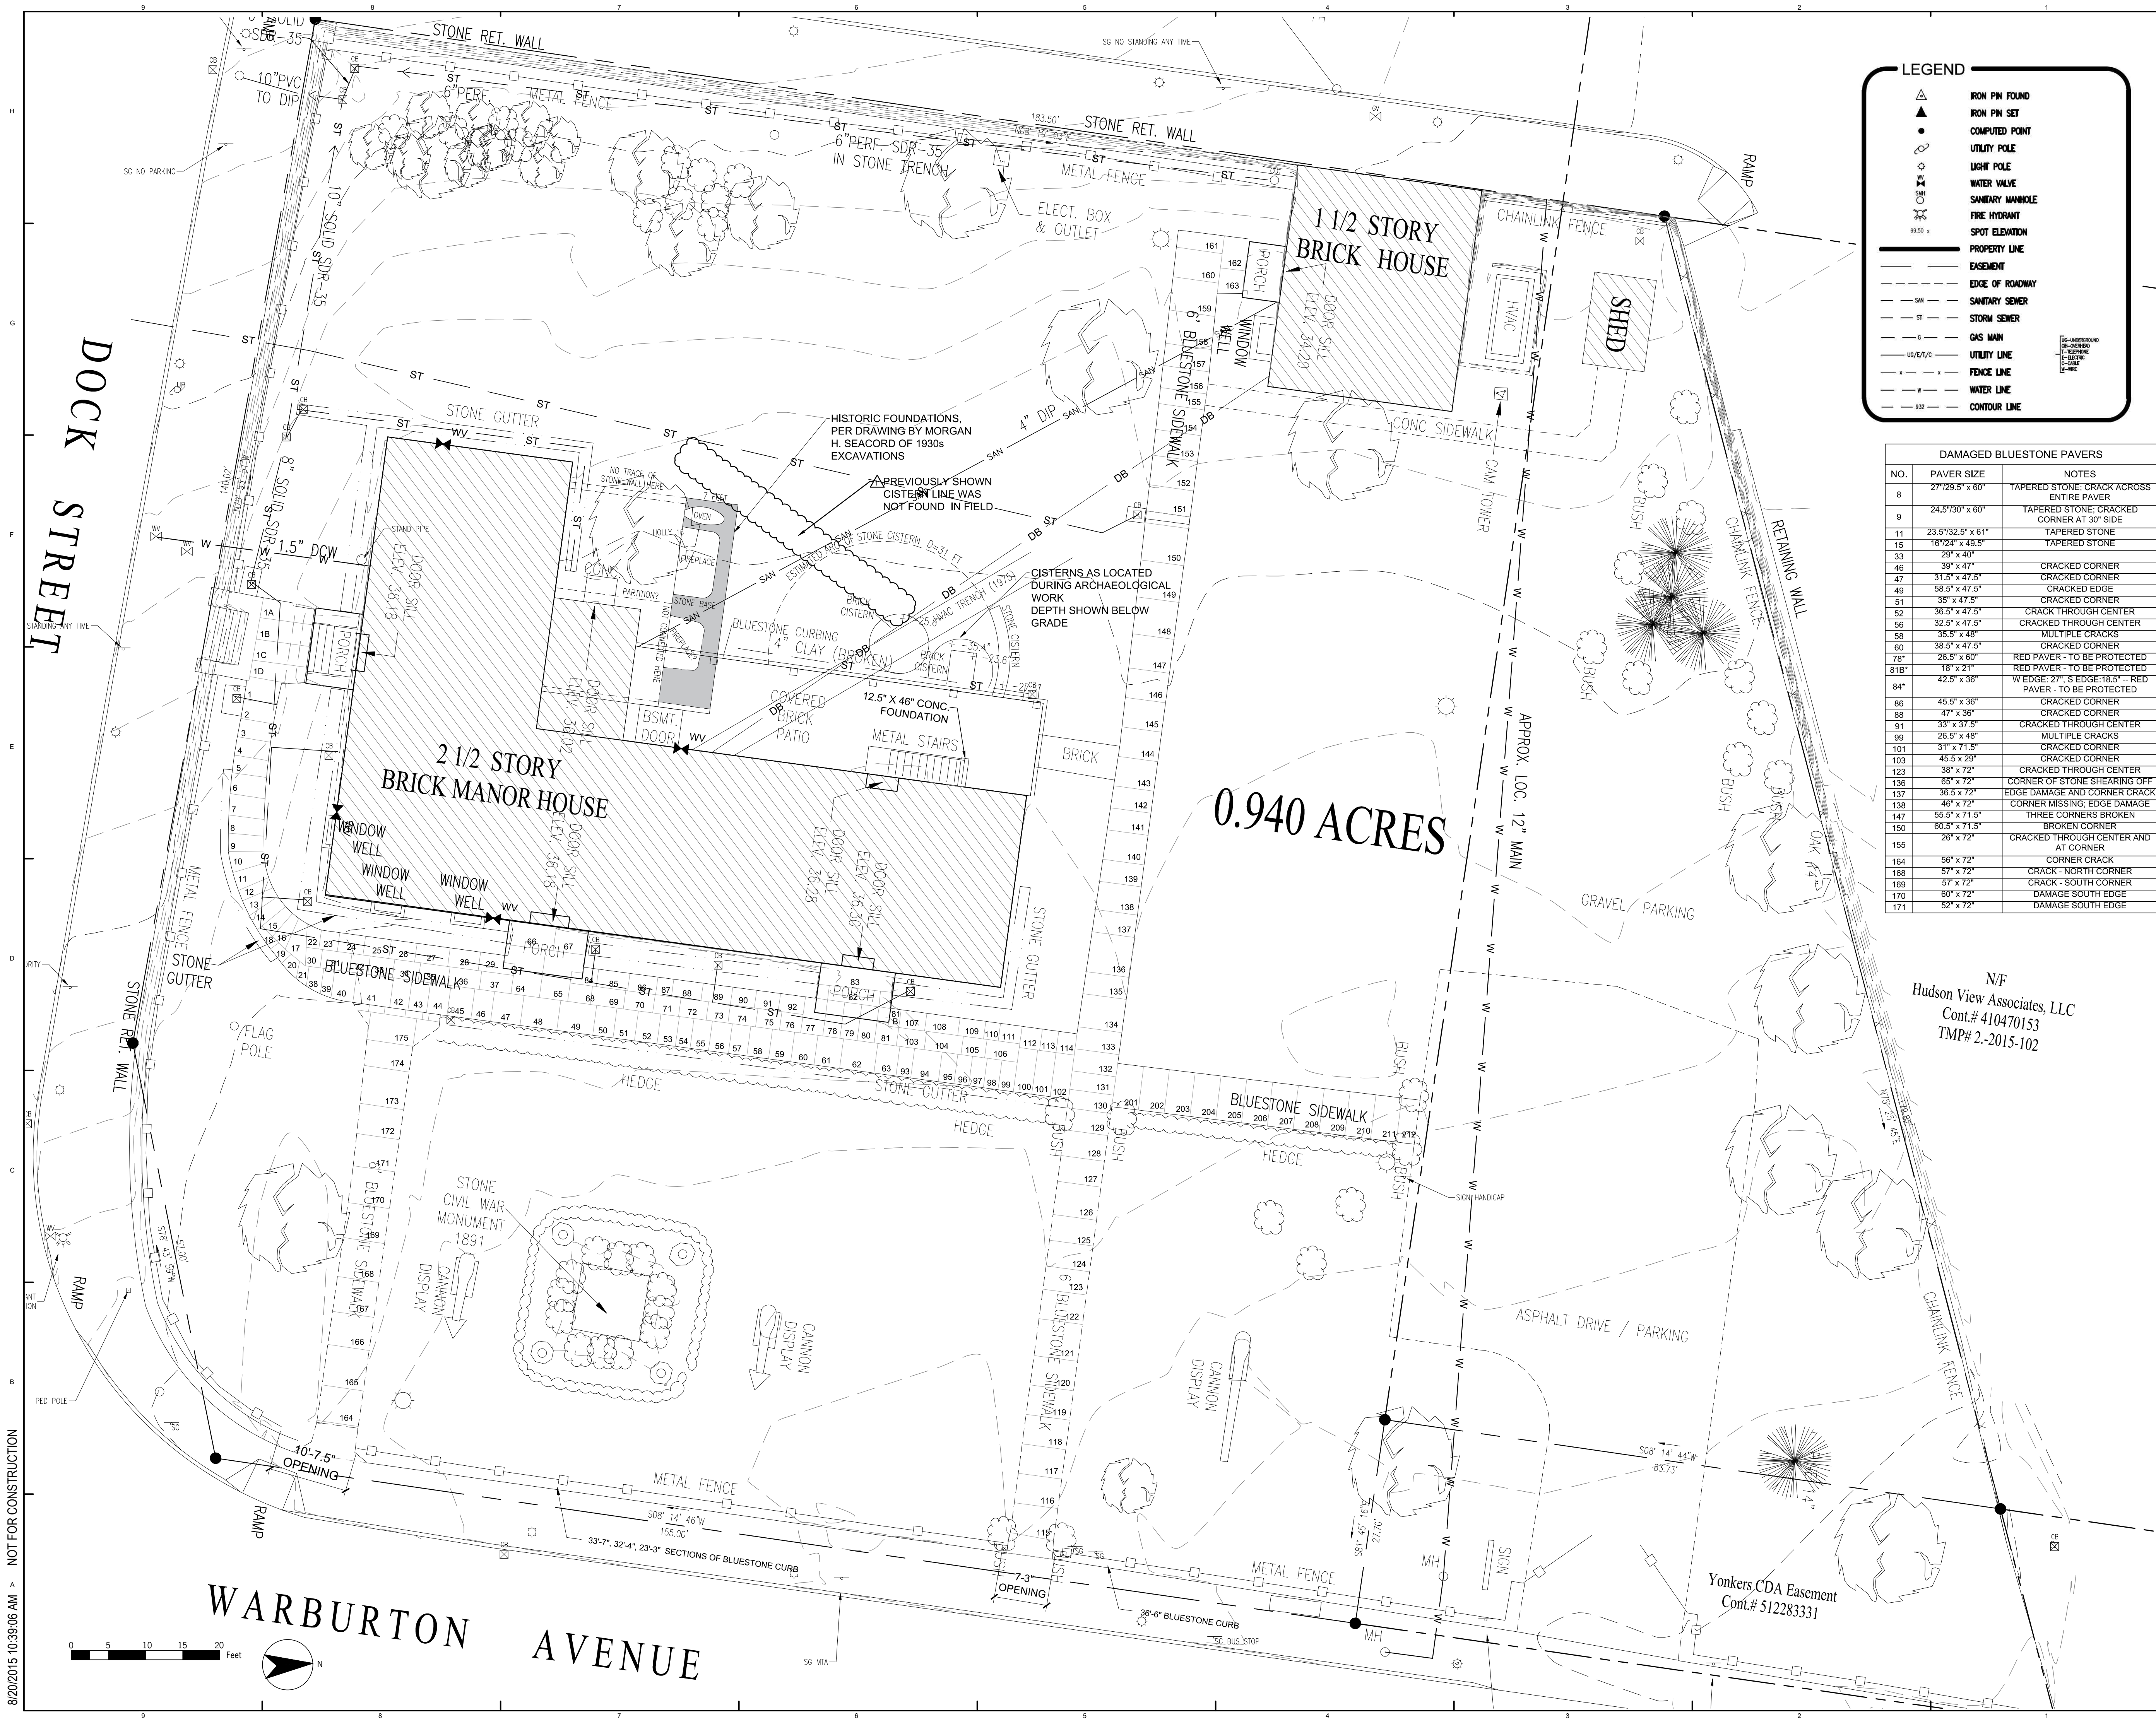
DAMAGED BLUESTONE PAVERS		
NO.	PAVER SIZE	NOTES
8	27"25.5" x 60"	TAPERED STONE; CRACK ACROSS ENTIRE PAVER
9	24.5"30" x 60"	TAPERED STONE; CRACKED CORNER AT 30" SIDE
11	23.5"32.5" x 61"	TAPERED STONE
15	16"24" x 48.5"	TAPERED STONE
35	28" x 40"	CRACKED CORNER
46	39" x 47"	CRACKED CORNER
47	31.5" x 47.5"	CRACKED CORNER
49	58.5" x 47.5"	CRACKED EDGE
51	39" x 47.5"	CRACKED CORNER
52	36.5" x 47.5"	CRACK THROUGH CENTER
56	32.5" x 47.5"	CRACKED THROUGH CENTER
58	35.5" x 48"	MULTIPLE CRACKS
60	38.5" x 47.5"	CRACKED CORNER
78*	26.5" x 60"	RED PAVER - TO BE PROTECTED
81B*	18" x 21"	RED PAVER - TO BE PROTECTED
84*	42.5" x 36"	W EDGE 37" S EDGE 18.5" RED PAVER - TO BE PROTECTED
86	45.5" x 36"	CRACKED CORNER
88	47" x 36"	CRACKED CORNER
91	33" x 37.5"	CRACKED THROUGH CENTER
99	28.5" x 48"	MULTIPLE CRACKS
101	31" x 71.5"	CRACKED CORNER
103	45.5" x 29"	CRACKED CORNER
123	38" x 72"	CRACKED THROUGH CENTER
136	65" x 72"	CORNER OF STONE SHEARING OFF

137	36.5" x 72"	EDGE DAMAGE AND CORNER CRACK
138	48" x 72"	CORNER MISSING; EDGE DAMAGE
147	55.5" x 71.5"	THREE CORNERS BROKEN
150	60.5" x 71.5"	BROKEN CORNER
155	26" x 72"	CRACKED THROUGH CENTER AND AT CORNER
164	56" x 72"	CORNER CRACK
168	57" x 72"	CRACK - NORTH CORNER
169	57" x 72"	CRACK - SOUTH CORNER
170	60" x 72"	DAMAGE SOUTH EDGE
171	52" x 72"	DAMAGE SOUTH EDGE
