Drawn By:  
Checked By:  
BDS Proj. #: 18-09  
Date: September 27, 2021

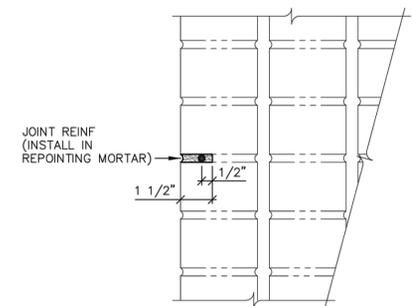
2 Elevation at Crack Repair  
SCALE: N.T.S.

NOTES:  
1. JOINT REINFORCEMENT TO EXTEND A MINIMUM 1'-6" BEYOND EDGE OF CRACK  
2. FOR CRACKS NEAR CORNERS BEND JOINT REINFORCEMENT AND EXTEND MINIMUM 1'-6" BEYOND CORNER
