TITLE
REPLACE ROOF
DOT REGION 8, ORANGE COUNTYLOCATION:
NYS NEWBURGH DOT FACILITY
112 DICKSON STREET
NEWBURGH, NY 12550CLIENT:
NEW YORK STATE
DEPARTMENT OF TRANSPORTATION

ELEVATIONS

A-102

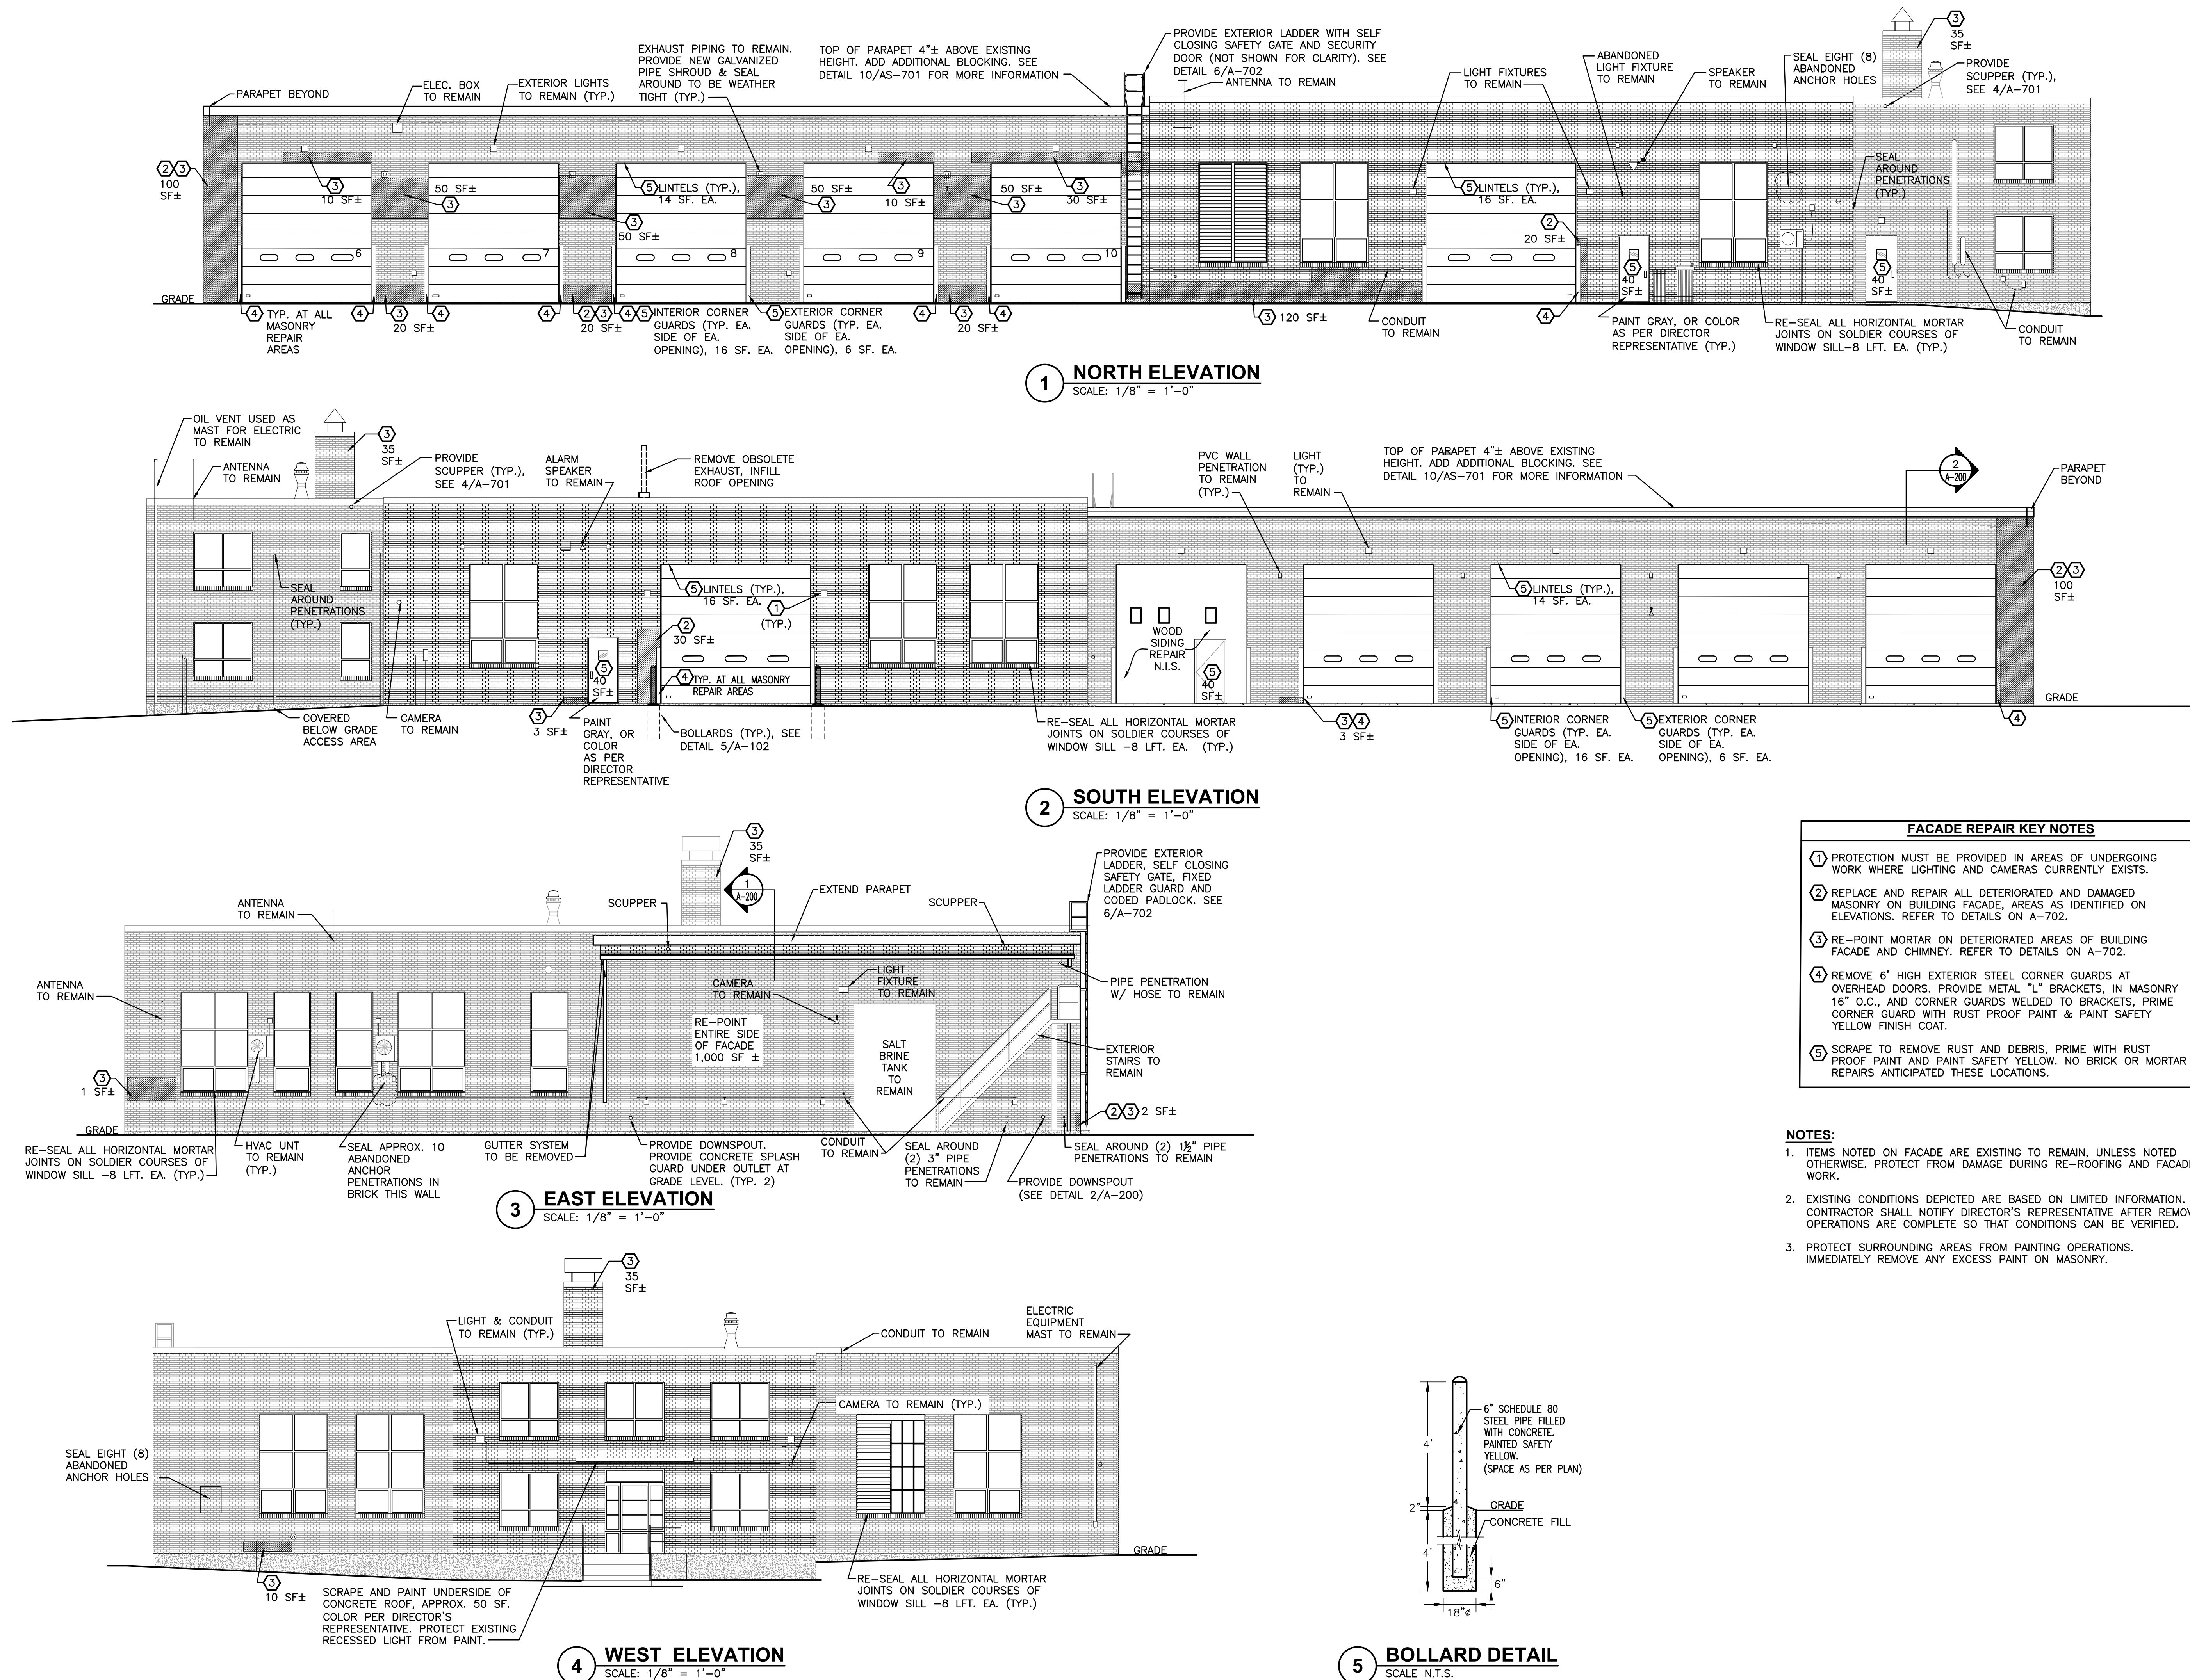
FACADE REPAIR KEY NOTES

- PROTECTION MUST BE PROVIDED IN AREAS OF UNDERGOING WORK WHERE LIGHTING AND CAMERAS CURRENTLY EXISTS.
- REPLACE AND REPAIR ALL DETERIORATED AND DAMAGED MASONRY ON BUILDING FACADE, AREAS AS IDENTIFIED ON ELEVATIONS. REFER TO DETAILS ON A-702.
- RE-POINT MORTAR ON DETERIORATED AREAS OF BUILDING FACADE AND CHIMNEY. REFER TO DETAILS ON A-702.
- REMOVE 6' HIGH EXTERIOR STEEL CORNER GUARDS AT OVERHEAD DOORS. PROVIDE METAL "L" BRACKETS, IN MASONRY 16" O.C., AND CORNER GUARDS WELDED TO BRACKETS. PRIME CORNER GUARD WITH RUST PROOF PAINT & PAINT SAFETY YELLOW FINISH COAT.
- SCRAPE TO REMOVE RUST AND DEBRIS. PRIME WITH RUST PROOF PAINT AND PAINT SAFETY YELLOW. NO BRICK OR MORTAR REPAIRS ANTICIPATED THESE LOCATIONS.
