TA-JJ-2023-001  
JOHN JAY HOMESTEAD: SITE AND BUILDING ENHANCEMENTS  
JOHN JAY HOMESTEAD STATE HISTORIC SITE

### Hazardous Materials Investigation Report –1/31/2024

# HAZARDOUS MATERIALS INVESTIGATION REPORT

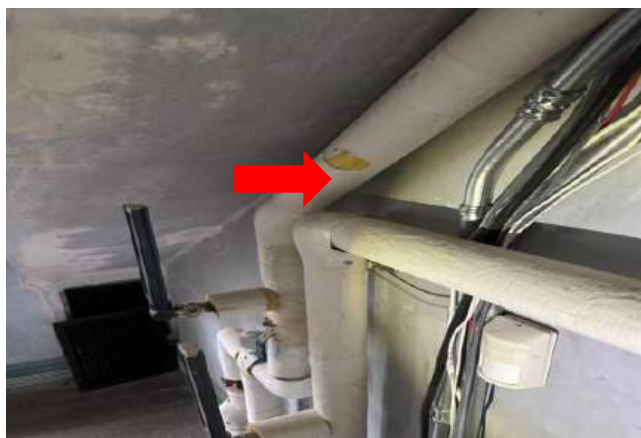
### PHOTO 40

Material: All Service Jacket to Fiberglass Pipe Insulation (HA-BH-04)  
Location: Bedford House- Third Floor

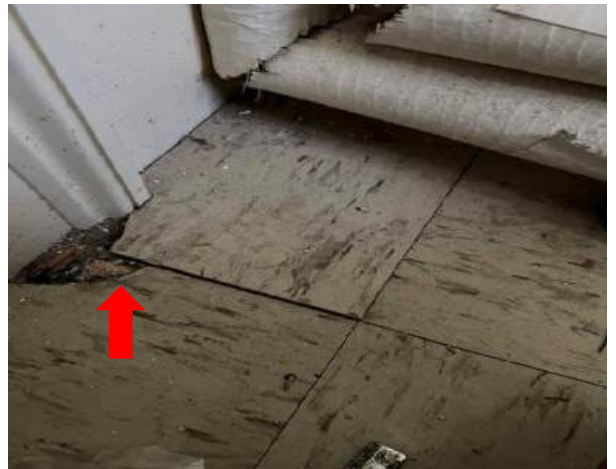
ACM: Multi-Layer Floor Tile Composite (HA-BH-06M/06)

Location: Bedford House – Second Floor

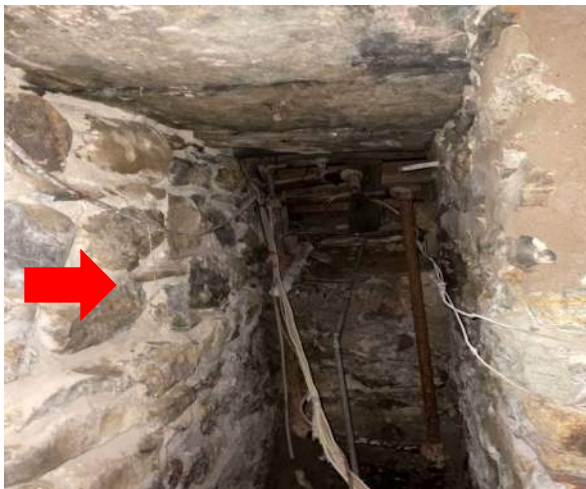
### PHOTO 43

Material: Skim Coat to Rubble Wall (HA-BH-07)

Location: Bedford House - Basement

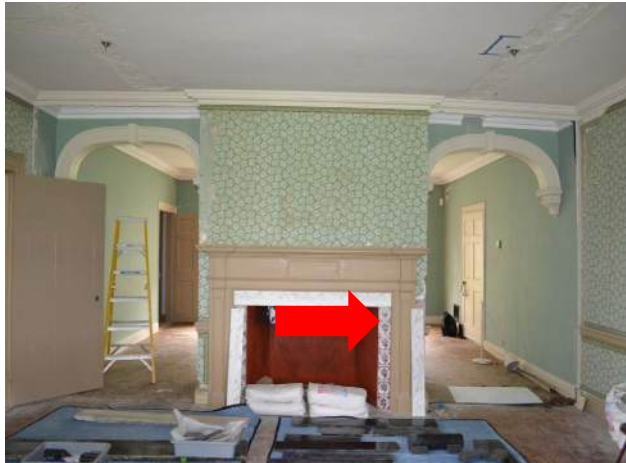
### PHOTO 45

Material: Ceramic Chimney Tile Grout and Mortar (HA-BH-09M/09G)  
Location: Bedford House – 1<sup>st</sup> Floor Room B102

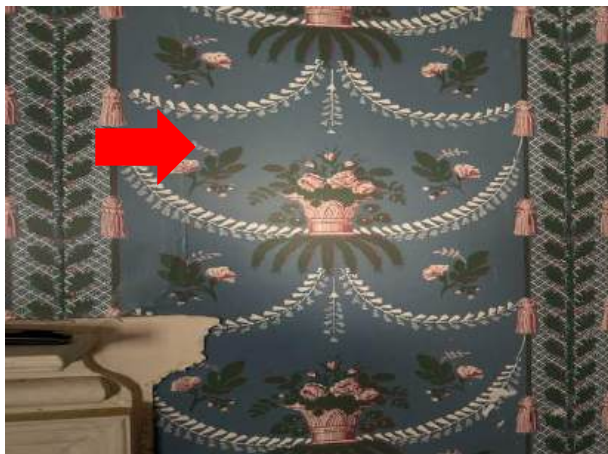
### PHOTO 51

Material: Blue Flower Pot Patterned Wallpaper (HA-BH-15)  
Location: Bedford House – 1<sup>st</sup> Floor Room B204

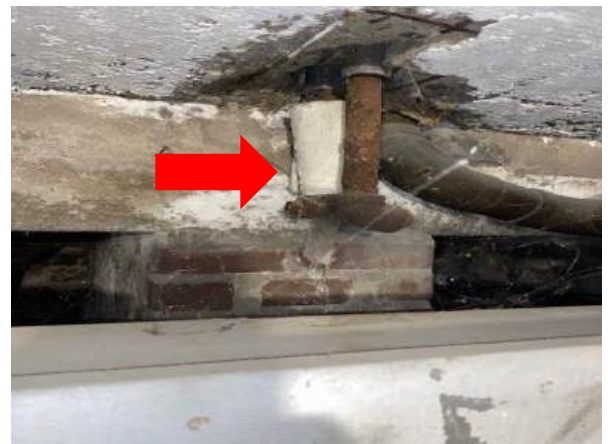
### PHOTO 52

ACM: Corrugated Pipe Insulation and Associated Jacket (HA-BH-16-L1/L2)  
Location: Bedford House – B17

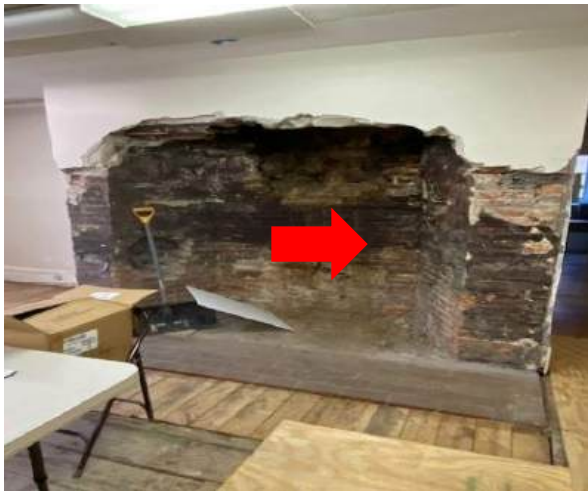
### PHOTO 53

Material: Chimney Liner (HA-BH-17)  
Location: Bedford House – 1<sup>st</sup> Floor Room B16
